Service Bulletin

Subject: Wind Buffeting Drone Type Noise And/Or Body Pressure Booming And/Or Water Leak

Models: 2015 Cadillac Escalade Models
2015 Chevrolet Suburban, Tahoe
2015 GMC Yukon Models
Vehicles Built Prior to 7/9/2015

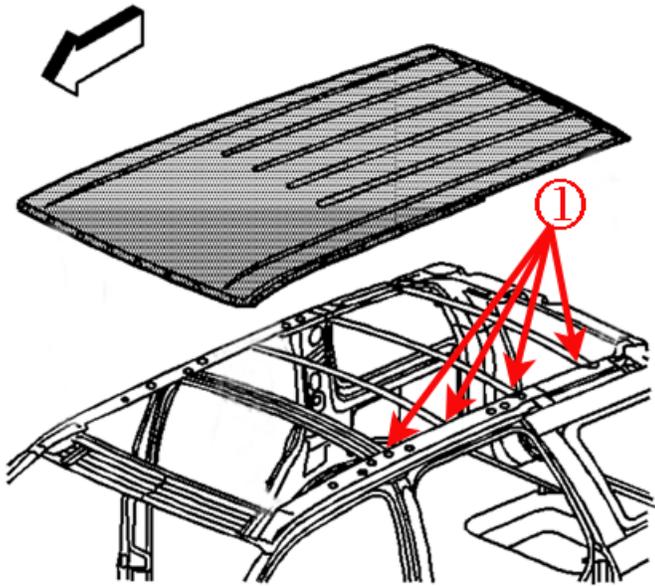
Some owners may comment of a wind buffeting/drone noise or body/pressure booming (the feeling of pressure in the ears) while driving. The body booming issue may be more noticeable when the engine is in V4 mode for active fuel management (AFM). These concerns may be caused or amplified by the roof sheet metal no longer being attached fully to the roof bows (1).

Correction for Condition 1

Remove the headliner to access the underside of the roof. Carefully inspect the front and rear sides of all 4 roof bows for insufficient bonding to the roof sheet metal (4). Press upward on the roof sheet metal to expose any separated sealer that may not be evident at first glance. Any roof bow that is not bonded to the sheet metal will need to be repaired. Note: The bonding does not have to contact the roof at the reinforcement ribs.

To correct this concern, remove the old bonding material, and apply panel vibration control material between the roof bows and roof sheet metal.

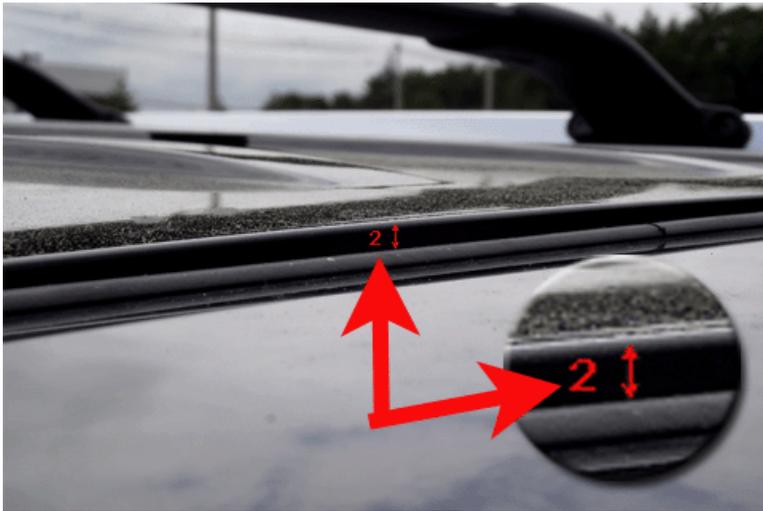
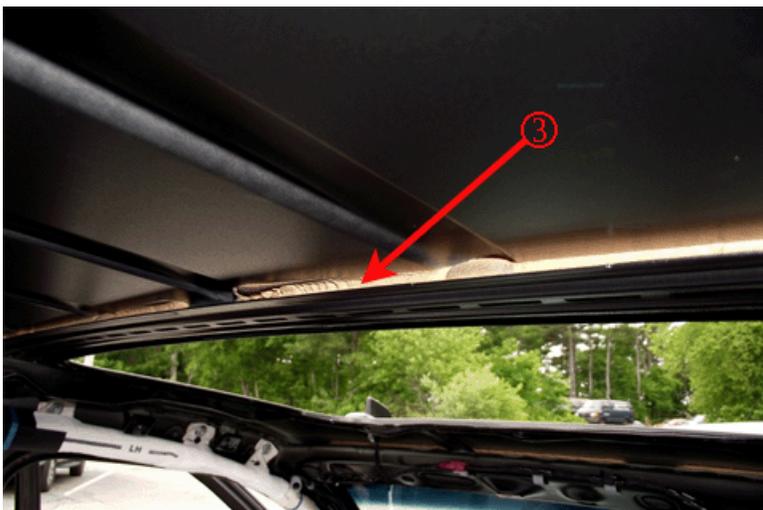
On sunroof equipped truck, they may also notice a water leak from the headliner area. It may be found that the rear edge of the sunroof glass is considerably lower than the roof (2), even after performing a sunroof glass height adjustment. This is due to the roof sheet metal being detached from the roof bow directly behind the sunroof opening (3).

Correction for Condition 2

Repair for 1st bow on trucks equipped with a sunroof.

1. Provide protection for the carpet and seats beneath the roof bow.
2. Using mechanics wire, and a plastic scraper or similar tool, remove the old foam.
3. Apply the panel control vibration material (listed below) along the top of the 1st roof bow, on both front and rear surfaces.
4. Obtain two 2x4 pieces of wood long enough to span the opening of the sunroof. Wrap one of the 2x4's with a cloth to protect the roof paint and place it on top of the roof, see Important Note below.
5. Place the second 2x4 underneath the roof bow, sandwiching the roof sheet metal and roof bow between the two pieces of wood.
6. Clamp everything together using three C-clamps as shown in the photo below (5 & 6). The clamps will need to stay in place until the panel control vibration material is dry.
