Service Bulletin

PRELIMINARY INFORMATION

Subject: Intermittent Or No Audio With DTC U0186 or B1325 sym03

Models: 2013-2015 Cadillac ATS Sedan
2015 Cadillac ATS Coupe
2014-2015 Cadillac CTS Sedan (VIN A)

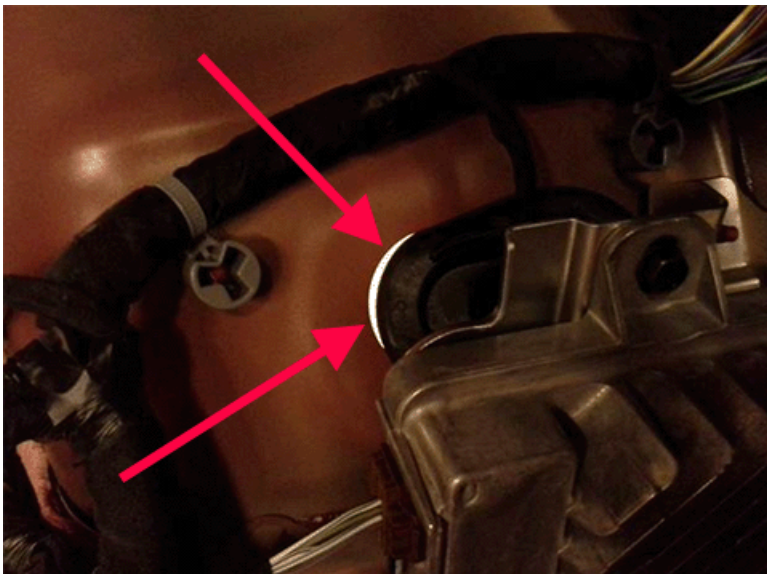
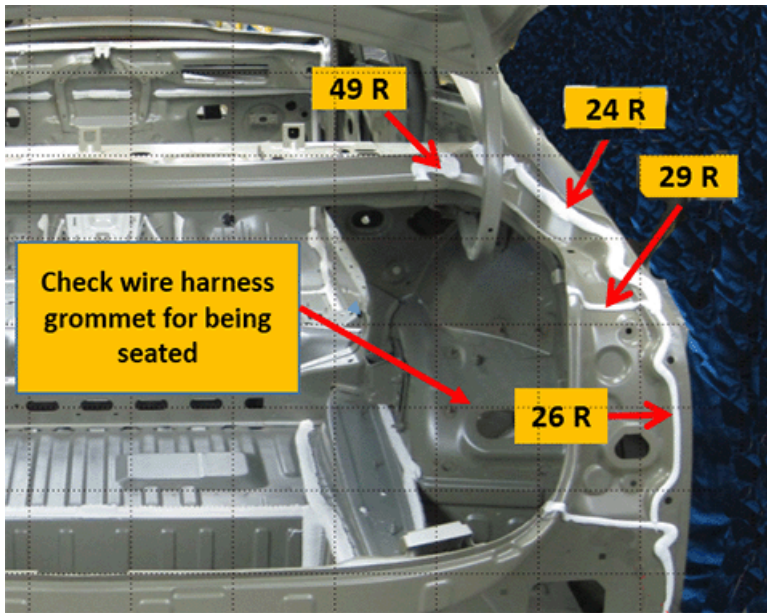
Some customers may comment that they have intermittent or no audio. When checking for DTC's, technicians may find B1325 sym03 in the amplifier or no communication with the amplifier and a U0186 set in other modules.

If this is encountered, inspect the trunk area for water intrusion. Amplifiers that have been returned to the WPC (Warranty Parts Center) have evidence of water intrusion causing the amplifier to fail. Water has been known to travel down the harness entering the amplifier through the connector. Repair the area of water intrusion prior to replacing the amplifier to correct this concern. Refer to the diagnostic tips and pictures below

- Visually inspect the trunk opening to deck lid seal. Ensure the seal is not pinched, crimped, or rolled. Water test the deck lid to check the seal integrity. Repair/replace the deck lid seal as needed.
- Remove the Trunk liner and trim. Inspect the wire harness that enters at the right wheelhouse in front of the amplifier. Ensure the grommet is properly installed as water may wick into the harness of the amplifier. Water test the wire harness grommet at the wheelhouse.
- Water test the body seams 24R and 49R (see attached picture) starting at the tail lamps working your way up to the back glass. If water intrusion appears to be in one of the body seams apply soap/water mixture to the seam and apply low pressure shop air (20 PSI or less to avoid damaging the seal) and look for signs of air leakage/bubbles. Repair the body seam as required.
- Water test the rear glass
