Service Bulletin

PRELIMINARY INFORMATION

Subject: Duramax Diesel Hard Start No Start P0087 P0088 P0191 P128E Or Injection Pump Replacement

Models: 2010 - 2015 Chevrolet Express and Silverado
2010 - 2015 GMC Savana and Sierra
Equipped with the 6.6L Duramax Diesel RPO codes LGH and LML

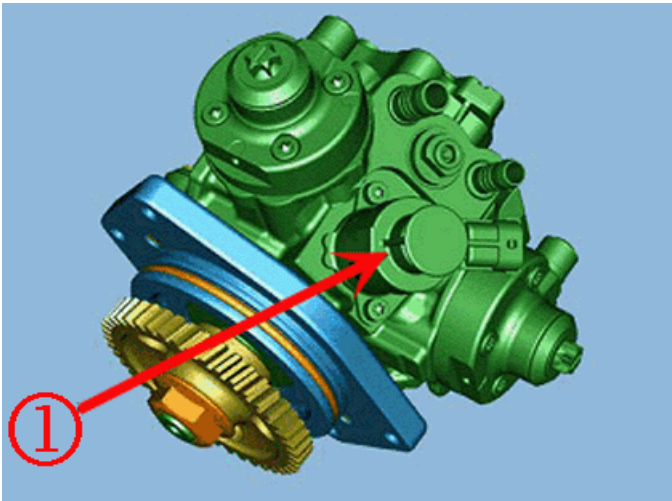
Remove the Fuel Injection Pump / Pressure Regulator 1 for inspection.

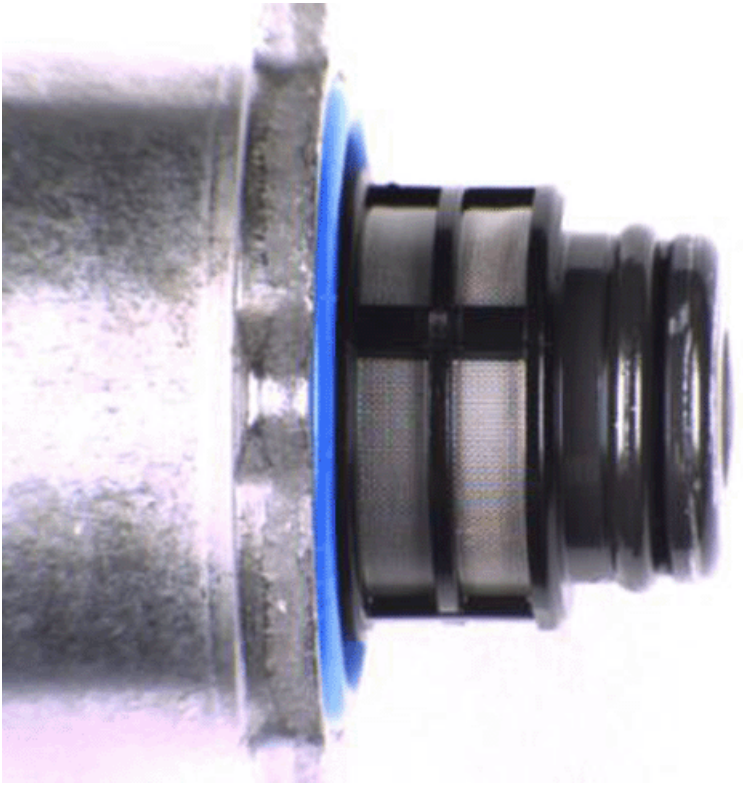
The picture above is an example of a clean Pressure Regulator 1

If Pressure Regulator 1 has no debris on the screen, complete the SI repair procedure and replace the Fuel Injection Pump.

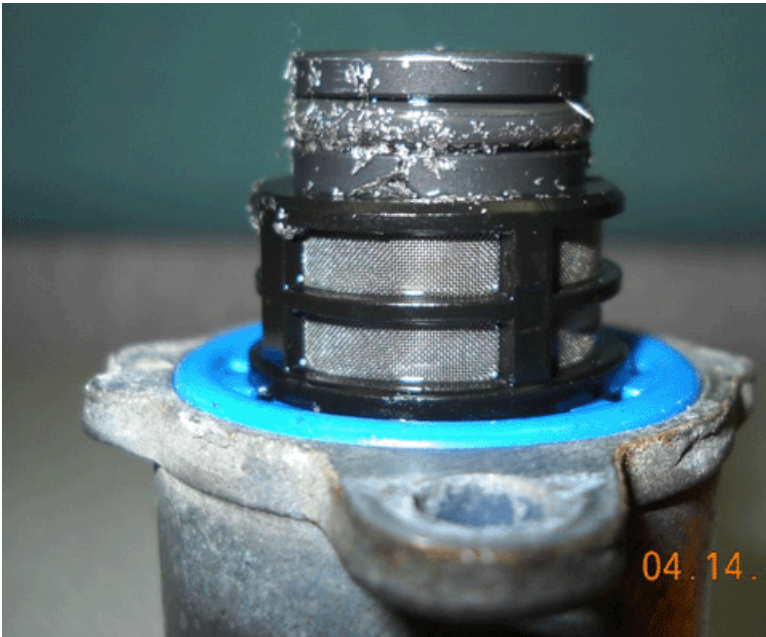
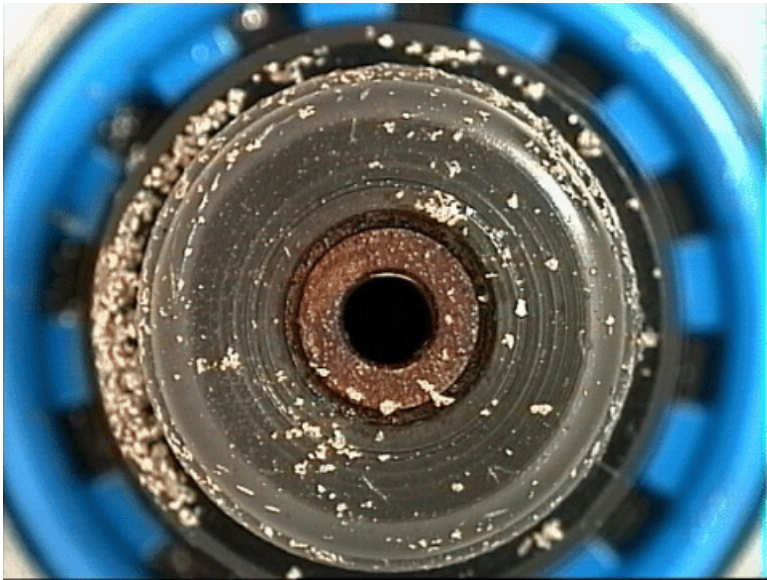
The pictures above are examples of Pressure Regulator 1 with the magnetic debris described

If magnetic debris described above is found, complete the following repairs:

1. Replace all of the parts listed under the latest version of PIP4949 found in the Service Forms section of Global Connect.
2. Clean and flush all fuel chassis lines, filter pipes, and other engine mounted fuel system pipes not replaced.
3. The fuel filter housing must be cleaned with a new fuel filter installed
4. The fuel tank and fuel sender must be cleaned and flushed.

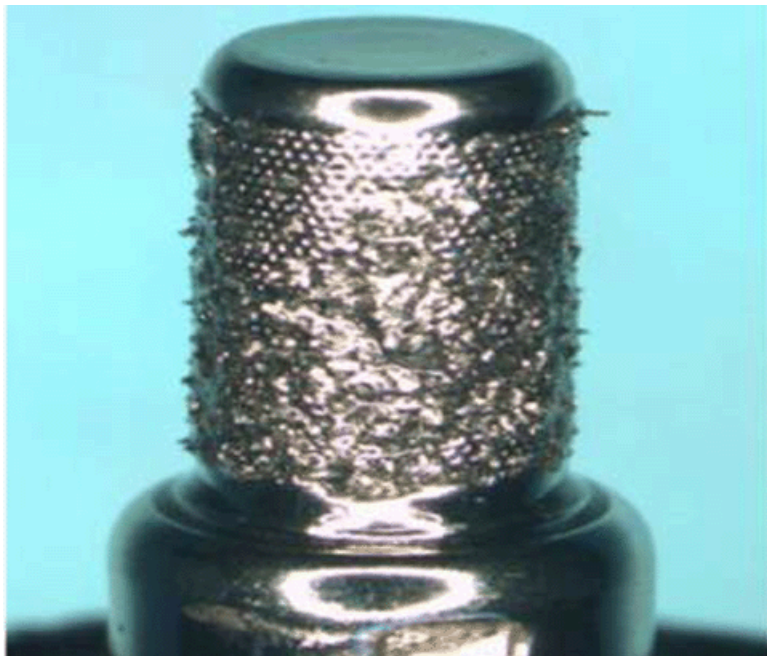
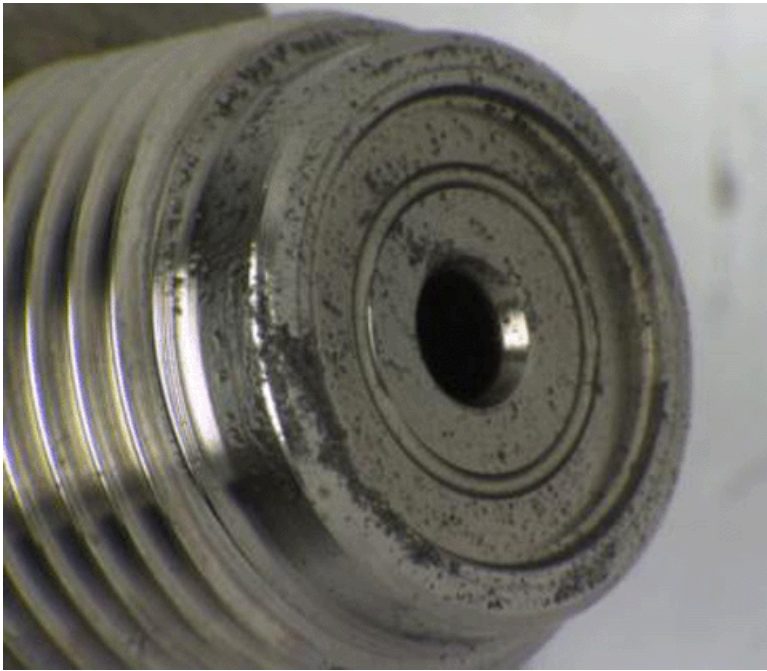
If there is a questionable amount of magnetic debris found on Pressure Regulator 1 remove the Fuel Rail Pressure Sensor and/or Fuel Pressure Regulator 2 (Pressure Relief Valve) for inspection.

If additional magnetic debris is found on the Fuel Rail Pressure Sensor and/or Fuel Pressure Regulator 2 (Pressure Relief Valve) the Fuel Injection Pump is experiencing the condition described.
