Service Bulletin

PRELIMINARY INFORMATION

Subject: Rough Harsh Ride

Models: 2015 GMC Sierra 1500 Denali
With Magnetic Ride Control Suspension (RPO Z95)
Vehicles Built Before 2/24/2015

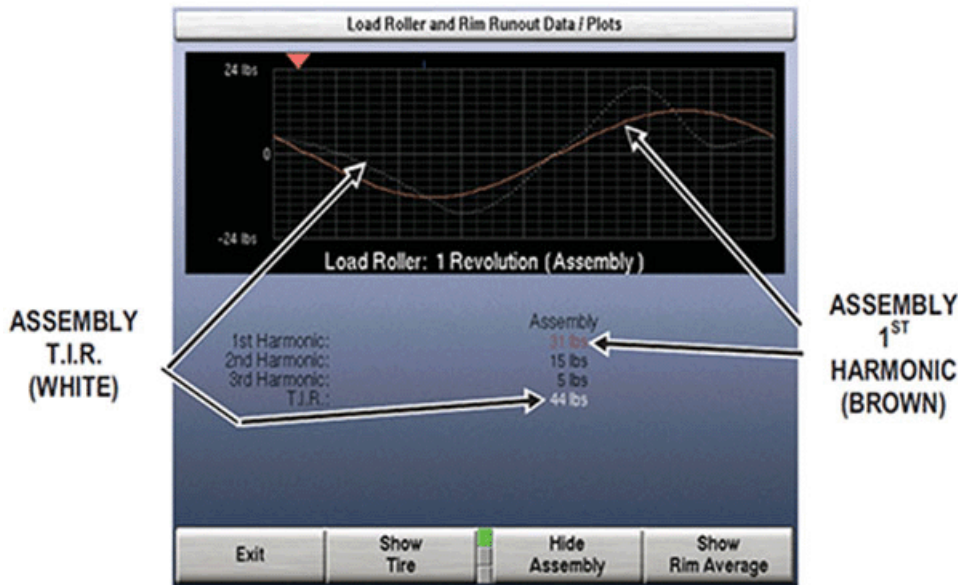
The GSP9700 is set to display T1 RFV. Higher order RFV, T2 & T3 can be displayed in the Assembly Data Plots Screen, as shown above. Depending on the level of GSP9700, the screen may be under 'Data' or 'Runout Plots,' then "Rim and Load Roller Runout Plots."

When checking tires on the GSP9700, if (radial) T2 is high or close to the (radial) T1 value, the tire should be replaced. As an example, if a tire and wheel assembly is measuring T1 at 10 lbs RFV, the tire would be considered good; however, if in displaying the higher orders, it is found that the tire and wheel assembly also has T2 at say 9 lbs RFV, the tire needs to be replaced. Refer to the latest version of PI1354 for latest procedures.
