Service Bulletin

PRELIMINARY INFORMATION

Subject: Engine Replacement Recommendations HFV6 Gen 1 Only

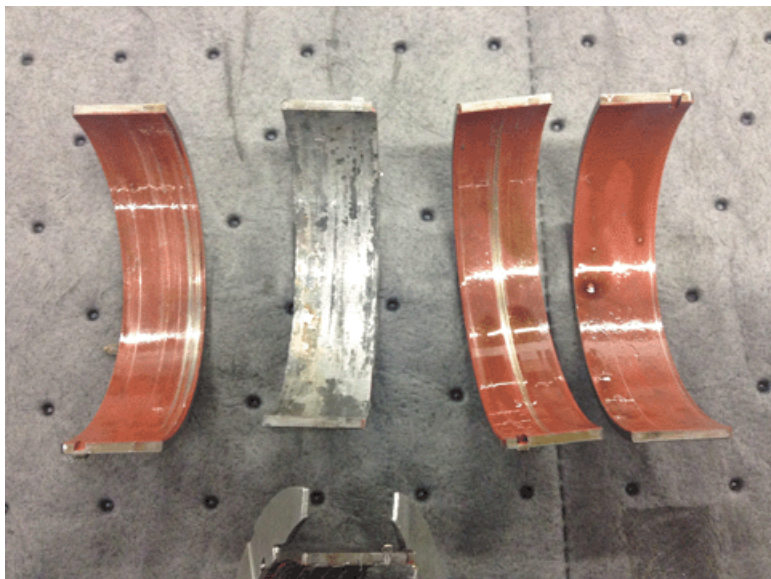
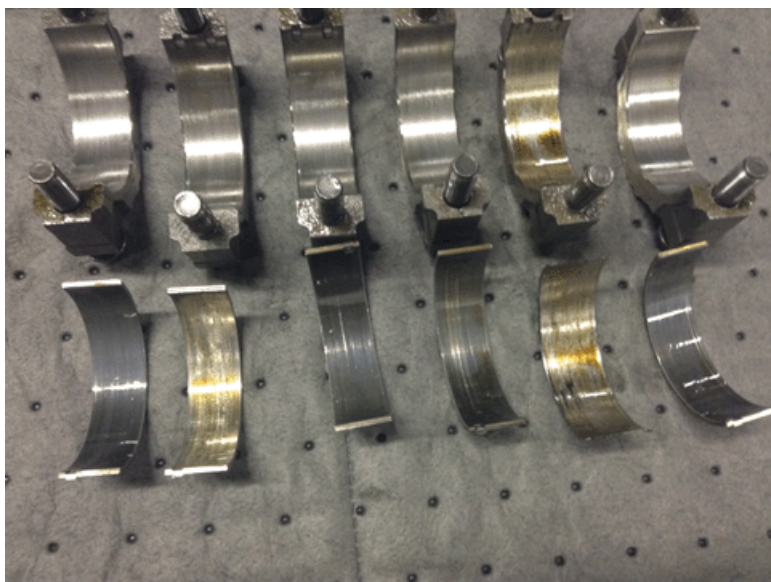
First, verify there is metal in the engine oil caused by BEARING DAMAGE / debris by removing the oil pan.

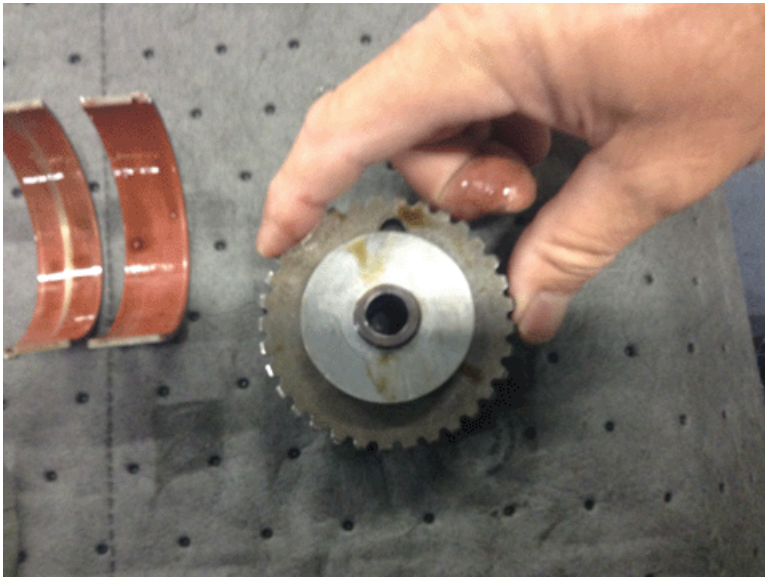
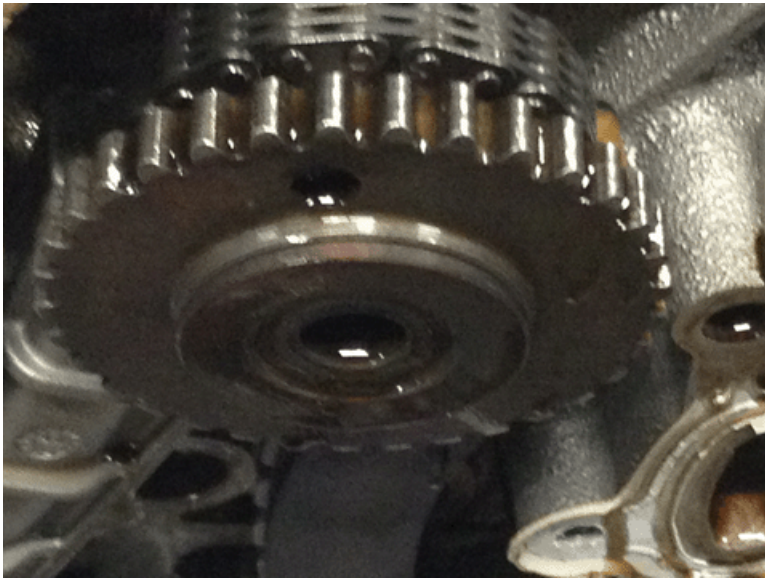
3. Inspect the timing chain idler sprockets for stiffness when turning. (Should turn smooth and free)

Any Of These 3 instances would be cause to replace the engine instead of repair.
