# Service Bulletin

**Subject:** Convertible Roof Cloth Sags At Rear / Large Gap Between Number 5 Bow And Rear Panel

**Models:** 2011 - 2013 Chevrolet Camaro Convertible  
Built prior to VIN D9801462

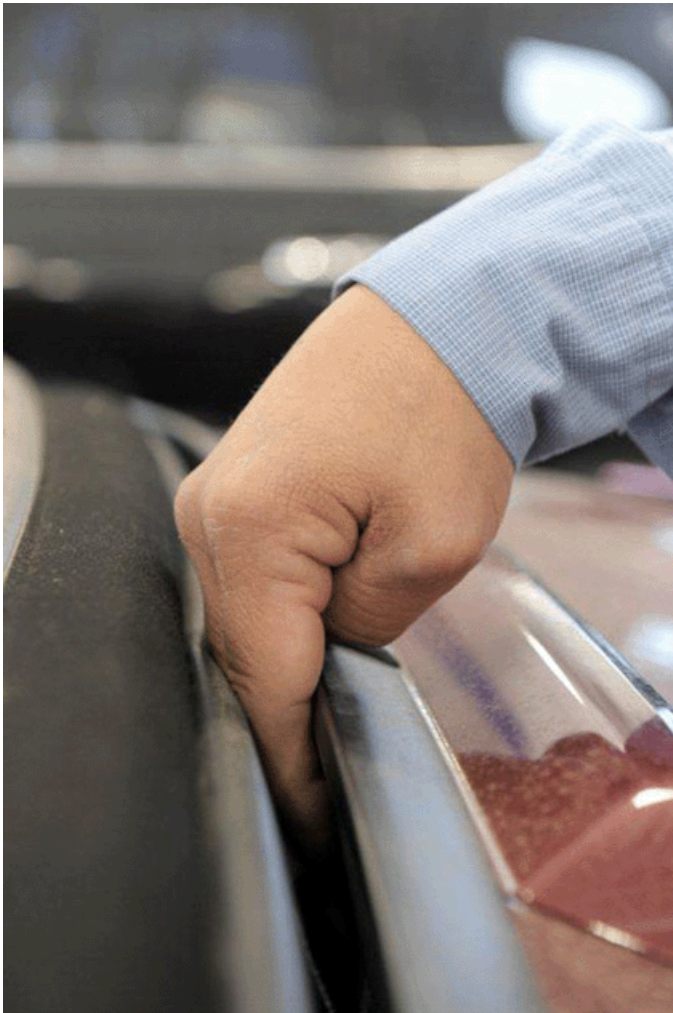
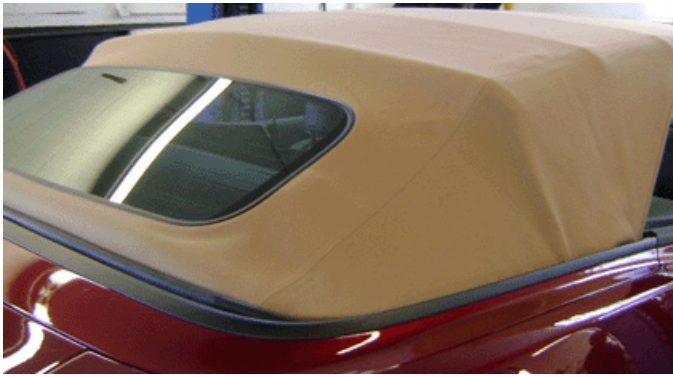
A dealer may report that there is a large gap between the #5 bow and the rear "tulip" panel when the top is closed and latched. This may cause a sag in the cloth top material, causing the appearance of a loose fit.

Replace the #5 bow as well as both LH and RH Folding Top Pivot Brackets following the repair procedures in SI. The pivot brackets use an updated design which will lessen the chance of damage to the 5th bow/brackets in the future.

Immediately following replacement of the #5 bow assembly or any time the top assembly has been removed from the vehicle and prior to cycling the top for the first time, it is imperative that service technicians follow the latest version of PI0406 to ensure that the Folding Top Quarter Outer Drain Panel (water management bag) is not interfering with the top assembly.
