Service Bulletin

PRELIMINARY INFORMATION

Subject: Diagnostic Tips - Unwanted Content Theft Alarm Sounds

Models: 2015-2016 Cadillac Escalade
2015-2016 Chevrolet Suburban, Tahoe
2015-2016 GMC Yukon
With Theft Protection Package (RPO UTT)

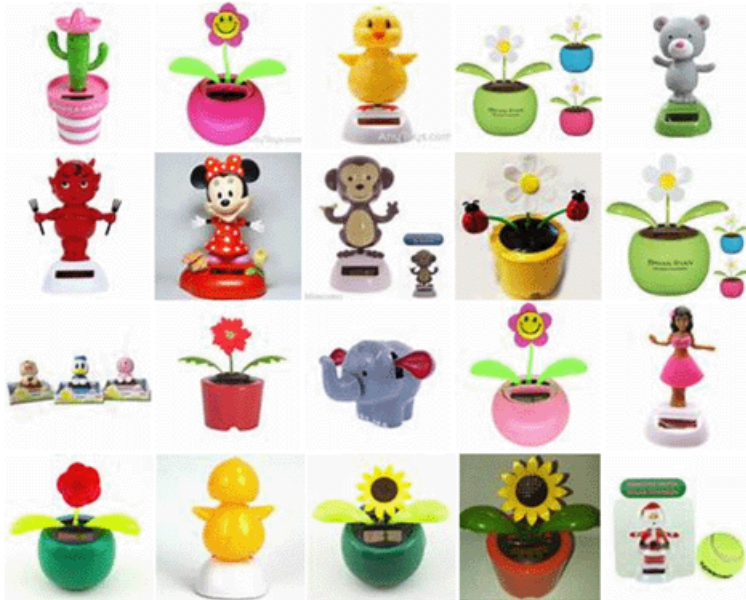
1. Intrusion- Located in the over-head console are ultrasonic intrusion sensors. These sensors are used to detect motion inside the vehicle. There have been reports of pets, items hanging from the rear view mirror, solar powered dancing characters (examples below), etc. moving inside the vehicle and triggering the alarm. These items will have to be removed and the system retested before performing any additional diagnostics.
