# Service Bulletin

## PRELIMINARY INFORMATION

**Subject:** Engine Vibration - Resonance/Boom Between 40 To 60 MPH

**Models:** 2010 - 2016 Chevrolet Equinox  
2010 - 2016 GMC Terrain  
Equipped With the 2.4 Cylinder Engine (RPO's LAF and LEA )

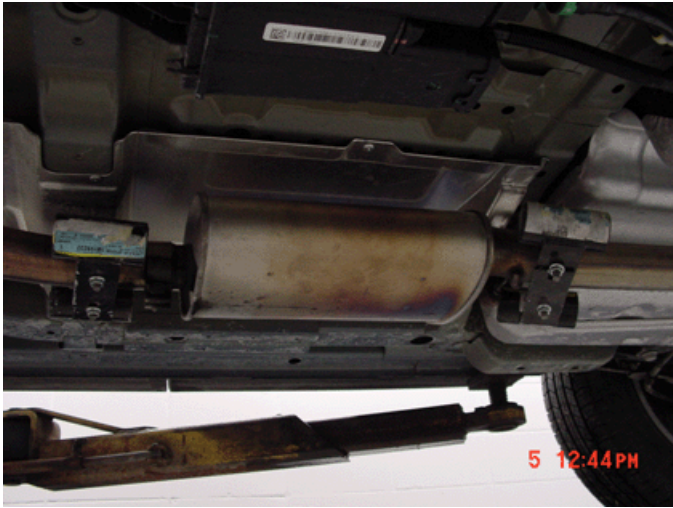
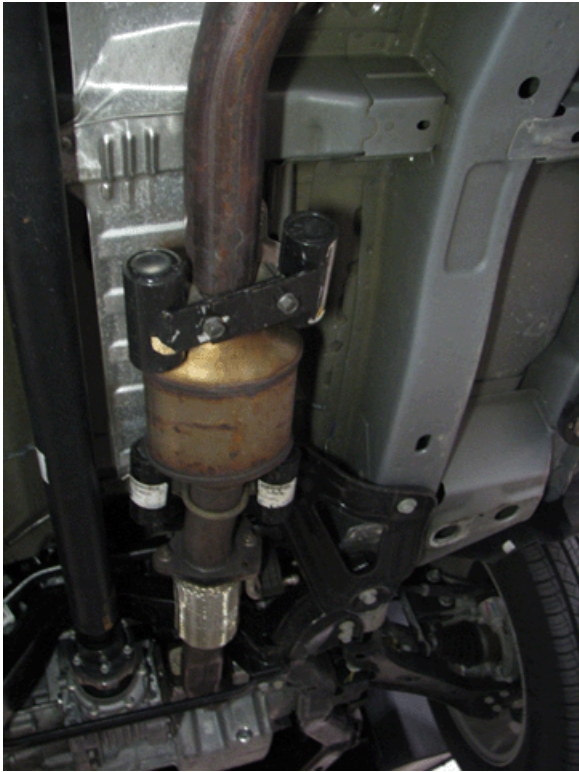
Some customers may comment that a resonance type vibration occurs between 40 to 60 MPH.

In most cases the engine must be under a slight load such as A/C compressor engagement, light throttle, and in 6th gear tcc applied.

It also is described as a 2nd order engine boom or vibration. In most cases this is an inherent condition on 4 cylinder models, however in some cases this condition is much more amplified.

If additional steps are required place two sets of exhaust dampeners (part #10199232 and attach with 2 1/2" exhaust clamps, part #15595206) one set before and one set after the front catalytic converter.

It may be required to move the pair of dampeners along the exhaust system to get the best results (photos attached).

Fabricate 2 dampers using the following procedure:

1. Obtain 4 dampeners, Part Number 10199232.
2. Line up 2 dampeners so the dampener pipes are opposite of each other.
3. Line up one mounting hole from each dampener with the holes of an appropriate size exhaust clamp.
4. With all of the holes lined up, weld the flat portion of the dampeners together and to the flat part of the exhaust clamp.
5. Attach the dampeners to the exhaust system using exhaust clamps.
