Bulletin No.: PIC6140A

Service Bulletin

Subject: Red LED and B2455 After Performing Canada Upgrade Bulletin 15-08-44-001

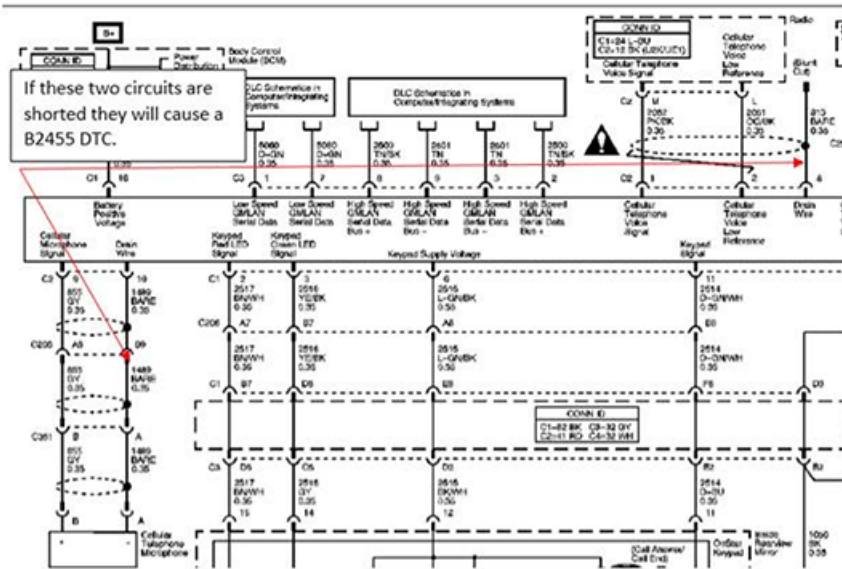
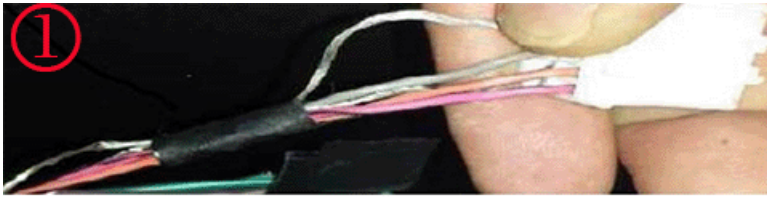
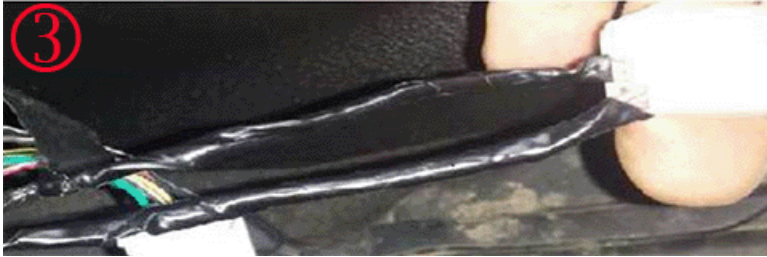
A dealer or customer may notice a red LED and DTC B2455 setting current in the VCIM after performing Canada upgrade bulletin 15-08-44-001.

1. It has been found that a short between the audio drain wire and microphone drain wire will cause this concern.
2. Pull back the tape at X2 of the VCIM far enough to see where the bare wires are covered.
3. Tape the bare wires individually to prevent them from shorting. Then tape the harness back up.
