January 2015

## On-Road

## Interpreting Trouble Codes

## **Erratic Shifting, But No DTCs**

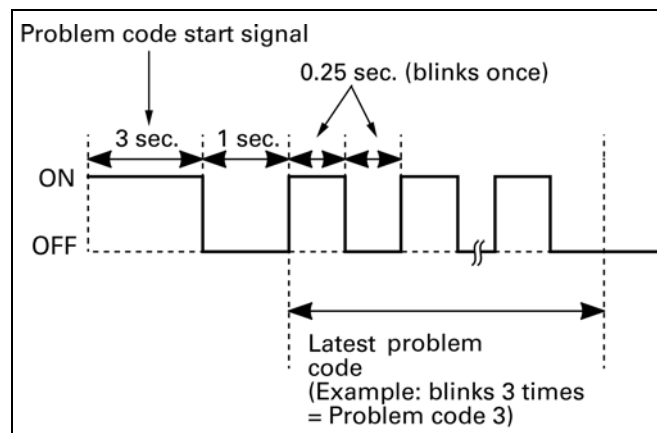
### **First Generation ABS (ST1100, GL1800, ST1300)**

It should be noted that the ABS indicator blink pattern for this system flashes only short blinks to indicate the problem code. *The long blink (3 seconds) in this system only indicates the problem code start signal (not "10" as is typical of PGM-FI and Second Generation ABS trouble codes).*

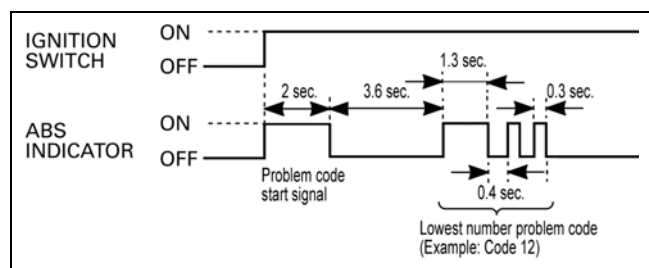
### **Second Generation ABS (FSC600A, VT1300CXA)**

This system flashes a blink pattern similar to a PGM-FI Malfunction Indicator Lamp (MIL) code, where one long blink (1.3 seconds) is equivalent to 10 short blinks; so that one long blink, followed by two short blinks equals problem code 12.

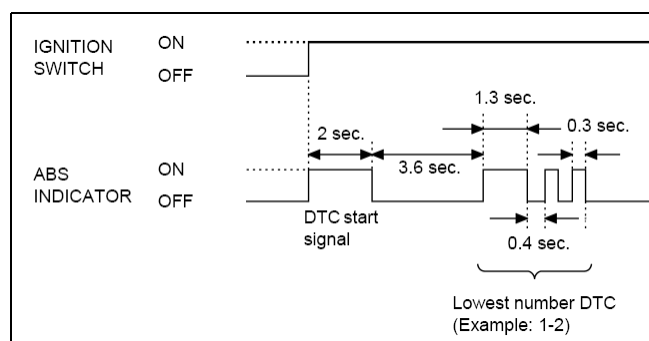
### **Third Generation ABS & CABS (VFR800F, CBR1000RA)**

These ABS systems use a two-part Diagnostic Trouble Code (DTC), like PGM-FI trouble codes, where the blink pattern includes a long blink(s) (1.3 seconds) to indicate the first digit of the code and short blinks to indicate the second digit of the code.

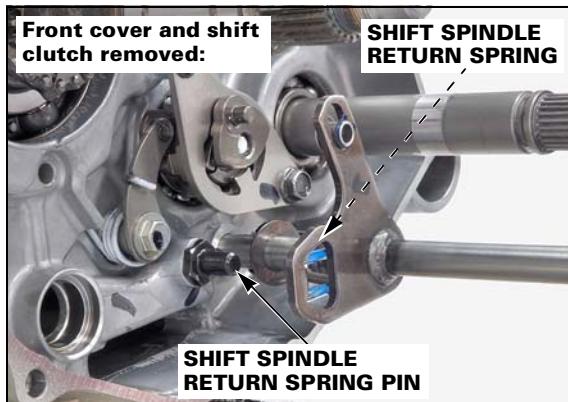
First, make sure the problem is not something simple, like the transmission is hung up between gears due to customer mis-use (See The Wrench, July 2014). If the shifting problem is repeatable and there are no Diagnostic Trouble Codes (DTC), the gear shift spindle return spring pin may be broken. The pin, along with the shift return spring, returns the shift spindle to its "at rest" position.

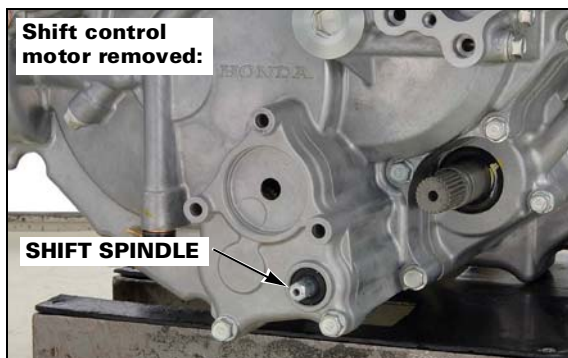
The easy way to check whether the pin is broken is to remove the shift control motor (a must, trust us) and then check for spring tension on the shift spindle by attaching an 8 mm box-end wrench to the end of the spindle and turning the wrench in both directions.

You should be able to feel the spring tension from the shift spindle return spring. If there is no ten-

sion, the shift spindle return spring pin is broken and needs to be replaced. Be sure to replace the shift angle sensor as well.
