MIN – 15106

20 May 2015

Installation of Harness Part Number 4047811C92

ProStar® vehicles involved in Safety Recall 14516, originally retrofitted with 4047811C91 Battery Cable Harness.

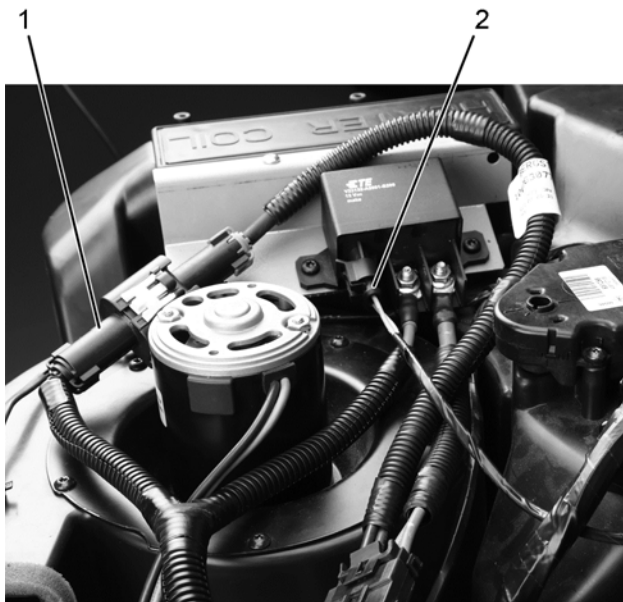
Figure 1. Power Center Harness to Relay Assembly Connection.

1. Battery power supply ground harness
2. Power center harness

7. Disconnect power center harness (Figure 1, Item 2).

8. Disconnect battery power supply ground harness (Figure 1, Item 1).

12. Connect power center harness (Figure 1, Item 2).

13. Connect battery power supply ground harness (Figure 1, Item 1).

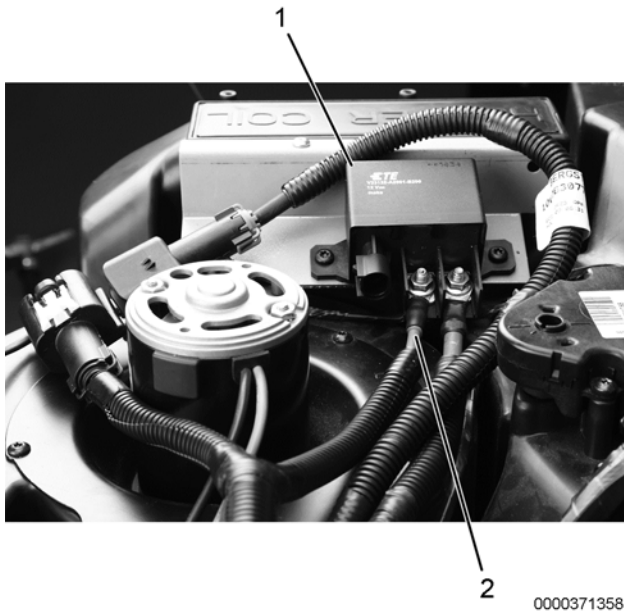
Figure 2. Battery Power Harness to Relay Assembly Connection.

1. 150 amp relay assembly
2. Battery power supply harness

9. Disconnect battery power supply harness (Figure 2, Item 2) at relay assembly (Figure 2, Item 1).

10. Remove battery power supply harness from vehicle and discard.

11. Obtain replacement harness and connect battery power supply harness (Figure 2, Item 2) to relay assembly (Figure 2, Item 1).

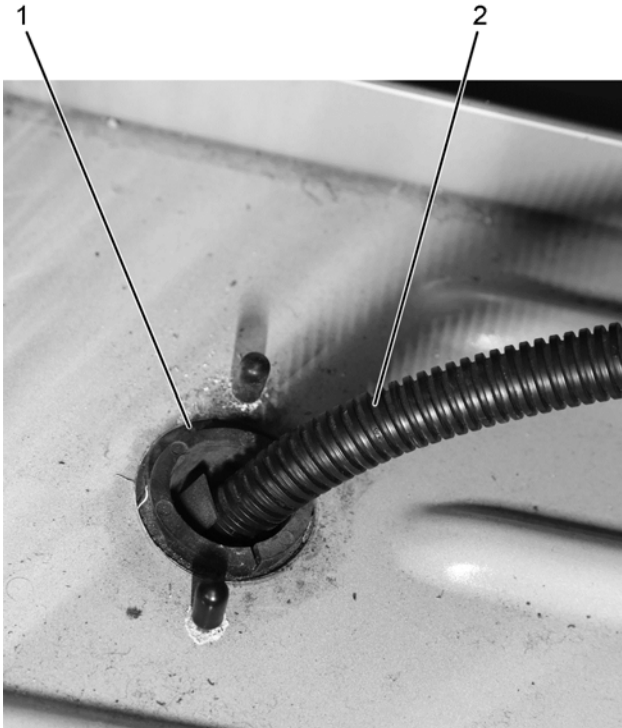
Figure 3. Auxiliary Battery Cable Grommet.

1. Grommet
2. Battery cable

14. Route replacement battery cable (Figure 3, Item 2) through grommet (Figure 3, Item 1) in floor to auxiliary battery box.
15. Install 50 amp power fuse, connect MaxxPower[®] harness, and negative battery cables to battery.
16. Using cable tie straps, secure recently installed harness assemblies.
17. Close auxiliary battery box.
18. Close sleeper compartment.
19. Remove wheel chocks.
