Document ID: IK1201012

Title: SPN 731 FMI 16 Knock Detected: Cylinder Acceleration above Normal

Applies To: All 2010 MF 11/13, 2013+ N13 Big Bore Engines with the latest 3.15 Software Level (Calibration ID xxxxARxx or higher)

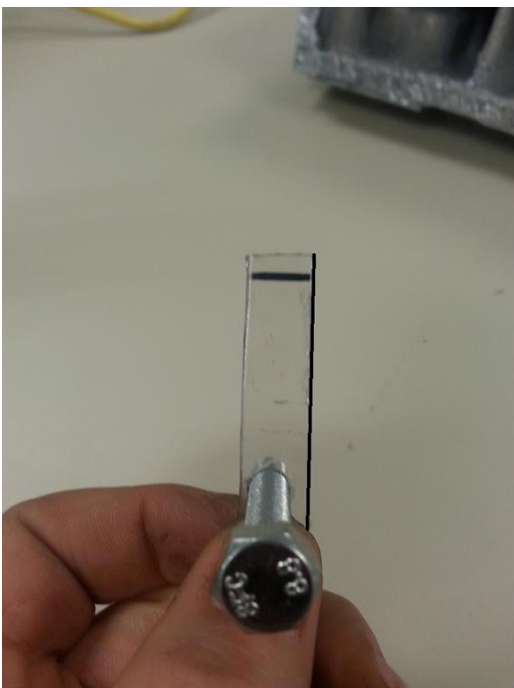
Figure 1: Flywheel Timing Tool

- 1) Drill a 1/4" hole, centered at one end of the clear plastic
- 2) Thread the M6 bolt through the hole
- 3) Measure 1.300 inches from the edge of the bolt using digital caliper and mark a line on the plastic
- 4) With the bolt-free end facing away, mark the right edge of the plastic with a marker, as shown in **Figure 1**

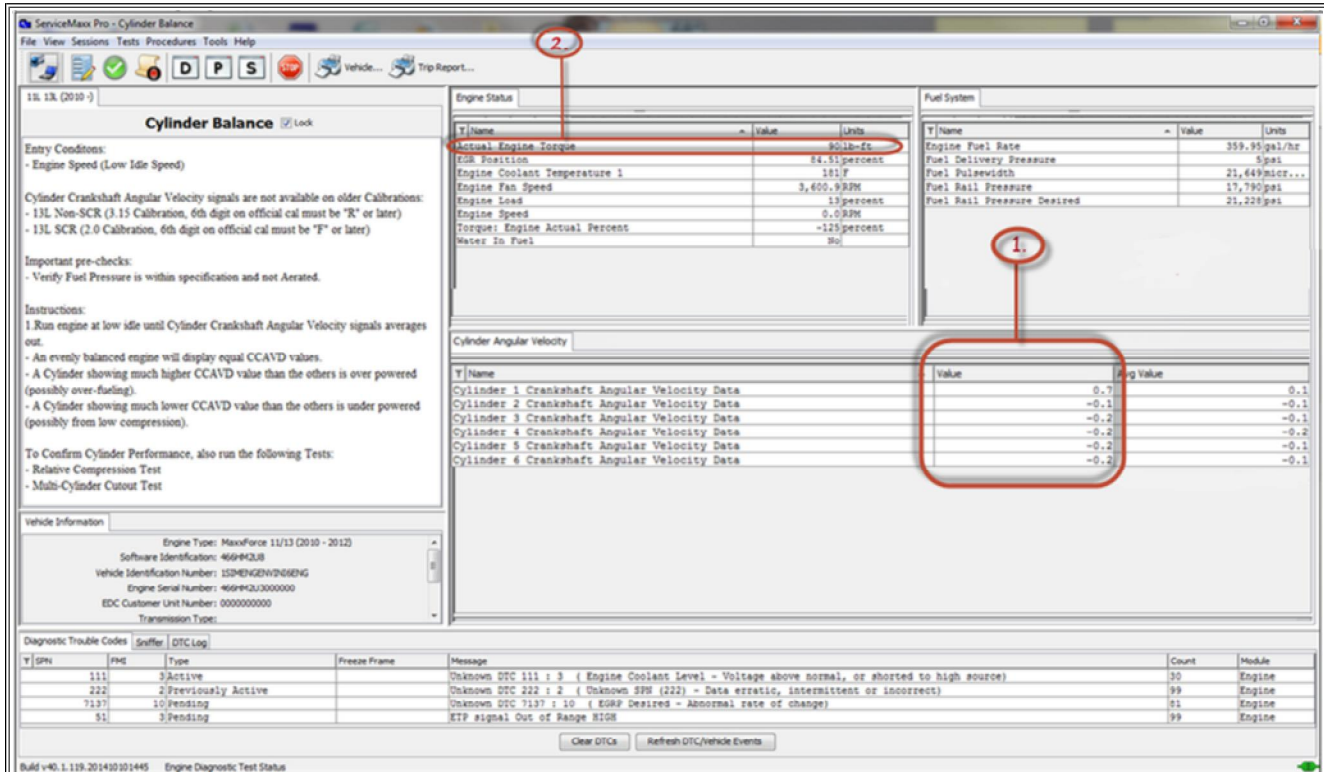
Figure 5. Screen Shot of Cylinder Balance Session

Cylinder 1 is reading the highest and is not consistent with other 5 cylinders that is the suspected cylinder causing the fault.

Item 1: Cylinder (x) Crankshaft Angular Velocity Data - Values
 Item 2: Actual Engine Torque Value

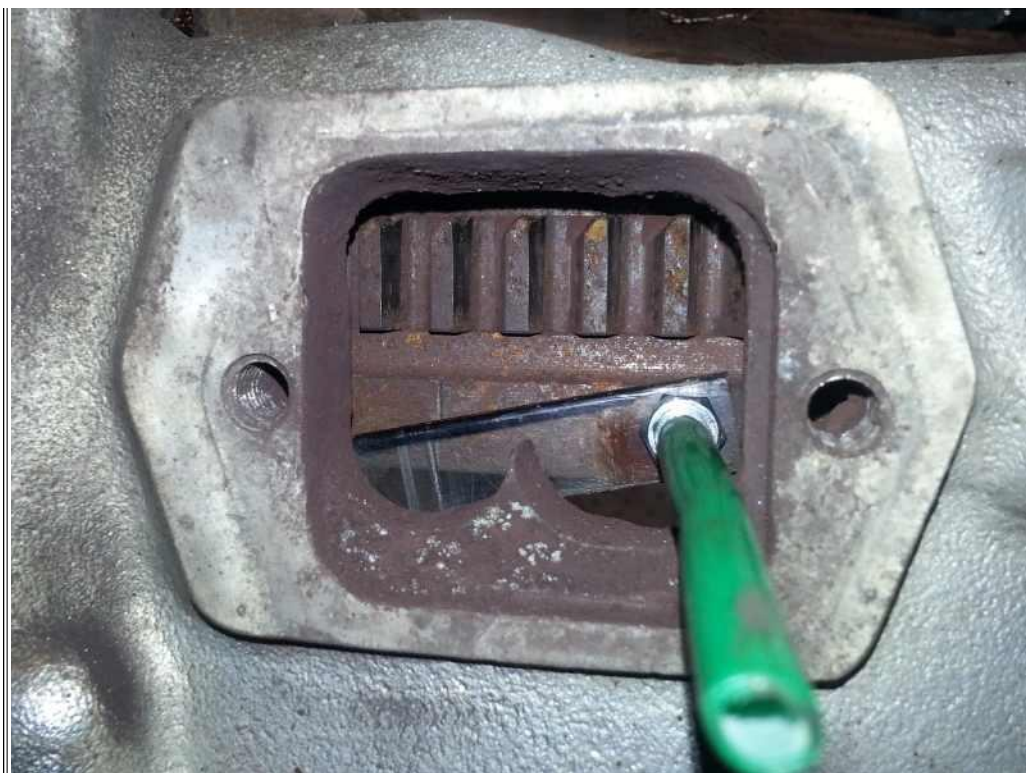
Figure 2: Flywheel Timing Tool Installed

Note: Tool is angled away to show flywheel timing mark, relative to the tool mark.

1. Use a 7mm socket to remove the two screws securing the flywheel housing cover
2. Remove the plastic cover (use caution to ensure plastic tabs are not damaged)
3. Rotate the flywheel so the timing mark is visible in the window
4. Place the gauge (with marked edge towards ring gear) and pin in hole closest to the timing mark (bottom, next to timing hole).
5. Verify the timing mark aligns with the mark on the tool
