Document ID: IK1201118
Revision: 5
Created: 5/1/2014
Last Modified: 3/17/2015
Author: Ted Grzeskowiak

Title: Big Bore Charge Air Cooler Outlet Temperature Sensor Damaged

Applies To: Prostar 113 Equipped with 2010 Emissions MaxxFORCE 11/13L and N13 Engines

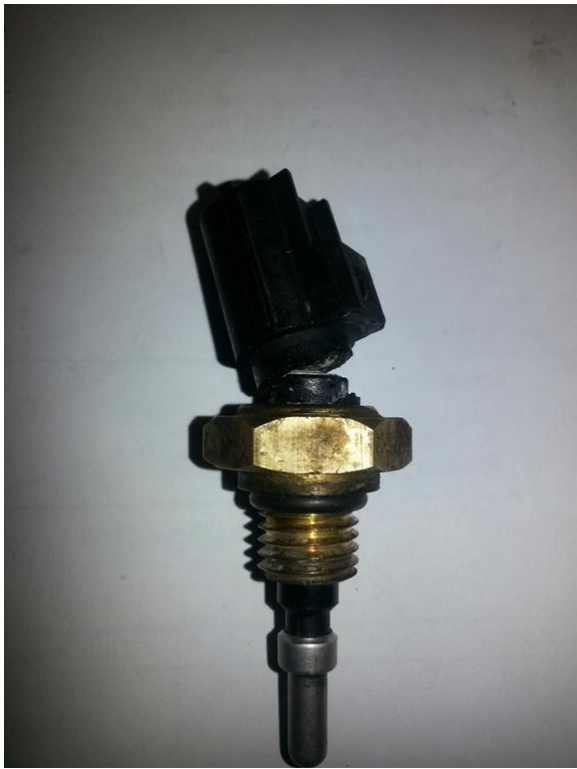
Step	Action	Decision
1	<p>Check for a damaged Charge Air Cooler Outlet Temperature sensor.</p> <p>Locate the CACOT sensor on the Engine Throttle Valve (ETV) casting.</p> <p>Is the sensor damaged, broken or is there evidence of rubbing on the hood?</p>	<p>Yes. Replace sensor and repair harness as needed. Clear codes. Go to Step 2.</p>
	<p>No. Reference the Engine Diagnostic Manual to diagnose the fault.</p>

Figure 1: Damaged CACOT Sensor

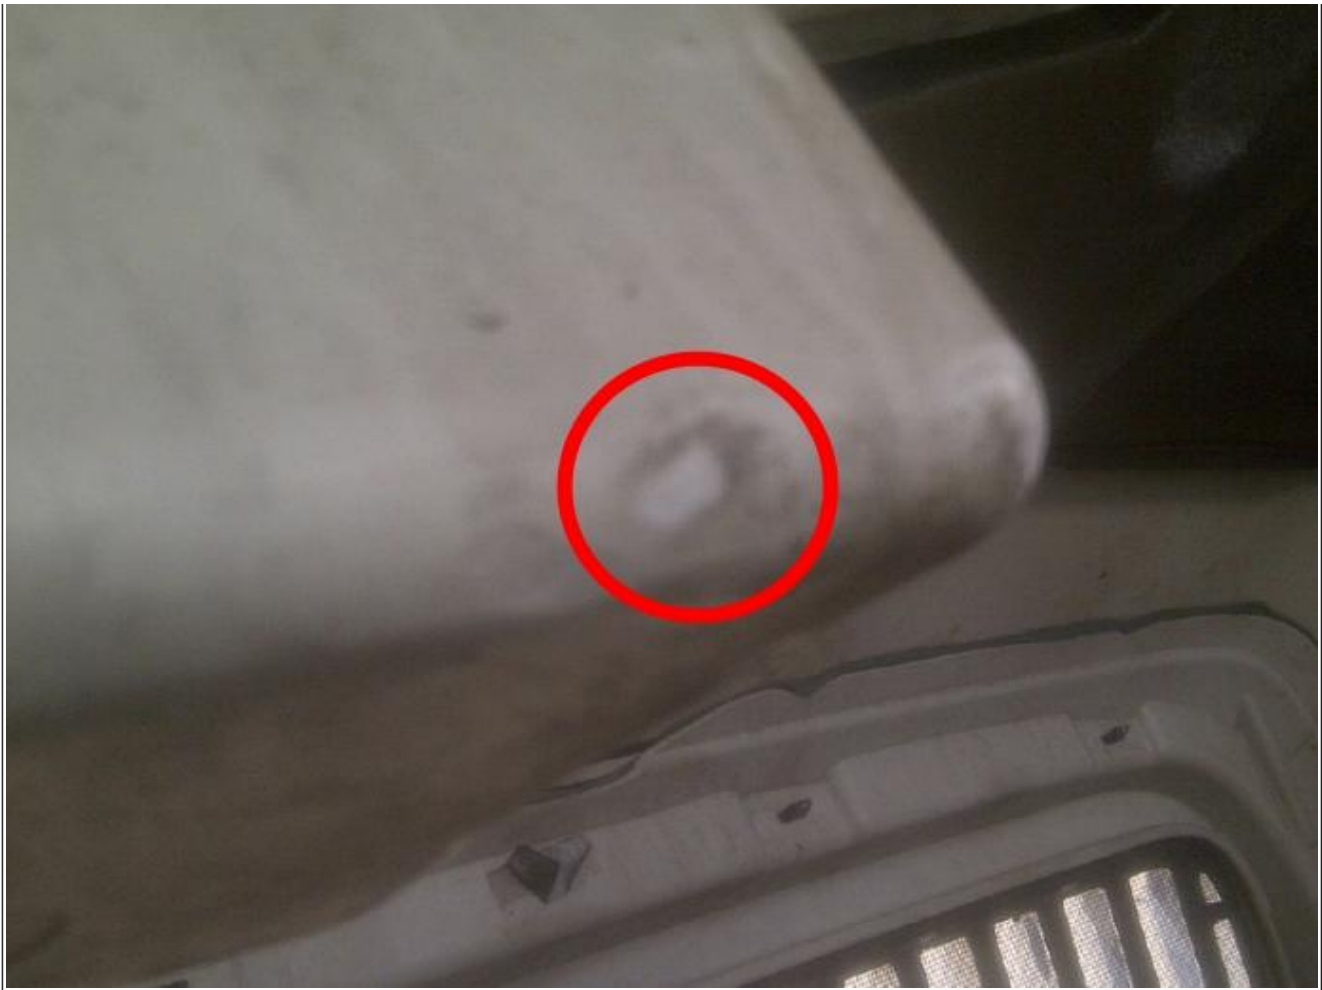
Step	Action	Decision
2	Verify hood to sensor contact.	1. Yes. Proceed to hood modification procedure, below. 2. No. Diagnostic is finished.
	<ul style="list-style-type: none"> • Inspect the inside of the hood for markings from rubbing the CACOT sensor. See figure #2 below for an example of hood rubbing marks. • Are there witness marks on the hood?

Figure 2: Rub mark in the hood from CACOT sensor contact (air inlet cowl).

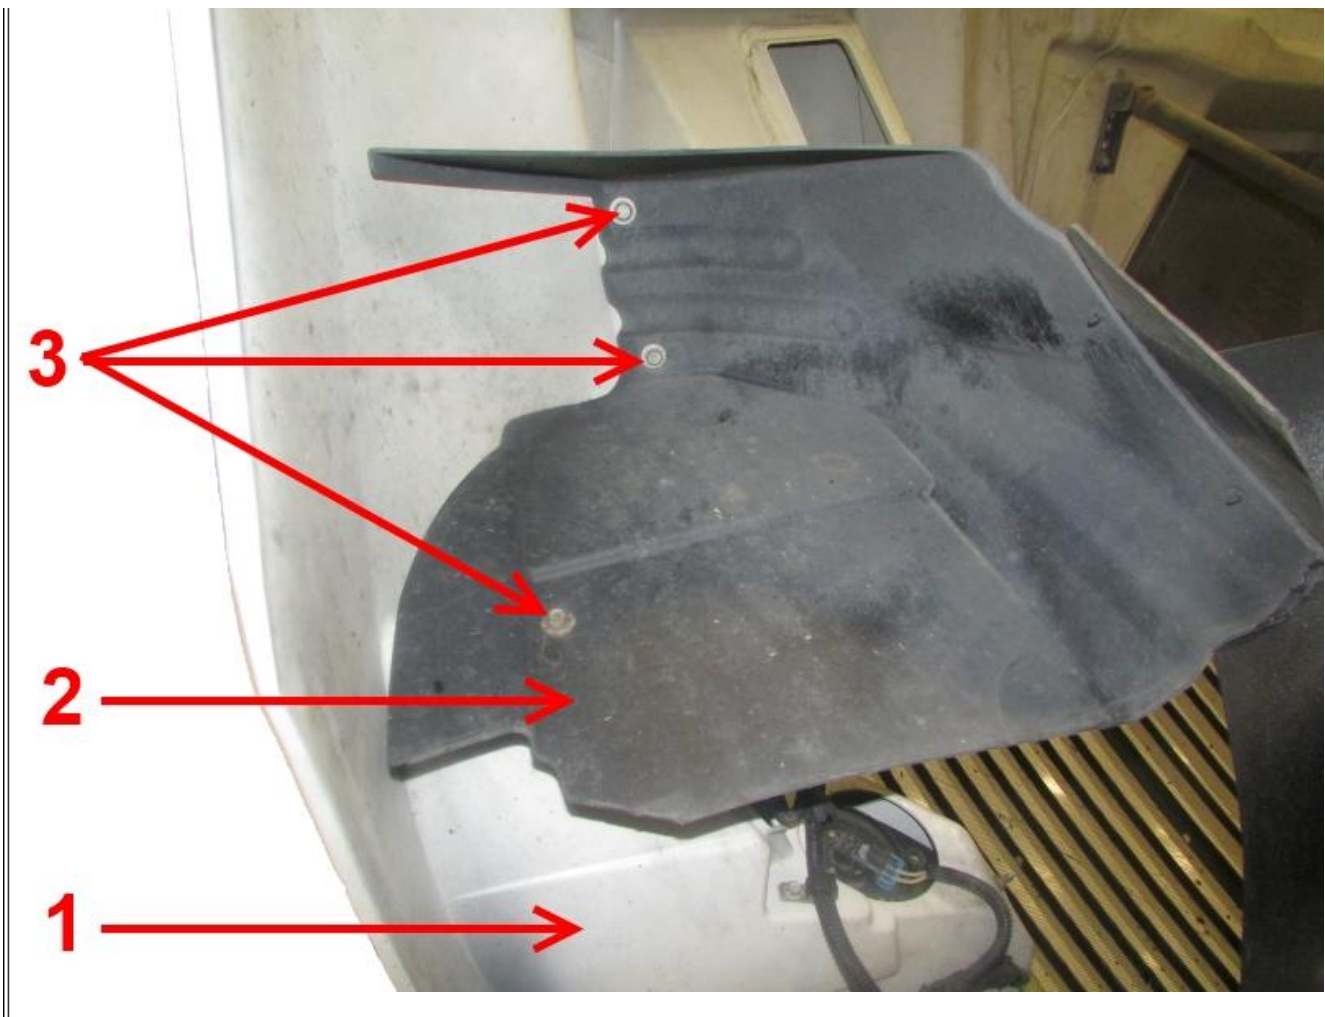
Figure 3: Removal of inner fender.

1. Remove the three bolts securing the driver side front inner fender to the hood.

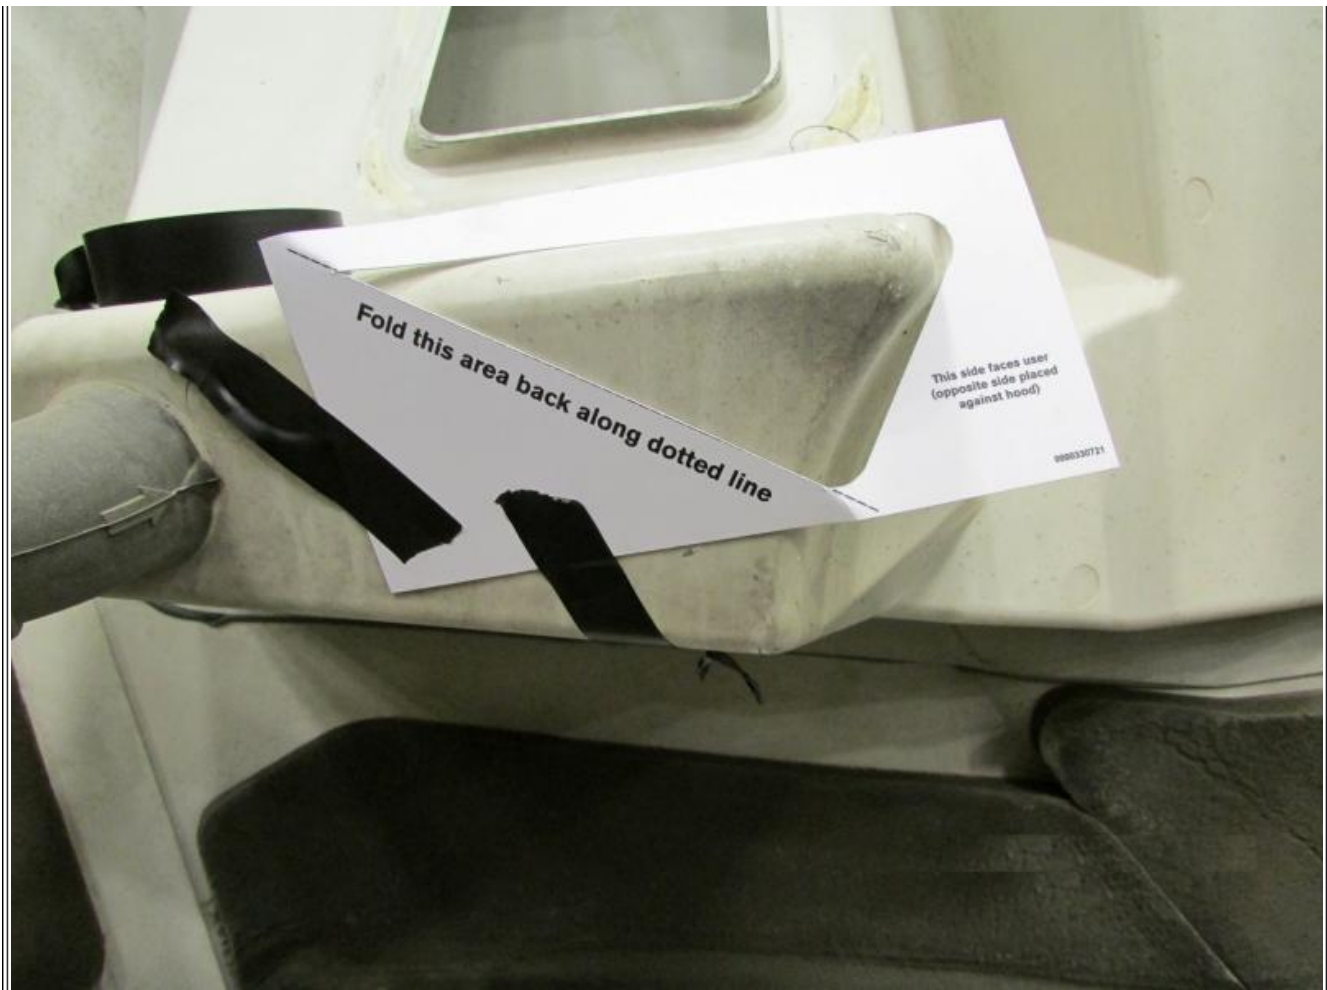
Figure 4: Hood modification template

2. Fold the template from the kit, as instructed, and secure it to the air inlet cowl on the hood, as shown in **Figure 4**.

The template should sit approximately 1.5 inches over the "top right" corner of the air inlet cowl.

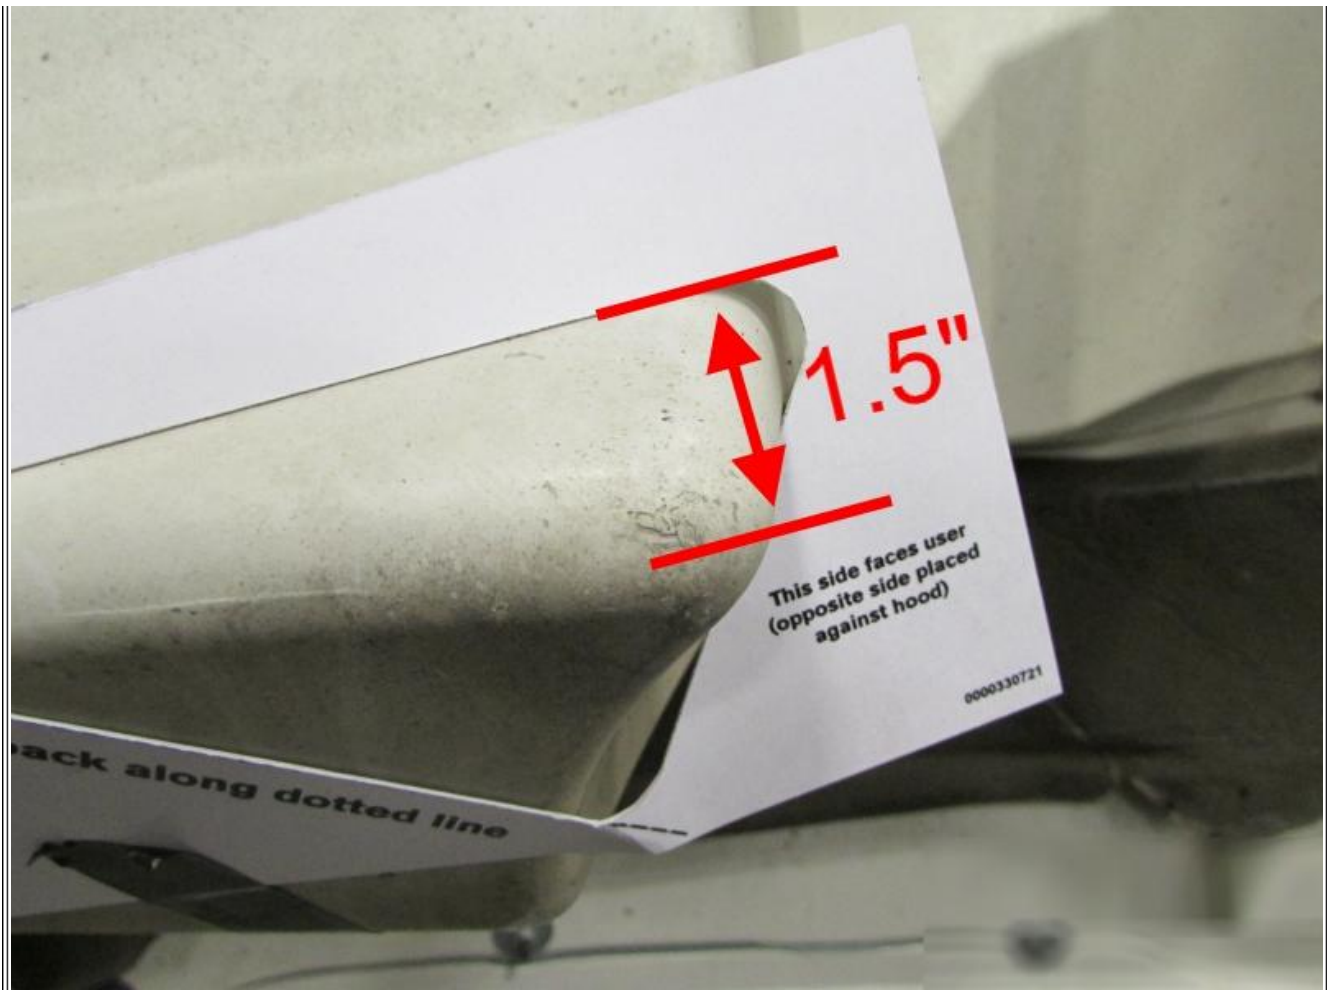
Figure 5: Hood modification template position

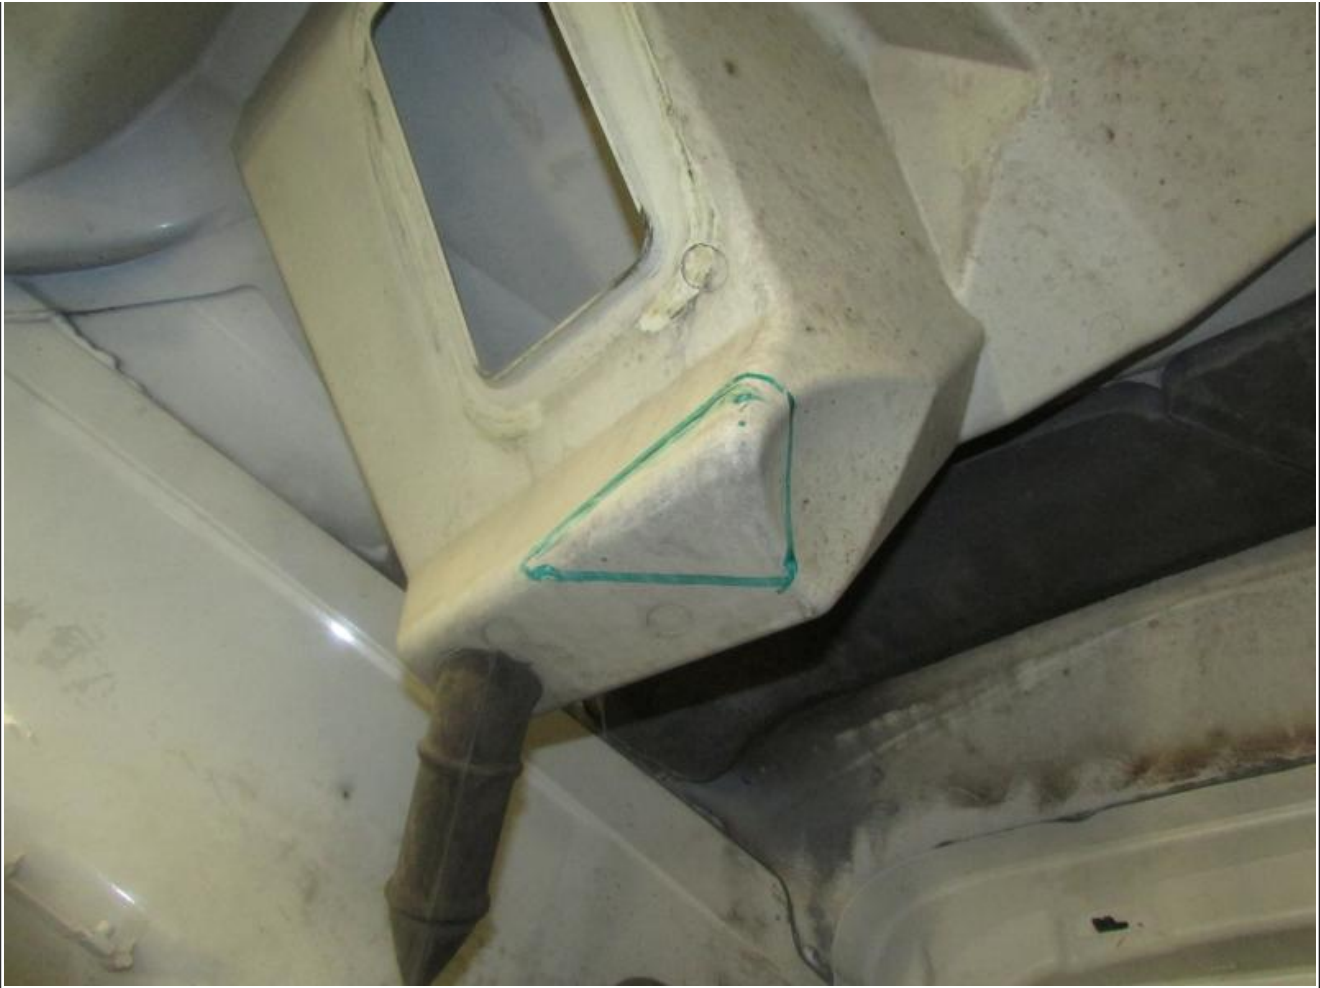
Figure 6: Template traced on air inlet duct.

3. Use a marker to transfer the outline of the template onto the air inlet cowl.

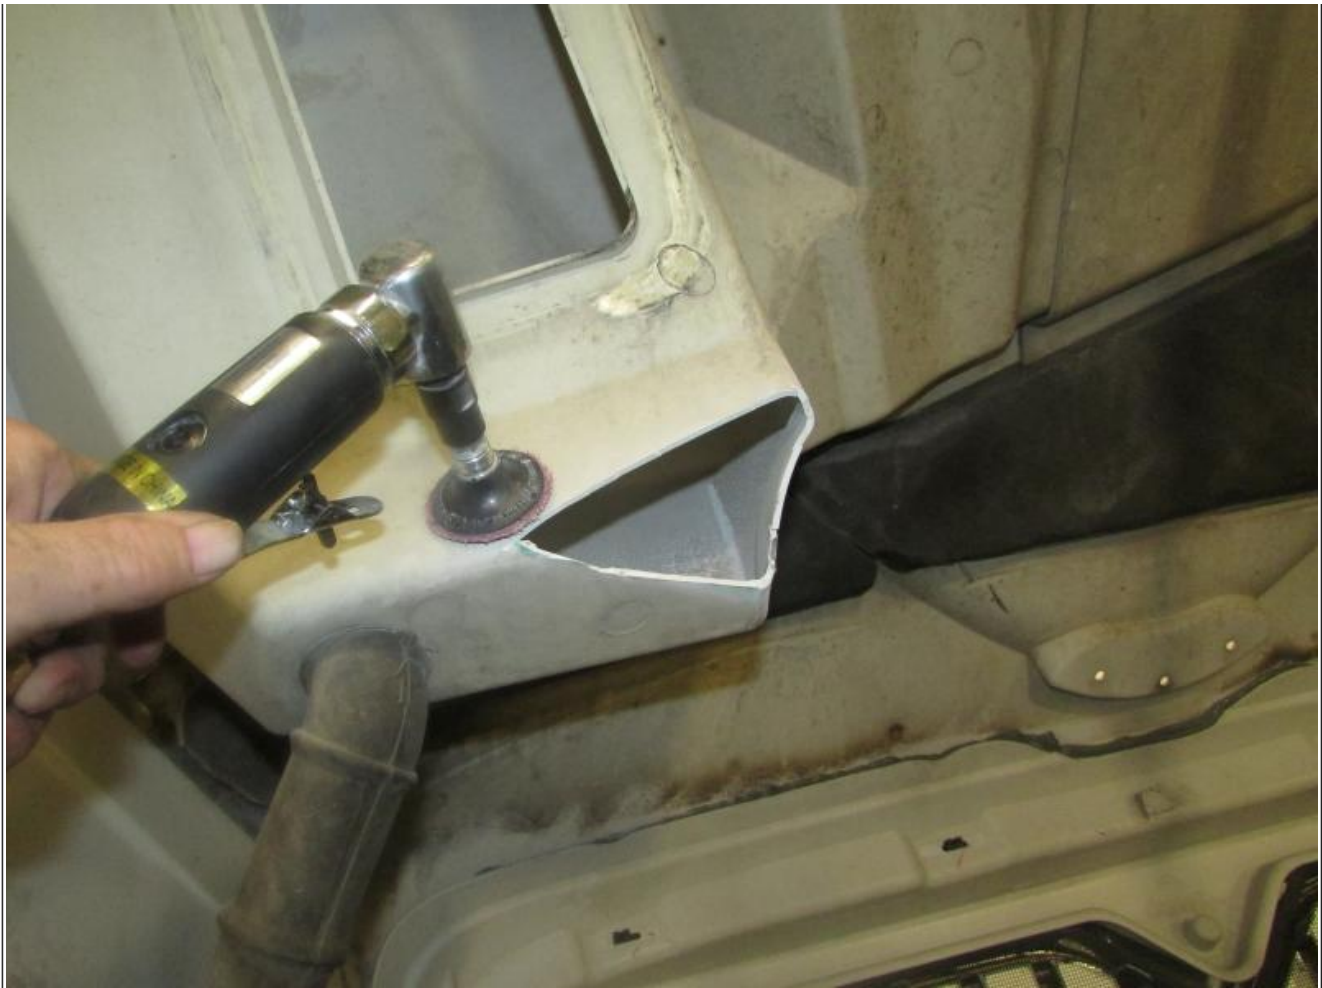
Figure 8: Sanding/roughing of the patch area.

5. Use the 3M pad (and tool) to rough up the area (roughly 7x7 inch square) around the removed section.

NOTE: Sandpaper can be substituted, if necessary. Ensure no dirt/debris are still on the cowl and the surface finish is rough.

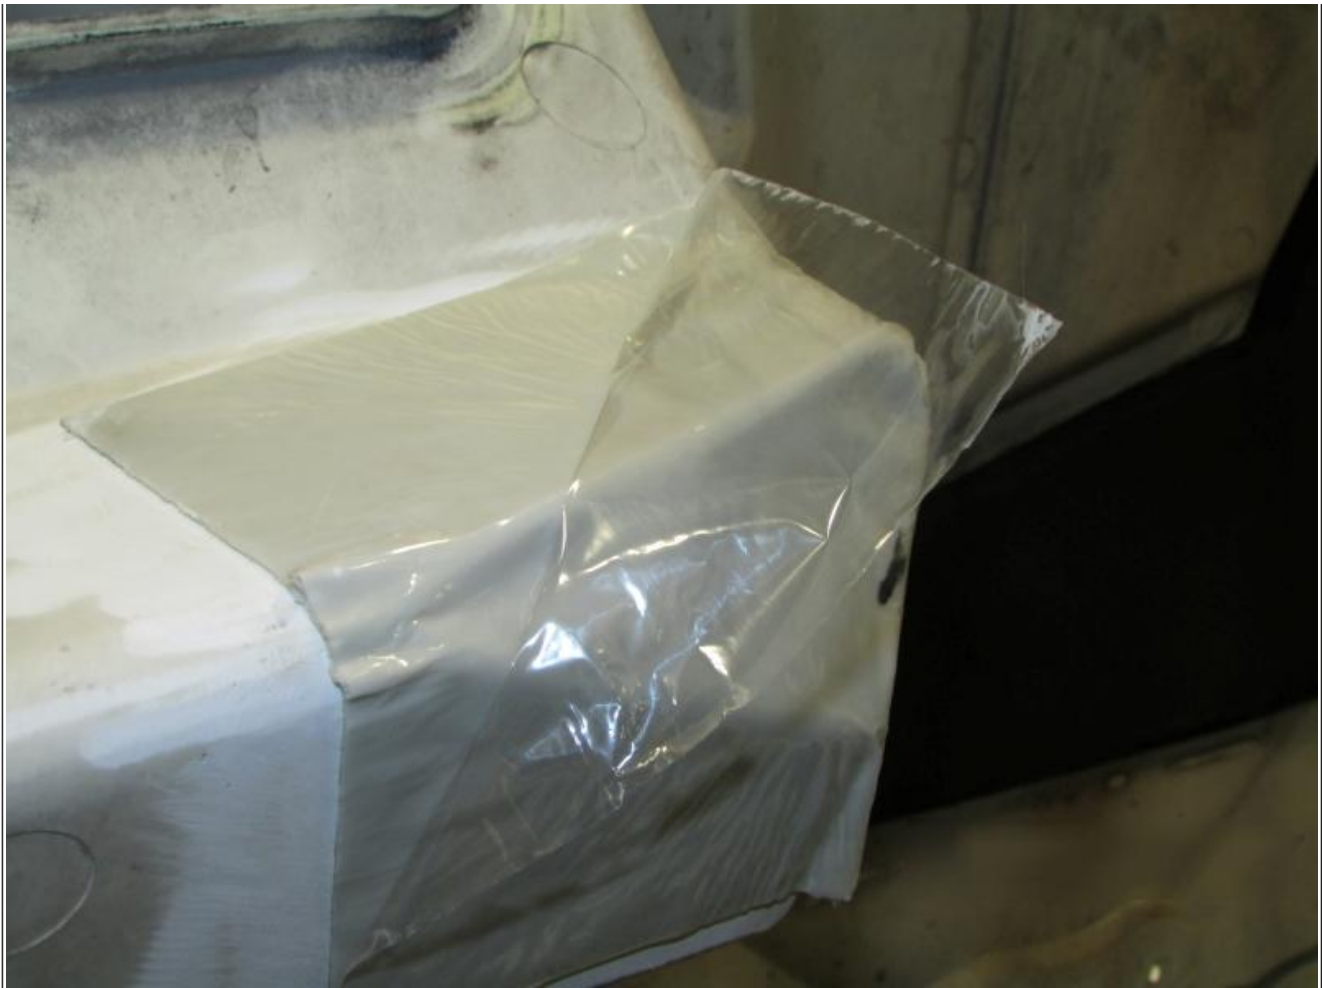
Figure 9: Patch placed and formed.

6. Use an air gun to clean the dust from the patch area.
7. Cut a section of the Easy Patch into a 6 x 6 inch square.
8. Remove the Easy Patch backing and apply to the air inlet duct, as shown in **Figure 9**. Form the patch into place (pressing firmly) and then remove the protective plastic film.

9. Allow the patch to dry with UV light for 10 minutes. Alternatively, let the hood/patch sit in direct sunlight for 10 minutes (drying times will vary depending on lighting conditions). Once dry, the patch will no longer be "tacky" and will be similar hardness to the cowl parent material.
10. Reinstall the front inner fender
