**Countries:** CANADA, UNITED STATES, MEXICO **Document ID:** IK1201266  
**Availability:** ISIS, Bus ISIS, FleetISIS **Revision:** 0  
**Major System:** ENGINES **Created:** 2/3/2015  
**Current Language:** English **Last Modified:** 3/24/2015  
**Other Languages:** NONE **Author:** Aaron Mimbs  
**Viewed:** 326

**Title:** MaxxForce 7 High Pressure Pump Harness Connections**Applies To:** 2010-2013 MaxxForce 7

This document will guide the user through the installation of tie straps on the MaxxForce 7 High Pressure Fuel Pump Harness 1889577C92. This harness has proven superior to 7080246C91 ([Click here for identifiers](#)) and should be replaced when presented the opportunity. Harness 7080246C91 was implemented on 10/4/2012 beginning with ESN 5314897. All engines built after this time or have had the high pressure fuel pump harness replaced will have the harness 7080246C91. It is imperative to check warranty history for related claims that may have involved replacing the pump harness.

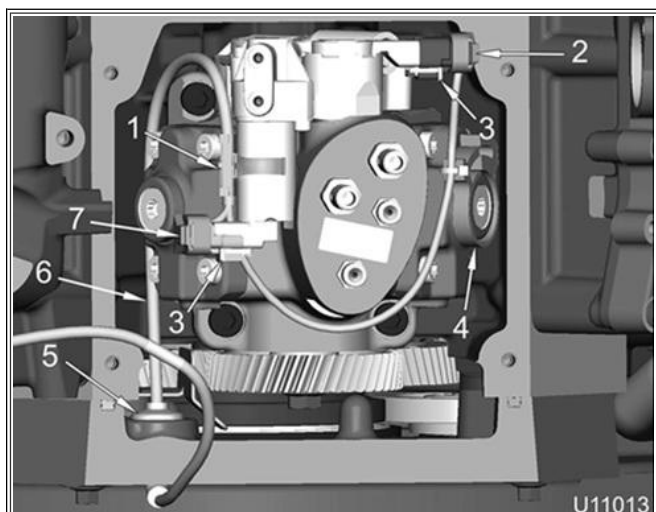
**Figure 1: High Pressure Fuel Pump Harness**

- Item 1: C-clip
- Item 2: PCV Connector (Black)
- Item 3: Yellow CPA
- Item 4: Snapper Clip
- Item 5: Pass-through Overmold Plug
- Item 6: High Pressure Pump Harness Assembly
- Item 7: VCV Connector (Orange)

1. Obtain both wire ties and high pressure fuel pump harness

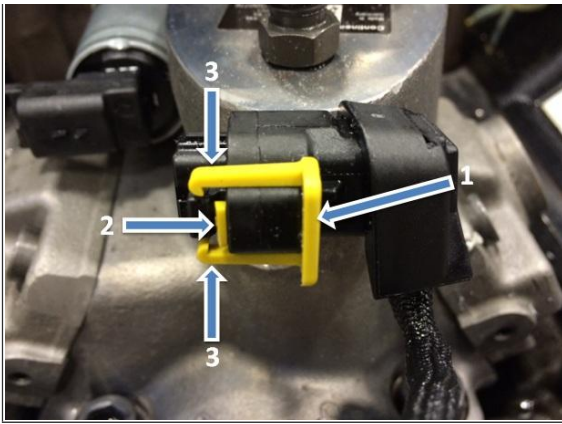
**Figure 2: Harness Connector and CPA**

Item 1: Yellow CPA  
Item 2: CPA Center Tab  
Item 3: CPA Hooks

3. Disengage the Pressure Control Valve (Black) Yellow CPA on the harness by pressing down on the center tab and pulling backwards
