Countries:	CANADA, TAIWAN, UNITED STATES, GUAM, KOREA, SOUTH KOREA	Document ID:	IK0700072
Availability:	ISIS	Revision:	2
Major System:	EXHAUST	Created:	6/5/2014
Current Language:	English	Last Modified:	11/3/2015
Other Languages:	NONE	Author:	Keith Kierzek
Viewed:	2043

Title: ISX Setting 3556-18 (FC3167), 5298-18 (FC1691), or 3482-2 (FC1925) Caused by Missing AFI Poppet

Applies To: ISX15 CM2350 Engines with SCR built prior to February 2014

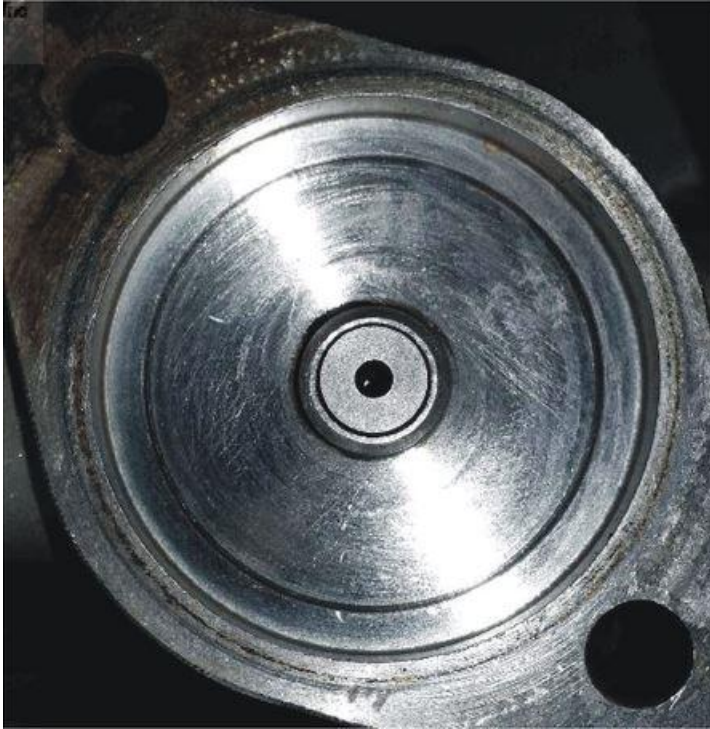
The new EcoFit™ aftertreatment fuel injector is susceptible to the inner poppet falling out due to a worn spring retainer. This situation can increase the probability of fouling that can cause a high restriction of the injection of fuel into the aftertreatment system. Malfunctioned EcoFit™ aftertreatment fuel injectors will have a hole in the center of the injection point. A normal EcoFit™ aftertreatment fuel injector will have a visible plunger (poppet) at the center of the injection point.

Figure 1: Missing Poppet - EcoFit™ Aftertreatment Fuel Injector

If the EcoFit™ aftertreatment fuel injector is missing the lower poppet, reference **Cummins® TSB 130159** located on QuickServe Online in the "TSB" tab under the "Service" section, or type "TSB130159" into the search bar, to find repair instructions.

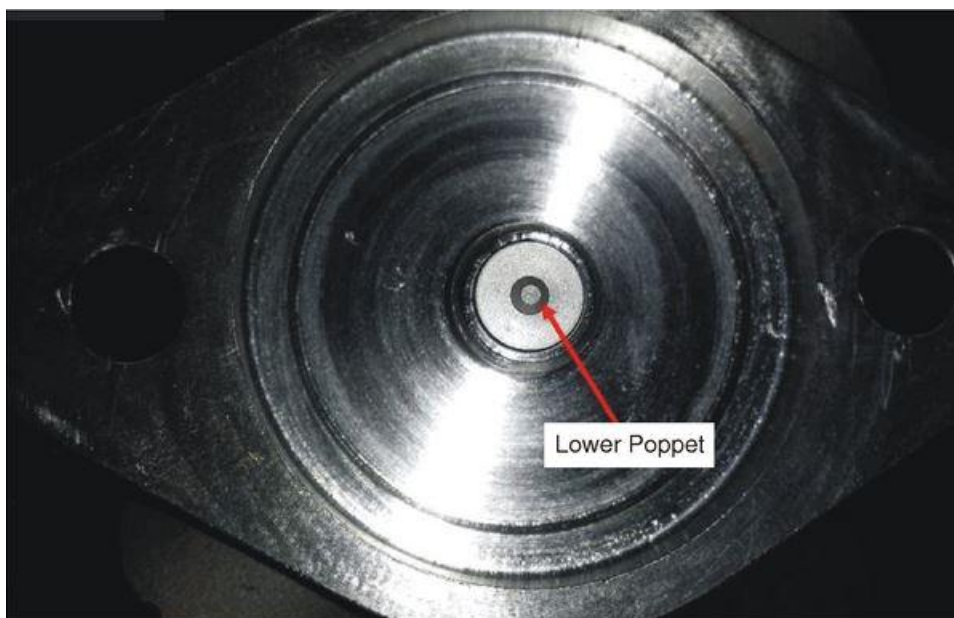
Figure 2: Poppet - EcoFit™ Aftertreatment Fuel Injector
