**Countries:** CANADA, UNITED STATES **Document ID:** IK0700082  
**Availability:** ISIS, Fleet!SIS **Revision:** 3  
**Major System:** EXHAUST **Created:** 1/9/2015  
**Current Language:** English **Last Modified:** 11/18/2015  
**Other Languages:** NONE **Author:** Keith Kierzek  
**Viewed:** 1507

**Title: N9/N10/N13 Aftertreatment Fault Codes Caused by Incorrect DPF Differential Pressure Sensor Orientation**

**Applies To: All Navistar Powered SCR Vehicles**

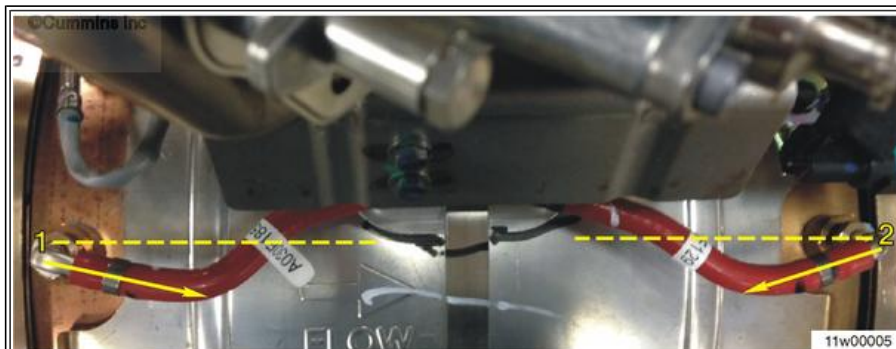
The aftertreatment DPF differential pressure sensor can be installed in an incorrect orientation (**Figure 1**). This orientation of the sensor allows moisture to be trapped inside the sensor and/or sensor tubes. The trapped moisture affects the signal processing of the sensor when reading the pressure inside the DPF, leads to incorrect pressure readings, and Fault Code(s) 3251-2, 3251-16, 3251-0, 3936-15, 3251-15, 3610-2, and 3936-16 being set.

**Figure 1: Incorrect DPF differential pressure sensor orientation**

The DPF differential pressure sensor tubes should have a 0-10 degree downward slope away from the sensor ports whether in a vertical or horizontal aftertreatment configuration. A 0-10 degree sensor tube downward angle is recommended to make sure that no cavity exists in the tubes to collect moisture.

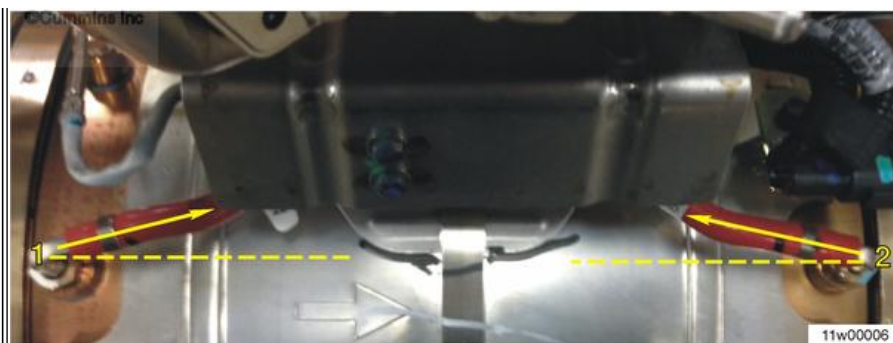
**Figure 2: Correct Orientation - Between 0 and 10 degrees**

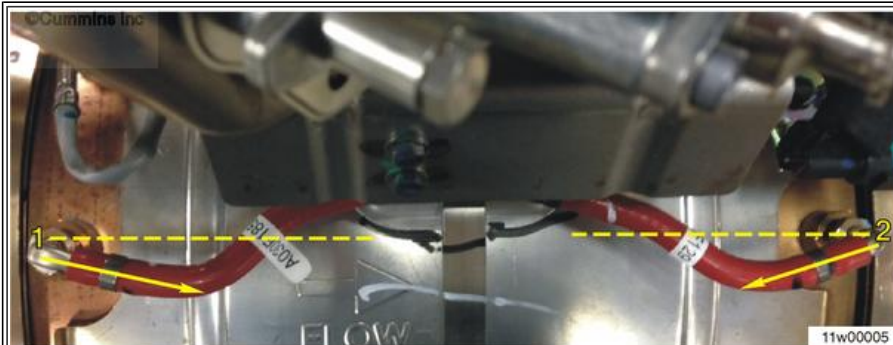
**Figure 3: Incorrect Orientation - Below 0 degrees**

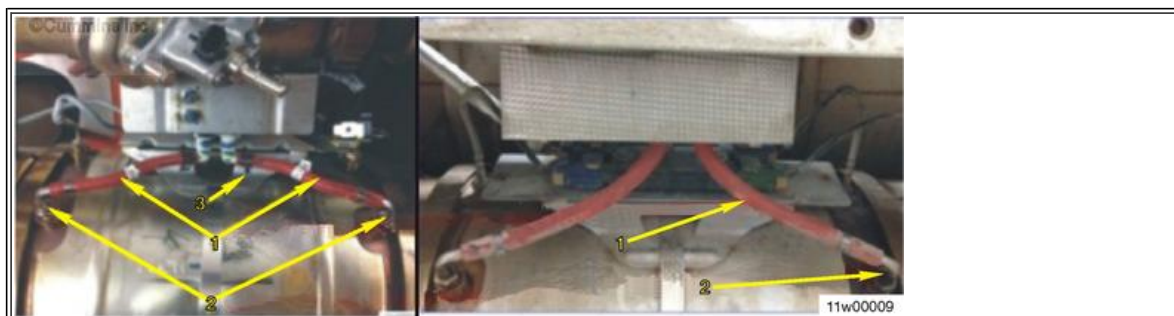
**Figure 4: Canister mounted (left) versus remote mounted (right) DPFDP sensor**

Align the temperature coupling on the diesel oxidation catalyst (DOC) inlet (stamped T1) and the temperature coupling on the DPF (stamped T2). If they are not aligned, loosen the band clamps and align the temperature sensor probes by rotating the aftertreatment DPF canister. **Figure 4** below shows the difference in mounting between a canister mounted and remote mounted DPFDP sensor. **Refer to appropriate section for repair steps below.**

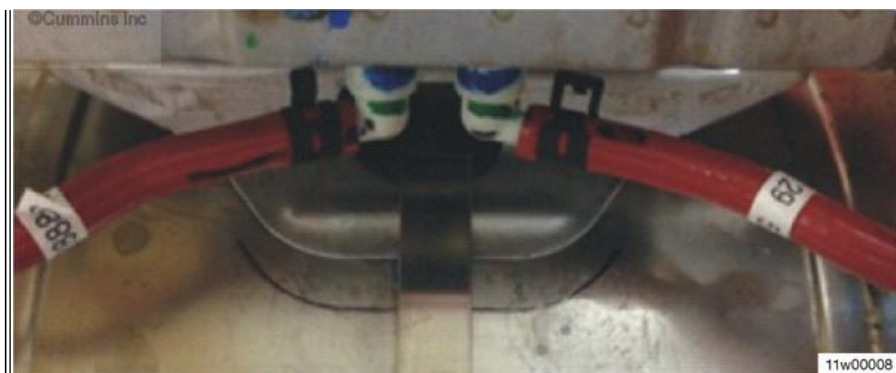
**Figure 5: Correct DPF differential pressure sensor orientation with marking from previous incorrect orientation**

1. Loosen the DPF differential pressure sensor mounting bracket strap and allow the DPF differential pressure sensor tubes to locate the aftertreatment DPF differential pressure sensor bracket on the aftertreatment DPF Canister.
2. Mark the location of the DPF differential pressure sensor bracket on the aftertreatment DPF canister by pressing the DPF differential pressure sensor bracket against the DPF canister and tracing along the bottom of the DPF differential pressure sensor bracket (**Figure 5**).

3. Rotate the DPF differential pressure sensor bracket by moving it toward the top of the DPF canister to achieve a 0-10 degree sensor tube downward angle. Do **not** move the sensor mounting bracket more than 19 mm [3/4 in] above the reference mark.
