**Document ID:** IK0500054

**Major System:** STEERING SYSTEM

**Title:** Steering Gear Seal Repair Guidelines**Applies To:** R.H. Sheppard Gears

This document will guide the user through properly identifying and repairing steering gear seal leaks.

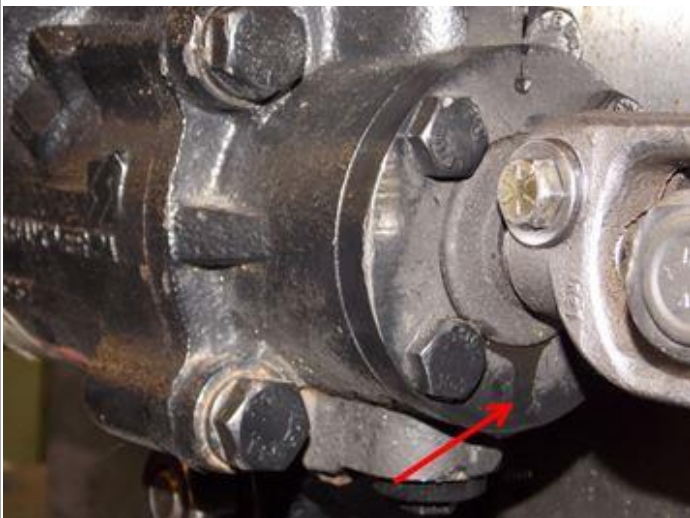
Figure # 1: Steering Gear Input

| Step | Action | Decision |
|---|---|---|
| #3 | DIAGNOSTIC:<br><br>Inspect Input Shaft Seal for leakage.<br><br>Is there any leakage coming from the input shaft seal? ( <i>Refer to Figure 1</i> ).<br><br> | <b>Yes</b> Follow service procedure <b>#1</b> for Input shaft seal replacement in Service Procedure section of this iKNow |

- #1. INPUT SHAFT SEAL REPLACEMENT FOR ALL MODEL GEARS- <http://www.rhsheppard.com/part09.htm>
- #2. BEARING CAP SEAL REPLACEMENT M-SERIES- <http://www.rhsheppard.com/part11.htm>
- #3. BEARING CAP SEAL REPLACEMENT D-SERIES- <http://www.rhsheppard.com/part12.htm>
- #4. SECTOR SEAL REPLACEMENT M AND D SERIES- <http://www.rhsheppard.com/part10.htm>

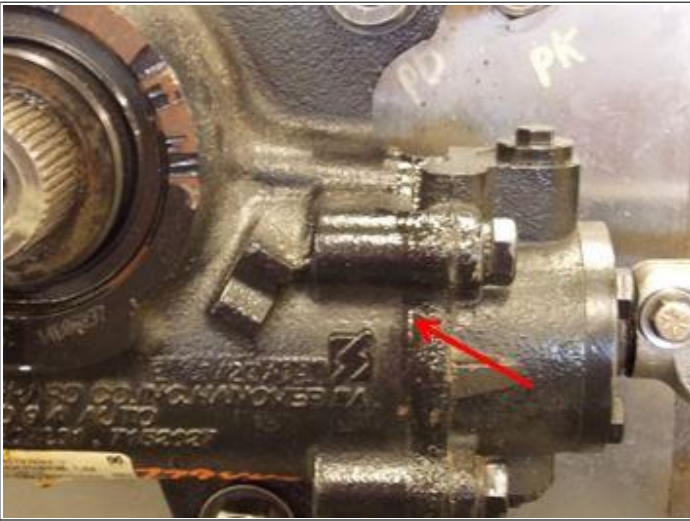
**Figure # 2: Steering Gear Bearing CAP**

| <p>Is the bearing cap leaking? <i>(Refer to figure 2)</i></p> | <p><b>Yes</b> Follow bearing cap seal replacement service procedure <b>#2</b> or <b>#3</b> in the service procedure section of this iKNow</p> <p><b>No</b> Proceed to step 5</p> |

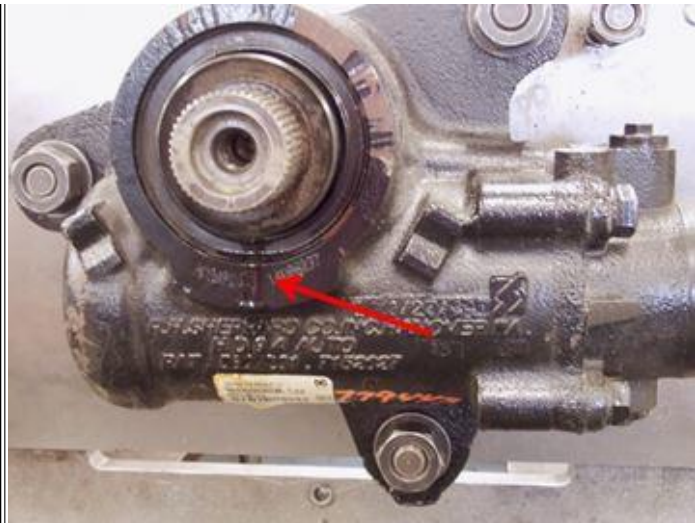
**Figure #3 Sector Shaft**

| Step | Action | Decision |
|---|---|---|
| #5 | <p><b>DIAGNOSTIC:</b></p> <p>Is sector shaft leaking? <i>(Refer to figure 3)</i></p> | <p><b>Yes</b> Follow Sector Shaft seal replacement service procedure <b>#4</b> in the service procedure section of this iKNow</p> |
