**Document ID:** IK1100031

**Title:** Hard to Crank Condition on ProStar, LoneStar, and TranStar Vehicles

**Applies To:** ProStar, LoneStar, and TranStar Vehicles with Hydraulic Clutch Linkage and Solo Clutch

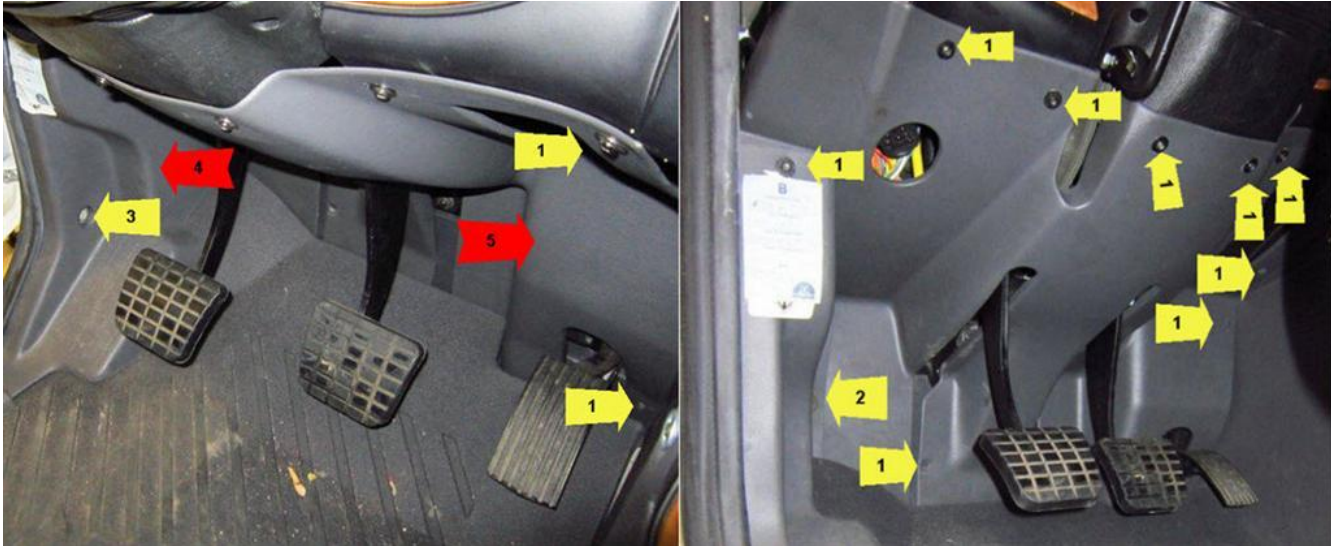
Remove the 11 self tapping pan head black screws, the 1 M6x35mm bolt, and the M8x45mm Bolt holding the 2 driver control module modesty panels. Once the fasteners are removed, the panels (4 and 5) can be removed and set aside.

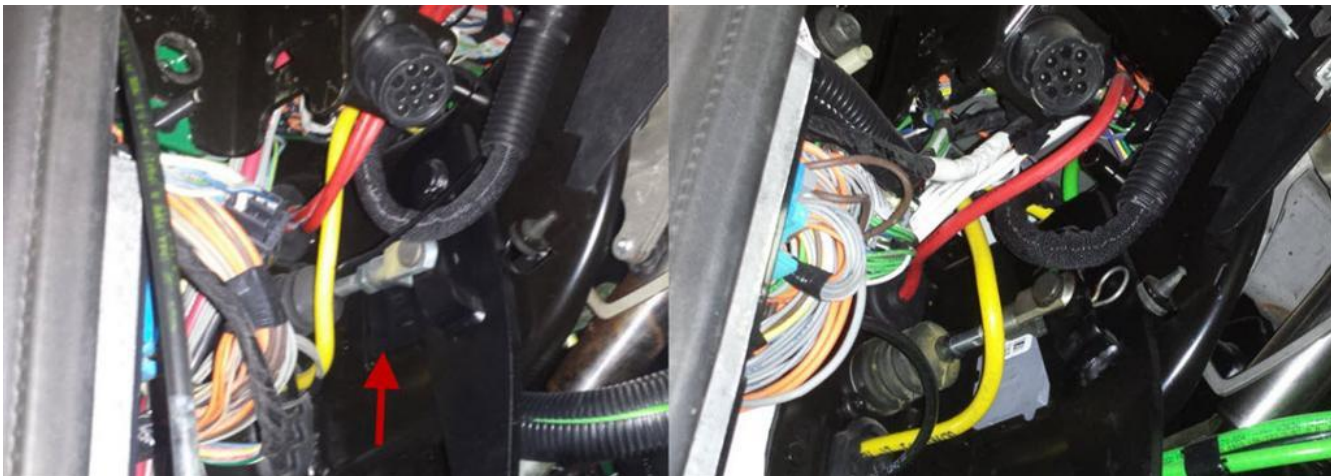
Inspect the color of the clutch switch. If the switch body is black, it will need to be replaced with switch part number 2512776C91.

2.	Remove the driver control module modesty panel and inspect the clutch switch color. Is the installed switch gray and not black?	<a href="#">Continue to Step 3</a>	Install clutch switch part number 2512776C91. Recheck operation. If the vehicle is operating correctly, return it to the customer. If the vehicle is still hard to crank, <a href="#">continue to step 3.</a>

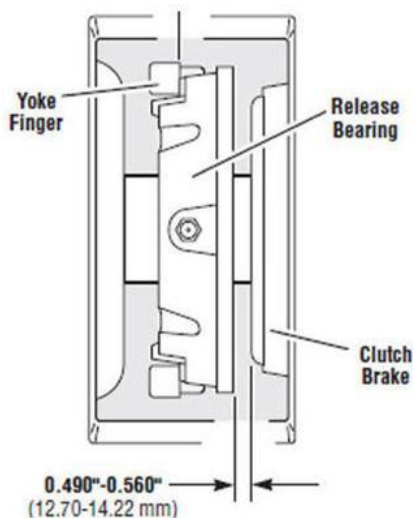
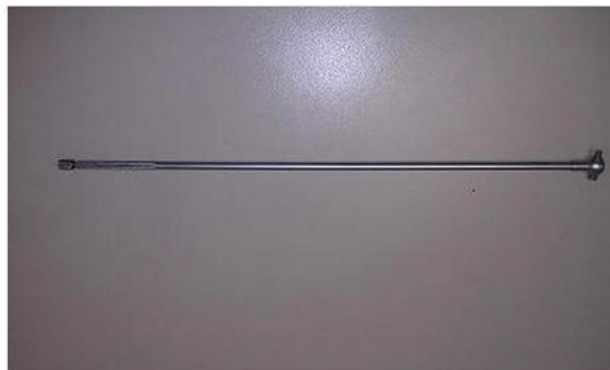
Remove the clutch inspection cover, and measure the bearing to brake position. Inserting a bar that is about 0.500" is NOT an acceptable procedure for checking the clutch bearing to brake measurement.

- If the clutch internal bearing to brake measurement is less than 0.490", and the clutch release pedal free travel is adjusted to 0.700"-0.800" the vehicle does not crank, then the clutch will need to be replaced.
- Resetting the clutch will not affect the static bearing position.

- Preferred Procedure- Use a telescoping gage or inside caliper capable of a 0.400" - 0.600" range, and insert it between the clutch bearing and the clutch brake aligned with the center of the brake and the center of the bearing. Then measure the gage using a micrometer or a dial/digital caliper.
- Alternate Procedure- Use a feeler gage set (shim stack), and stack the correct number and size feeler gages to allow the feeler gage stack to fit snugly between the clutch bearing and brake. Then measure the feeler gage stack using a micrometer or a dial/digital caliper.
