**Document ID:** IK1200937

**Title:** Oil filter bypass slug in oil filter housing

**Applies To:** 2010 + MaxxForce DT, 9, 10, N9 & N10 (ESN 3,300,000 and later)

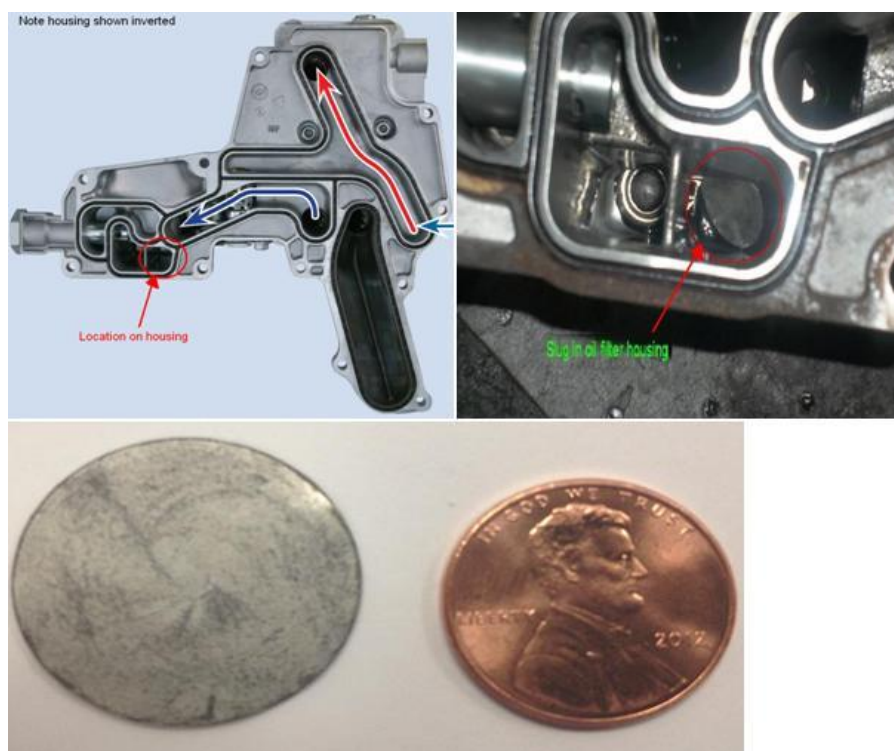
A machine slug in the oil filter bypass has the potential to become loose and lodge in the oil filter housing. This can then block off oil flow and lead to engine operation issues.

If no major scoring is found, remove the filter housing and inspect for the blockage shown below.

If a slug is found in the oil filter housing, the slug should be removed and the oil filter should be replaced. Also examine the oil pressure regulator and oil housing for any damage. If heavy scoring is found, then replace damaged parts.
