January 20, 2015

51321-00375 Version 3

## Chirping From the Engine Area While Driving On Rough Roads in Hot Weather

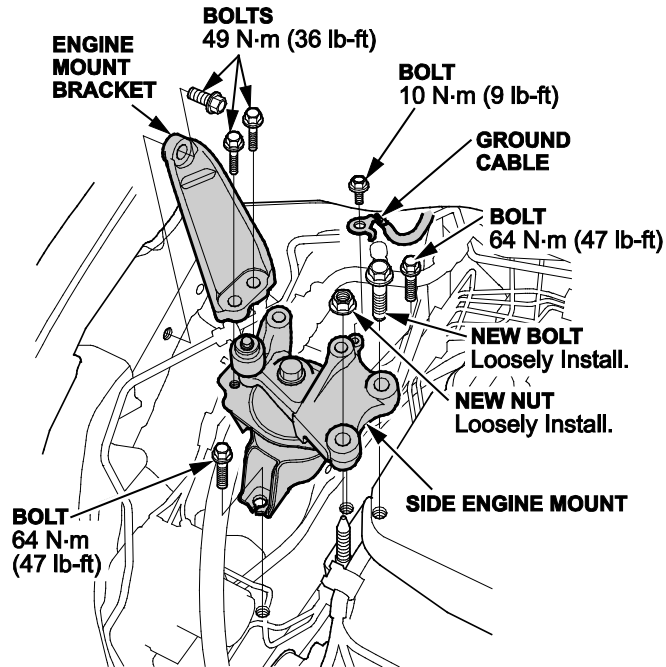
**2.0 ENGINE**

The side engine mounts internal components are rubbing together, causing a noise.

7. Install the new side engine mount.
