**Subject:** FIELD ACTION UPDATE: PROMPT ACTION REQUIRED: Vector 8500 and 8600MT Battery Cable Clamp Installation  
**Attachments:** SER14-008.pdf; NATT. Vector Clamp Customer Letter.docx; NATT. Vector Clamp Dealer Letter.docx

SER14-008  
03/13/2014

### SUBJECT: Tier4 Vector Battery Cable Clamp

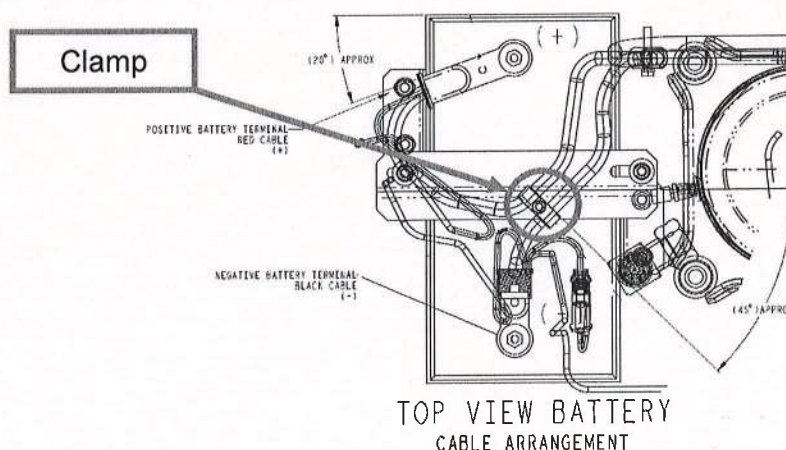
It has been determined that Tier4 Vector units, model 8500 and 8600MT, in the serial number range PAH91333094 through PAT91367875 require an additional battery clamp. Failure to install this battery cable clamp could lead to chaffing of the battery cable.

Insert should be installed in the battery hold down and the clamp should be installed at a 45 degree angle from the compressor side of the battery (see below picture). Torque to 4-5 ft lbs.
