# Newmar Corporation

### Technical Service Bulletin

| Date Issued | Model Year(s) Affected | TSB # |
|---|---|---|
| 11/12/2015 | 2007, 2008 | 432 |

**Issue:** Tag axle wheel bearings may overheat. Overheating of the tag axle may be detected by distortion or melting of the Stemco cover or ABS lamp illumination. If the wheel bearings overheat, there may be an increased risk of a wheel end fire.

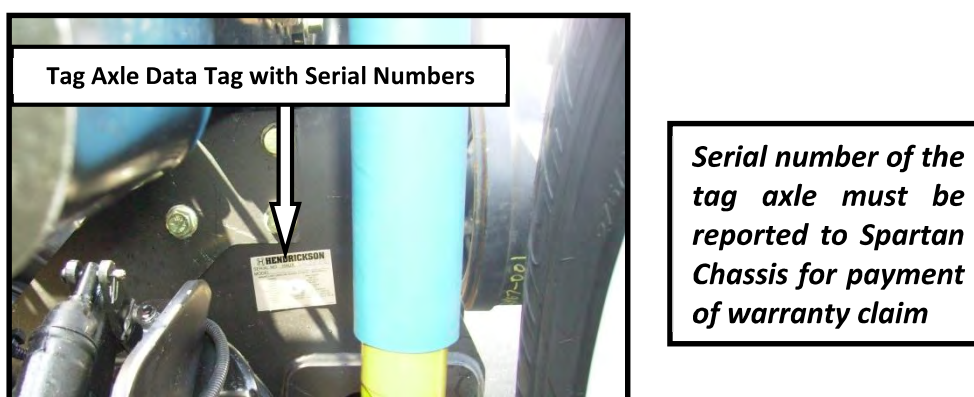
**FIG. 2-1**

**TAG AXLE DATA TAG LOCATION**

**NOTE: Refer to FIG. 2-1. To be paid for claim you must report tag axle number to Spartan Motors USA, Inc. Customer and Product Support.**
