## SUBJECT: Passing Oil Complaints in GH7 Turbochargers

Department: Service  
Section: Engine  
Model(s): GH7  
Model Year(s): 2011, 2012 & 2013  
Effective Date: October 8, 2015  
Form #: TB EN-57  
Rev #:  
Supersedes:

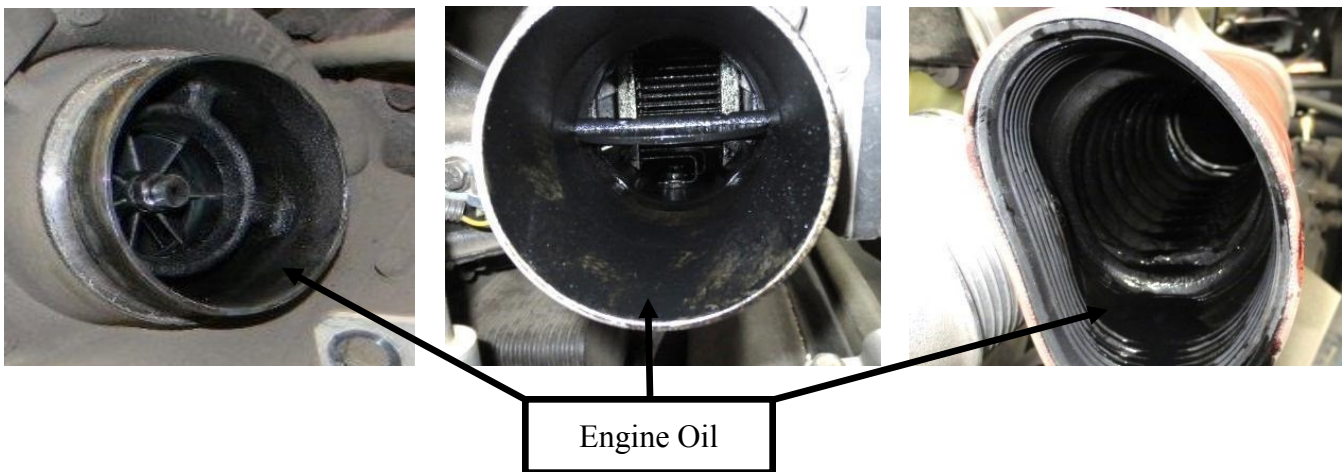
### Example in which a lot of oil entered into the intake system from CCV

**Condition 1.** If a large amount of oil has been entering the intake air system on the inlet side of the turbo the warranty repair procedure is to clean the oil from the parts. See drawing 50 below.

**Do not replace the turbo for this condition.**

- Turbo air inlet and outlet
- All intake piping
- Remove CAC and clean
- Inspect the intake manifold and clean as required
