Countries: CANADA, UNITED STATES Document ID: IK0700082

Title: N9/N10/N13 Aftertreatment Fault Codes Caused by Incorrect DPF Differential Pressure Sensor Orientation

Applies To: All Navistar Powered SCR Vehicles

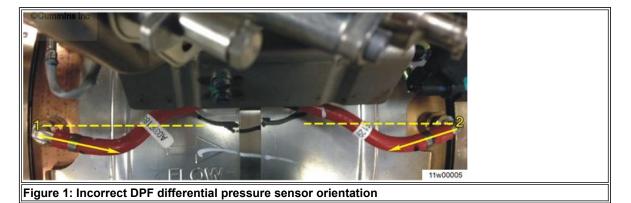
The aftertreatment DPF differential pressure sensor can be installed in an incorrect orientation (**Figure 1**). This orientation of the sensor allows moisture to be trapped inside the sensor and/or sensor tubes. The trapped moisture affects the signal processing of the sensor when reading the pressure inside the DPF, leads to incorrect pressure readings, and Fault Code(s) 3251-2, 3251-16, 3251-0, 3936-15, 3251-15, 3610-2, and 3936-16 being set.

The DPF differential pressure sensor tubes should have a 0-10 degree downward slope away from the sensor ports whether in a vertical or horizontal aftertreatment configuration. A 0-10 degree sensor tube downward angle is recommended to make sure that no cavity exists in the tubes to collect moisture.
