Document ID: IK0800336

Title: Horn Sounds On Its Own While Vehicle Parked - OR - Horn Inoperative

Applies To: Trucks and busses using one of these horn pad assemblies: 3616382C1 or 3586911C1 or 3862892C1. Affected vehicles have a build date prior to March 25, 2014.

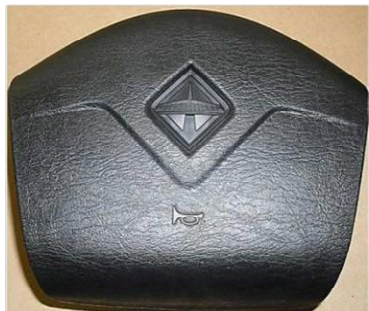
Top View

Potential cause: Horn pad assembly contains a manufacturing defect, in which the metal contact plates are out of tolerance. During cold temperatures, the metal plates deflect, and come into contact.

Replace horn, and horn pad assembly depending on test results. See below for further information.

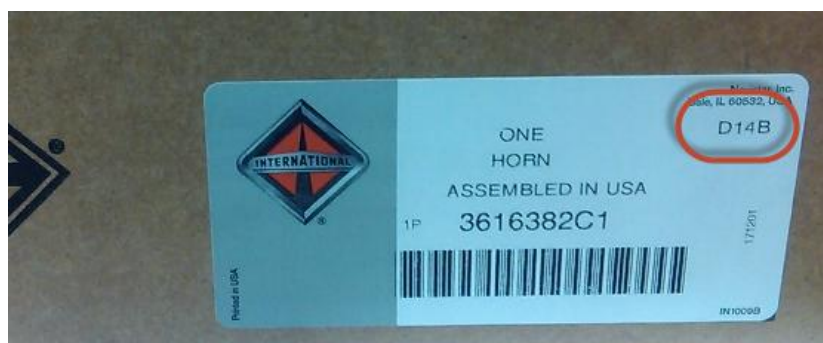
Horn Pad Package with Date Code :

Note: Known good horn pad label date code (circled in red below) ends with the letter "B".
