**Document ID:** IK1200753

## Title: Hydrocarbon Injector & Housing Cleaning Procedure (AFI Plugging)

Applies To: EPA 2010 MaxxForce DT, 9, 10

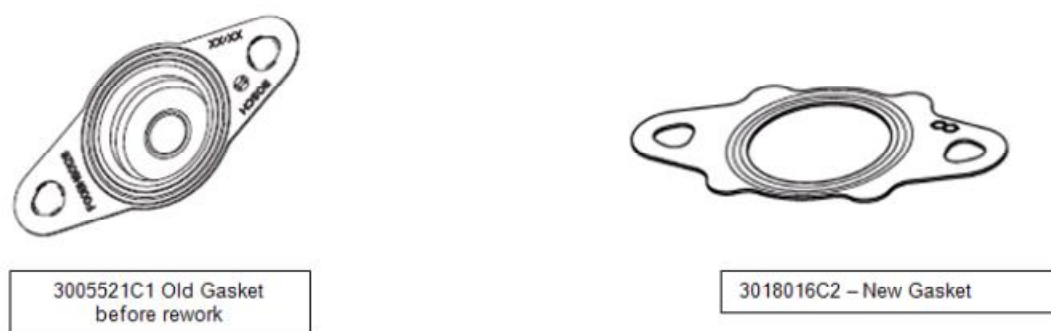
**Figure 1 - Gasket Changes**

The old gasket (p/n **3005521C1**) has been reworked and replaced with p/n **3018016C2**. The new style gasket will have the raised center portion of the gasket removed (Figure 1).

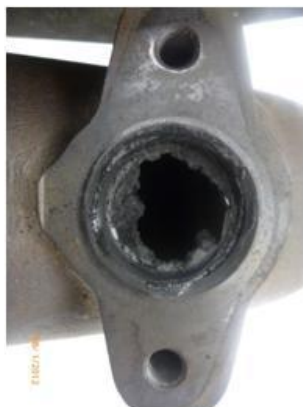
A plugged HC injector port will result in frequent aftertreatment regenerations (regens) or low temperatures during On Board Filter Cleanliness Test (OBFCT). If the AFI port is plugged, use this procedure and Navistar's Engine Diagnostic Manual (Found on the **Service Portal>Publications>Master Service Information**) for additional reference.

**Figure 2 – Partially plugged AFI port**

5. Use ZTSE4301 (Brass Brush) to clean any carbon buildup that may be present at the tip of the AFI.

6. If carbon buildup is present: Carefully remove carbon from the HCI / AFI port on the exhaust back pressure valve housing with a chisel or other appropriate tool. Remove debris with a shop vac.

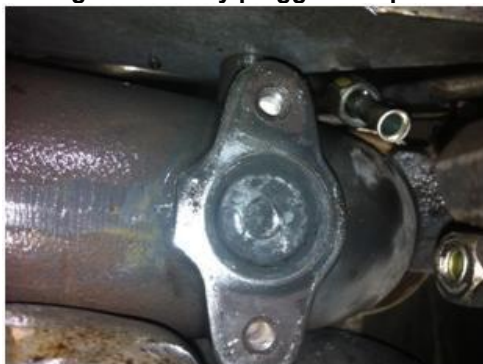
**Figure 3 – Fully plugged AFI port**

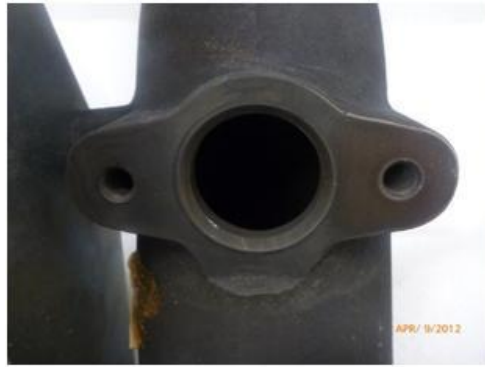
**Figure 4 – Clear AFI port after cleaning**
