**Document ID:** IK1200909

**Title:** Complete High Pressure Turbocharger Replacement Guidelines for MaxxFo<sup>®</sup> 11/13 and 15L

**Applies To:** 2010 MaxxFo<sup>®</sup> 11/13/15, 2013 MaxxFo<sup>®</sup> 11/13 HDOBD, 2013 N13 with SCR

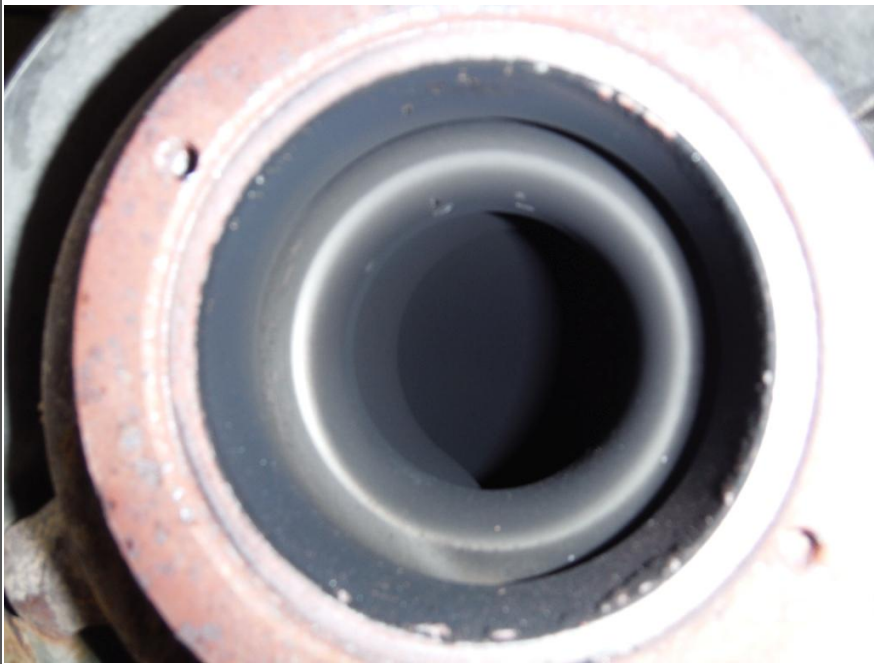
| Reference Picture | Actions |
|---|---|
| | <p>Minor damage to the Turbine housing (Exhaust Side) of High Pressure Turbo. Reference <b>Special Requirement</b> for proper cleaning and replacement procedure.</p> |

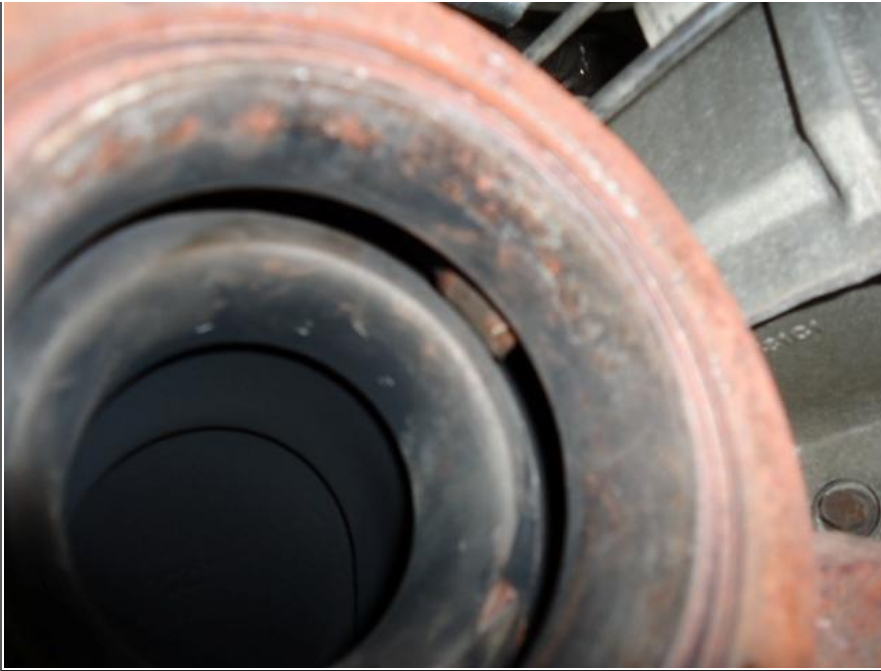
| Reference Picture | Actions |
|---|---|
| | <p>Small nick's in the Turbine (Exhaust Side) Housing of the HP Turbo. Reference <b>Special Requirement</b> at the bottom of the page for proper cleaning and replacement procedure.</p> |

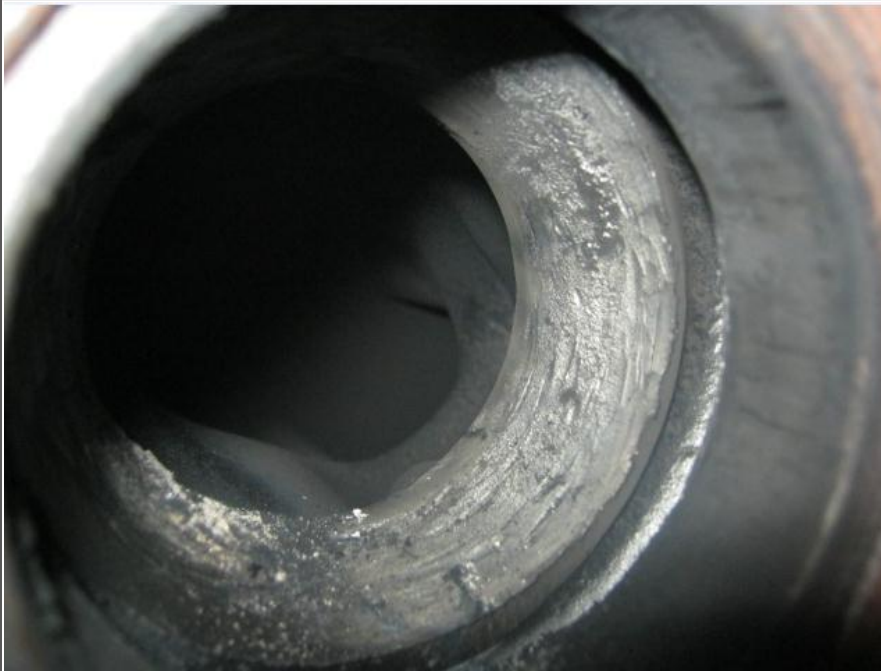
Major Damage to Turbine (Exhaust Side) Housing of the High Pressure Turbo. Turbo is recommended to be replaced as an assembly.

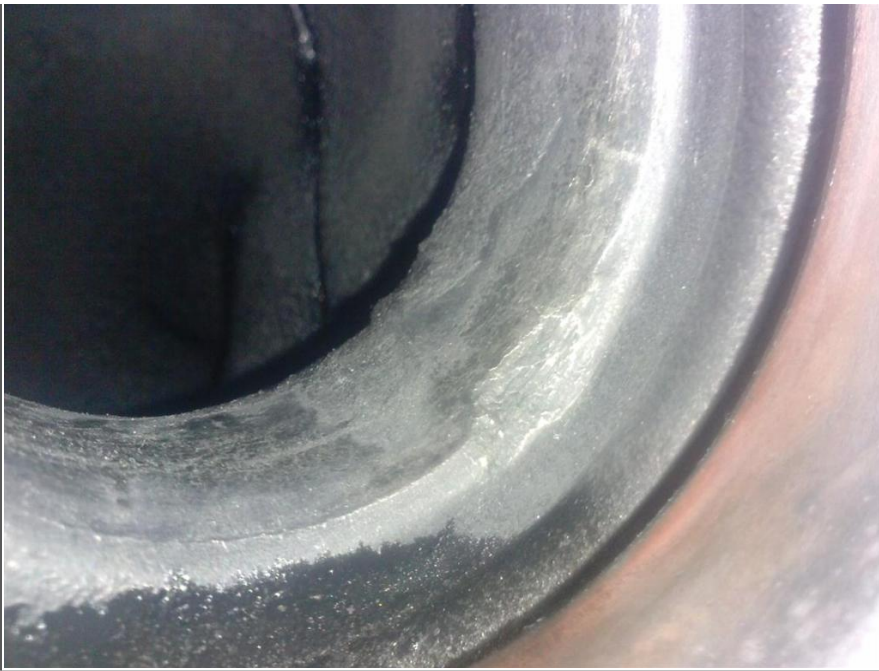
Damage to Turbine (Exhaust Side) Housing of HP Turbo. Turbine housing will need to be cleaned.

**Special Requirement** at the bottom of the page for proper cleaning and replacement procedure.

Once clean of all soot reevaluate damage to HP Turbo. If major Damage to Turbine Housing of the High Pressure Turbo is found after cleaning. Turbo is recommended to be replaced as an assembly.

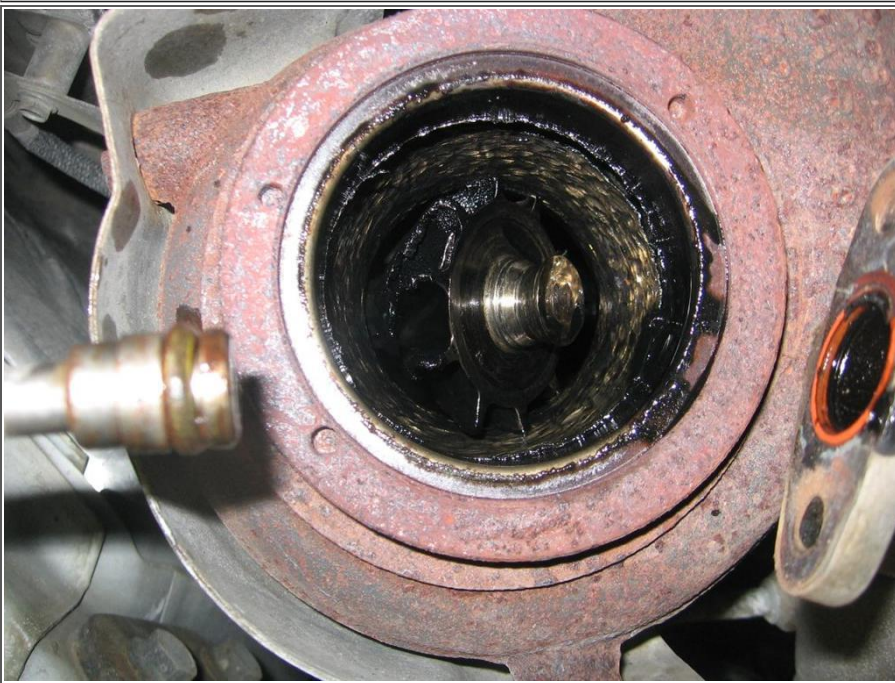
| | <p>Major Damage to Turbine (Exhaust Side) Housing of the High Pressure Turbo. Turbo is recommended to be replaced as an assembly.</p> |
