**Document ID:** IK1201090  
**Revision:** 8  
**Created:** 3/11/2014  
**Last Modified:** 4/29/2015  
**Author:** Aaron Wenthold

**Title:** Big Bore Coolant in the Intake

**Applies To:** EPA 2010 MaxxForce 11/13L Engines

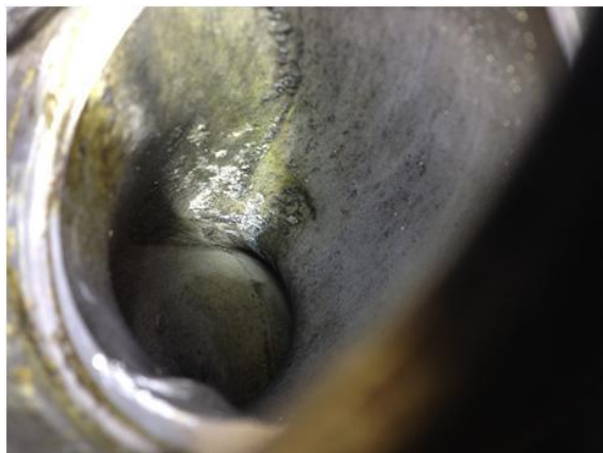
Figure 1: Porous HP turbocharger air inlet duct leaking coolant into the intake.

| Step | Action | Decision |
|---|---|---|
| 5 | Visually inspect HP turbocharger air inlet duct for signs of coolant and/or coolant residue. <ul style="list-style-type: none"> <li>Inspect for coolant seeping through the casting (porosity).</li> <li>Figure 1 shows a porous HP turbocharger air inlet duct leaking coolant into the intake.</li> </ul> <p>Is the HP turbocharger air inlet duct leaking?</p> | Yes: Replace HP turbocharger air inlet duct following the procedure in the Engine Service Manual. Repair complete. |
