| <b>Countries:</b> | CANADA, TAIWAN, UNITED STATES, MEXICO, GUAM, KOREA, SOUTH KOREA | <b>Document ID:</b> | IK1201195 |

**Title: SPN 3216 FMI 4 NOxIN signal Out of Range LOW**

**Applies To: EPA 2014 N9 and N10 SCR Engines ESN 3540000+**

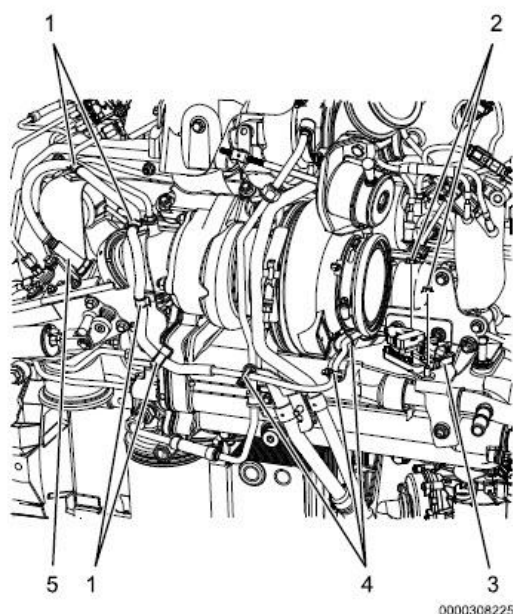
**Figure 53 NOxIn Concentration Sensor and Module**

1. Harness clipping (4)
2. M6 nut (2)
3. NOxIn Concentration Module
4. Tie straps (3)
5. NOxIn Concentration Sensor

1. Remove two NOxIn Concentration Sensor Module M8 nuts from NOxIn Concentration Sensor bracket.
2. Cut three NOxIn Concentration sensor harness tie straps.
3. Undo NOxIn Concentration sensor harness from four routing and clipping points.
4. Remove NOxIN Sensor and Module from exhaust brake under rail housing.

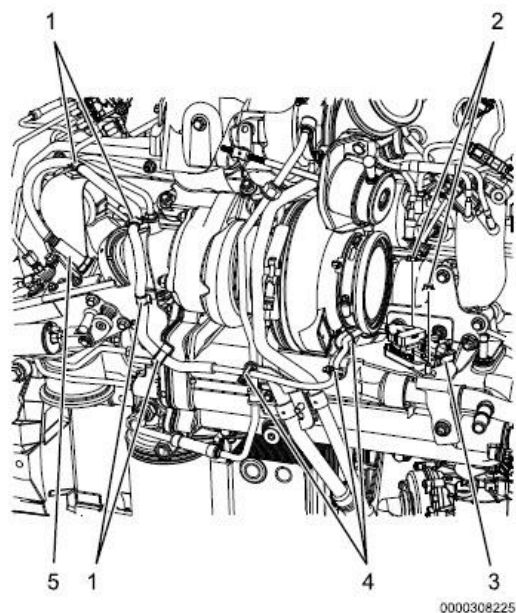
**Figure 53 NOxIN Concentration Sensor and Module**

1. Harness clipping (4)
2. M6 nut (2)
3. NOxIN Concentration Module
4. Tie straps (3)
5. NOxIN Concentration Sensor

1. Install NOxIN Concentration sensor into exhaust brake under rail housing.
2. Torque NOxIN Concentration sensor to 50 N·m (37 lb·ft).
3. Route NOxIN Concentration module harness through four routing and clipping points.
4. Install three new tie straps onto NOxIN Concentration module harness.
5. Install NOxIN Concentration module onto NOxIN Concentration module support.
6. Install two NOxIN Concentration module M6 nuts onto NOxIN Concentration module support and torque nuts to 10 N·m (7 lb·ft).
