**Document ID:** IK1201245  
**Revision:** 4  
**Created:** 11/25/2014  
**Last Modified:** 4/27/2015  
**Author:** Michael Sokolowski

**Title:** 2010+ DT/9/10 EGR Valve Diagnostics

**Applies To:** 2010+ MaxxForce DT/9/10

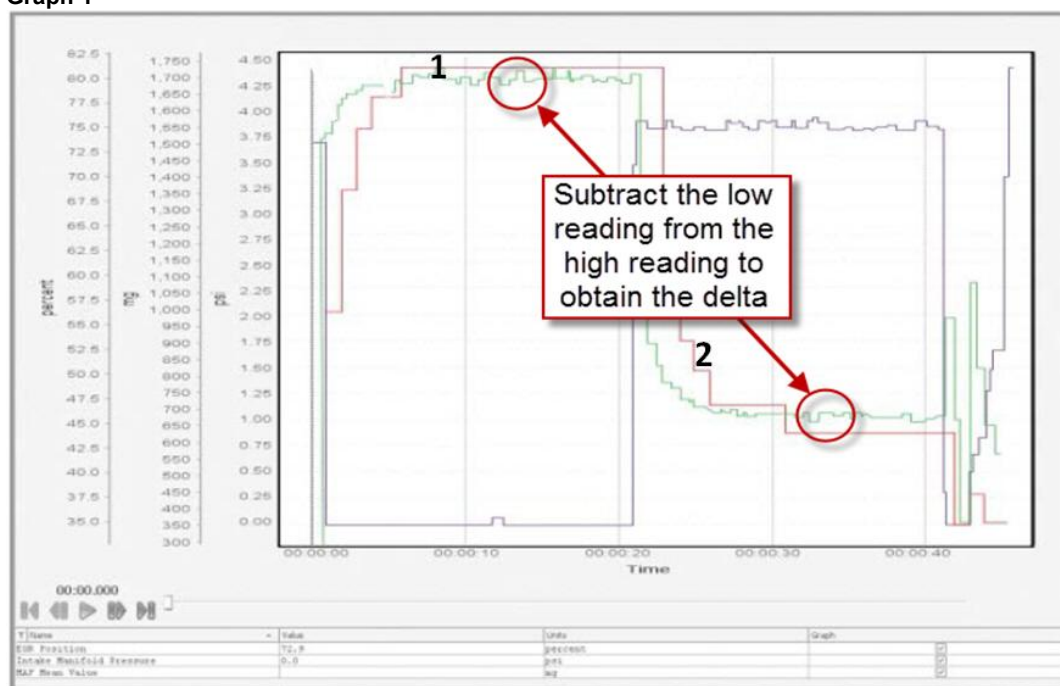
Graph 1

| Step | Action | Decision |
|---|---|---|
| 6 | Perform & Record Air Management Test.<br>MAF Mean Value Delta obtain the reading by subtracting the high reading in the beginning of the test to the low reading near the end as shown below in Graph 1: | <b>Yes:</b> No further action required |
| | 1. 466 ST ≥ 690 mg<br>2. 466 HT ≥ 740 mg<br>3. 570 ≥ 850 mg | <b>No IMP:</b> Go to step 7 |

1. MAF Mean Value High Point  
2. MAF Mean Value Low Point

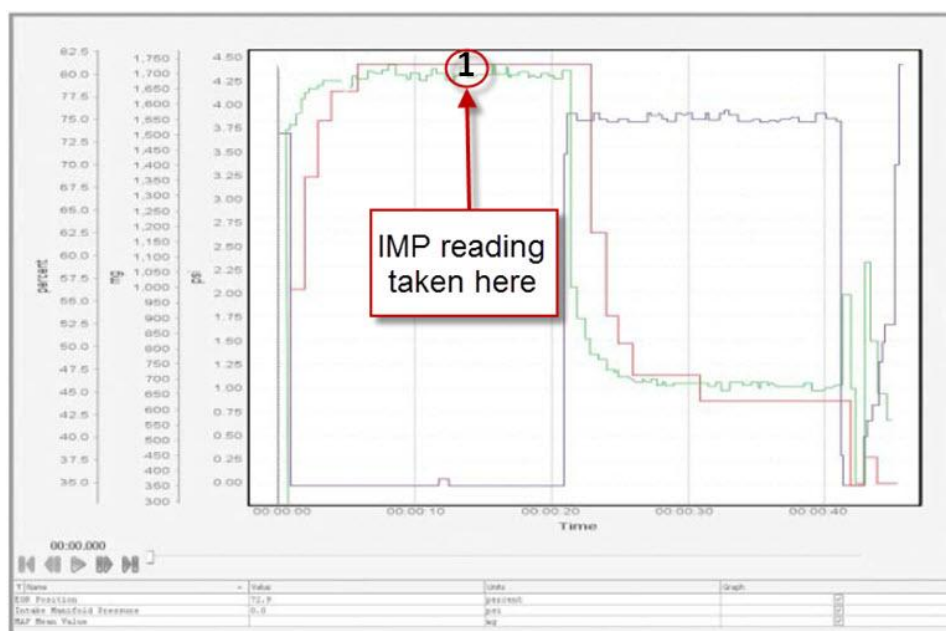
Graph 2

| Step | Action | Decision |
|---|---|---|
| | Intake Manifold Pressure (IMP) Graph 2:<br>1. 2 - 6 PSI<br><br>Does Air Management test meet specifications listed above? | <b>No MAF Delta:</b> Go to step 8 |

1. Intake Manifold Pressure (IMP)

| Step | Action | Decision |
|---|---|---|
| 7 | Was Intake Manifold Pressure (IMP) above or below specification? | <b>Above Specification:</b> Follow <a href="#">Turbocharger wastegate adjustment in IK1201103</a><br><br><b>Below Specification:</b> : Follow <a href="#">IK1200648 Low Power Complaint due to Low Boost</a> |

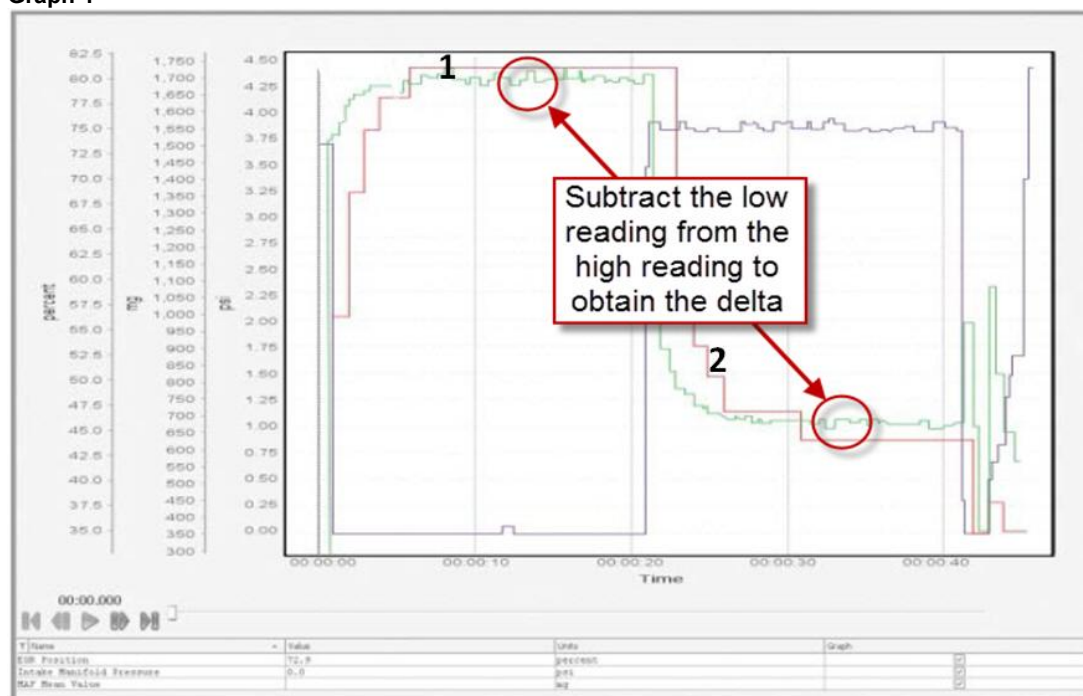
Graph 1

| <b>Step 5</b> | <b>Action</b><br>Perform & Record Air Management Test.<br>MAF Mean Value Delta obtain the reading by subtracting the high reading in the beginning of the test to the low reading near the end as shown below in Graph 1:<br><br>1. 466 ST $\geq$ 690 mg<br>2. 466 HT $\geq$ 740 mg<br>3. 570 $\geq$ 850 mg<br><br>Intake Manifold Pressure (IMP) Graph 2:<br><br>1. 2 - 6 PSI<br><br>Does Air Management test meet specifications listed above? | <b>Decision</b><br><b>Yes:</b> No further action required<br><br><b>No IMP:</b> Go to step 6<br><br><b>No MAF Delta:</b> Go to step 7 |

1. MAF Mean Value High Point (mg)
2. MAF Mean Value Low Point (mg)

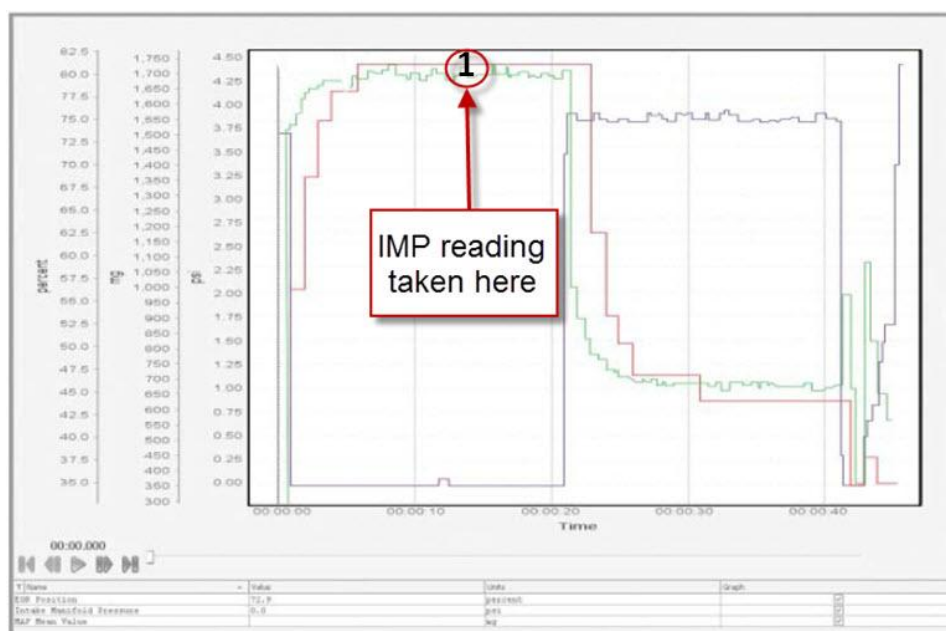
Graph 2

1. Intake Manifold Pressure (IMP)

| Step | Action | Decision |
|---|---|---|
| 6 | Was Intake Manifold Pressure (IMP) above or below specification? | <b>Above Specification:</b> Follow <a href="#">Turbocharger wastegate adjustment in IK1201103</a><br><br><b>Below Specification:</b> : Follow <a href="#">IK1200648 Low Power Complaint due to Low Boost</a> |
