MIN – 15104

WorkStar® Charge Air Cooler (CAC) Clamp Interference with Hood

WorkStar® Vehicles built between 05 January 2015 and 12 March 2015.

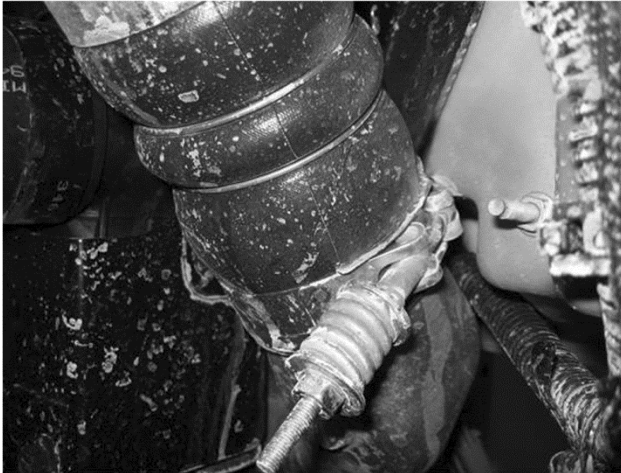
Figure 1. CAC Inlet Hose Clamp – Original Orientation.

Certain WorkStar vehicles built between 05 January 2015 and 12 March 2015 may experience a condition where the lower CAC inlet hose clamp is rubbing against the hood when closed. This condition is caused by orientation of the clamp, which could cause the clamp's integrity to be compromised, resulting in the CAC hose disconnecting / disengaging under operating conditions.

5. Inspect lower right CAC inlet hose clamp:
 - If clamp is oriented with T-bolt portion outboard of CAC hose (Figure 1), proceed to Step 6.
 - If clamp is oriented with T-bolt portion inboard of CAC hose, proceed to Step 8.
