**Document ID:** IK0900114

**Major System:** COOLING

**Title:** Upper Radiator (Inlet) Hose Saddle Clamp Causing Leaks

**Applies To:** DuraStars and CE Buses with Cummins ISB

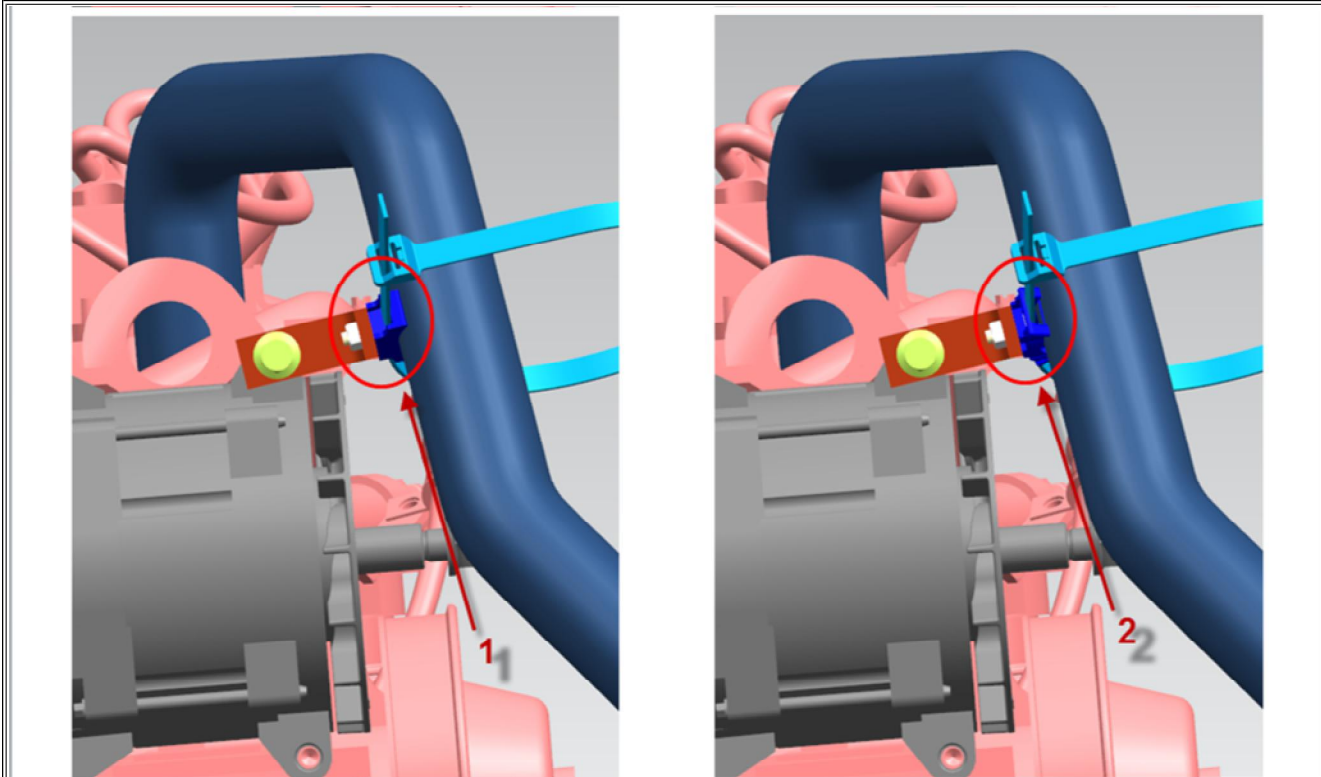
**Figure 1: Old and new design of saddle clamp**

Visually inspect for rubbing/hose damage. See **Figures 1 and 2** for comparison of old and new saddle clamp design. If the hose is punctured and the saddle clamps are the old design, replace hose and replace saddle clamps with new design.

- Item 1: Old design - P/N 2041341C1
- Item 2: New design - P/N 4039319C1

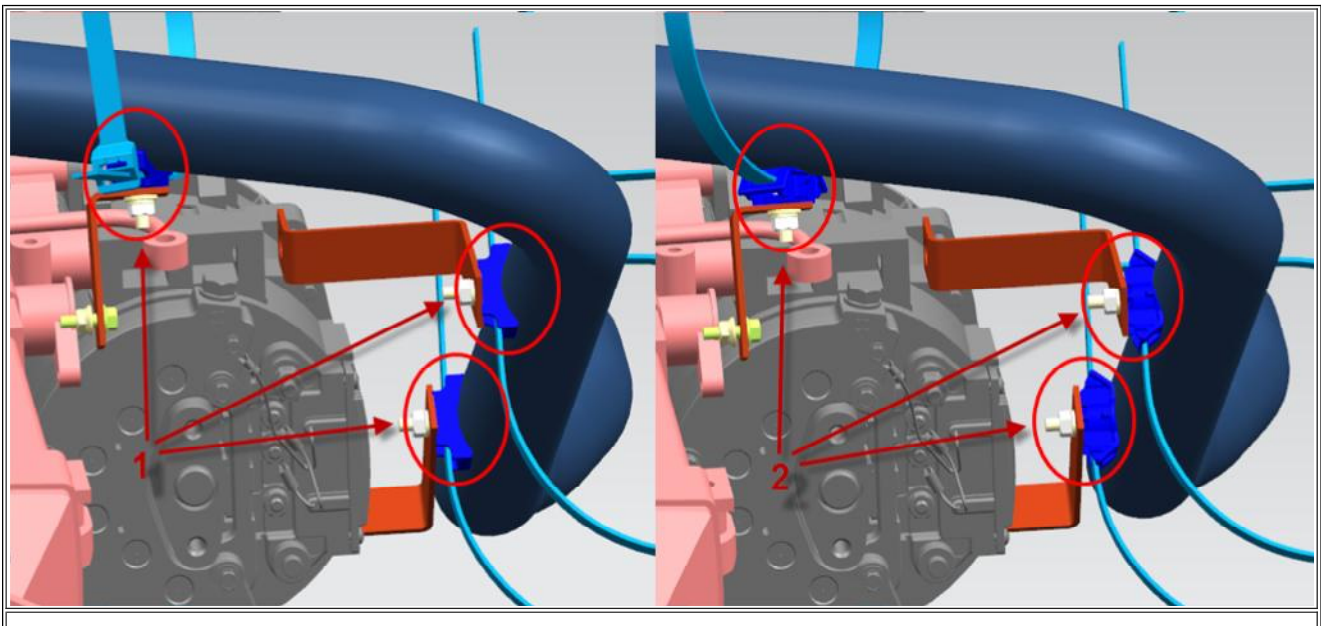
**Figure 2: Old and new design of saddle clamp**

Item 1: Old design - P/N 2041341C1  
Item 2: New design - P/N 4039319C1

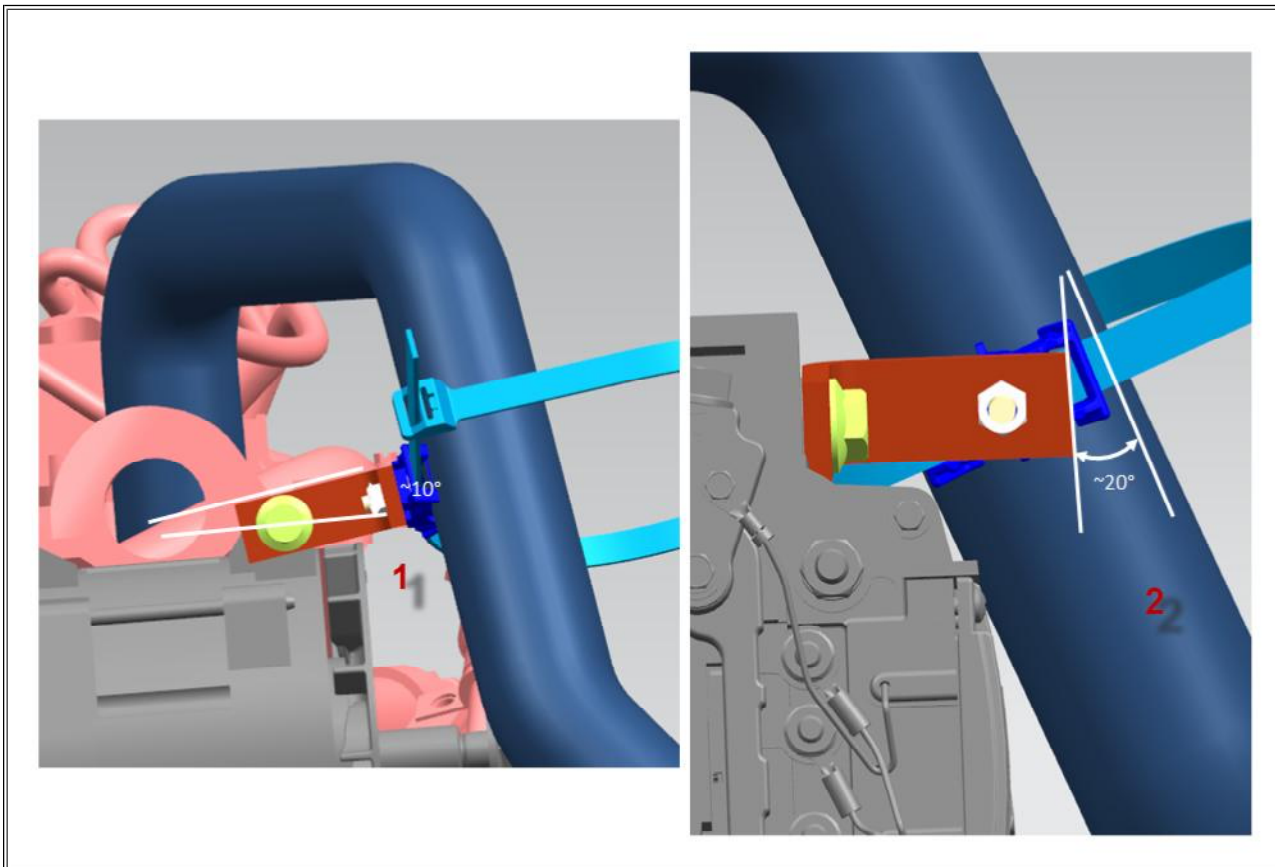
**Figure 3: Engineering specifications for saddle clamp and extension bracket**

Item 1: Extension bracket angled up from parallel  $\sim 10^\circ$ .  
Item 2: Saddle clamp angled  $\sim 20^\circ$  up from parallel. Axis of saddle should align with axis of hose.

1. Remove old zip straps and saddle clamps.
2. Replace upper radiator hose.
3. Install new saddle clamp and zip strap, as shown in **Figure 3**. The angle of both the extension bracket and the saddle clamp in relation to the bracket must be correct, otherwise rubbing can occur.

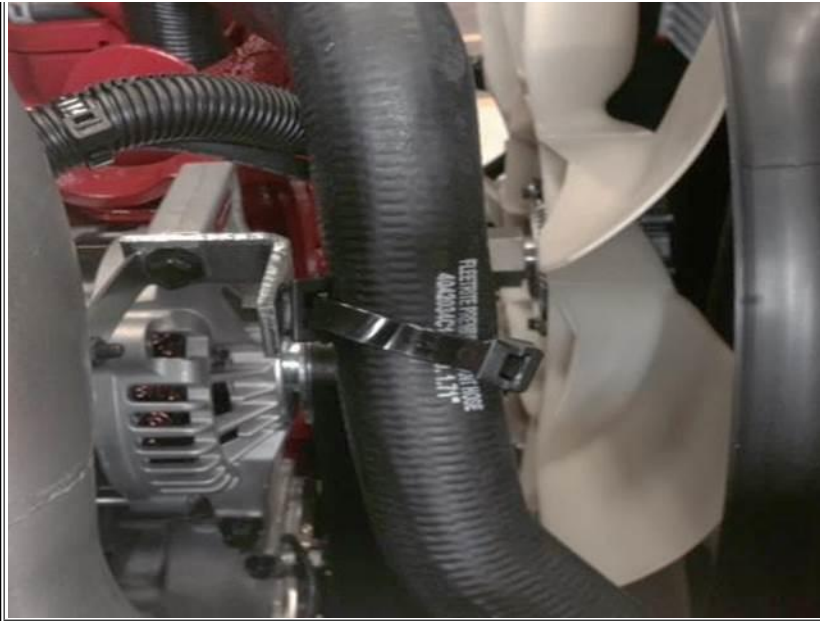
Figure 4: Issues - zip strap loose, extension bracket not at correct angle and saddle clamp is off angle

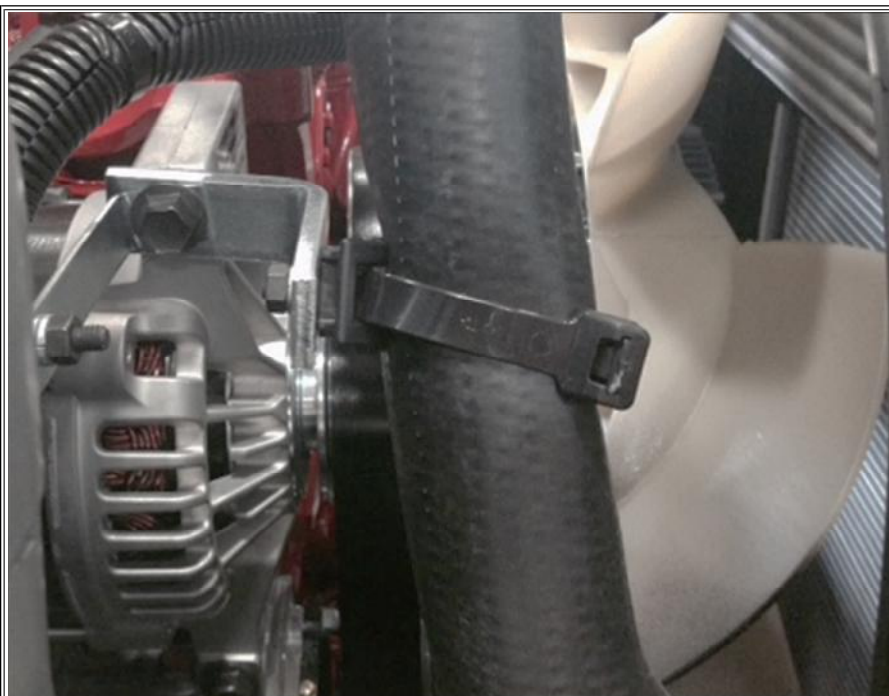
Figure 5: Issues – zip strap over tight, saddle clamp at incorrect angle, and extension bracket at incorrect angle causing saddle and strap to dig into hose

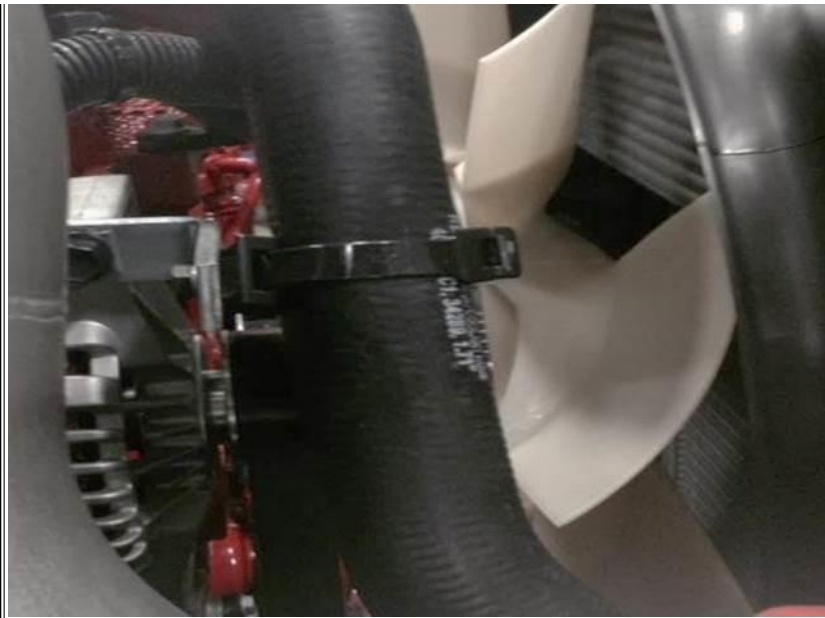
Figure 6: Unit assembled to specifications
