**Document ID:** IK1201100

**Title:** MaxxForce 11/13L - SPN 2659 FMI 21 - EGR Low Flow

**Applies To:** 2010 Emissions MaxxForce 11/13 All truck models

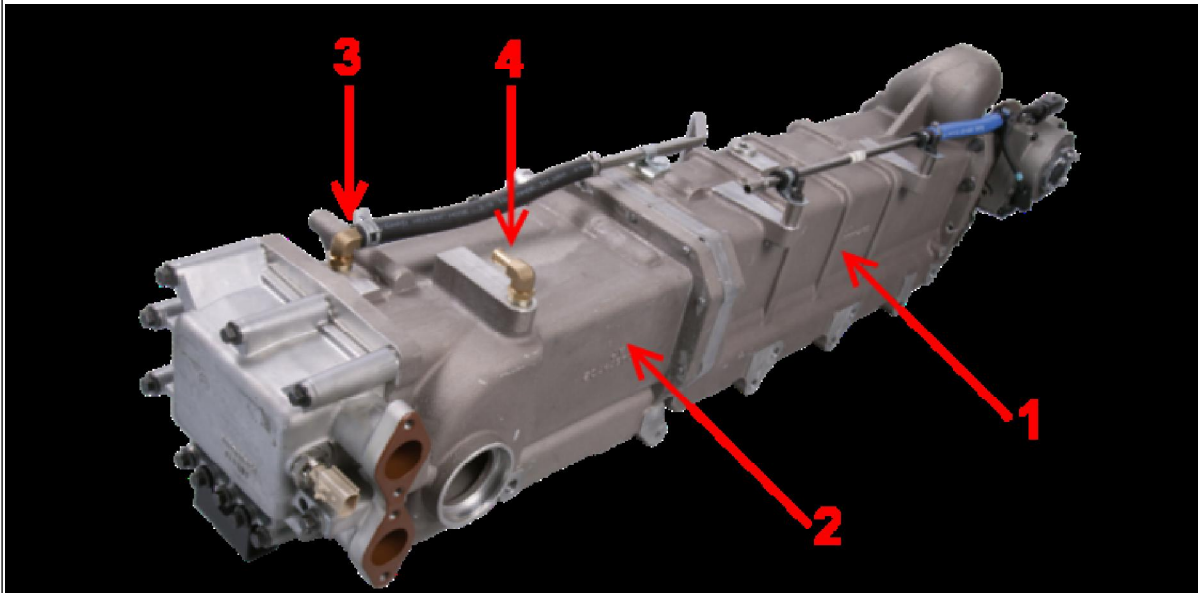
**Figure 1: 2010 MaxxForce 11/13 EGR Cooler Assembly**

Item 1: High Temp (HT) Cooler

Item 2: Low Temp (LT) Cooler

Item 3: LT Cooler Pressure Test Port (dearation fitting)

Item 4: HT Cooler Pressure Test Port (dearation fitting)

| Step | Action | Decision |
|---|---|---|
| 6 | <b>DIAGNOSTIC:</b><br><br>Use 12-892-02 (EGR cooler pressure tester) to test the EGR Cooler--Low Temp section first.<br><br>Which section is leaking?<br><br>Reference <b>Figure 1</b> for a cooler configuration visual aid (dearation fittings). | HT. Proceed to <a href="#">IK1201113</a> . After replacing the HT core (and coolant still drained), return to <b>Step 2</b> |

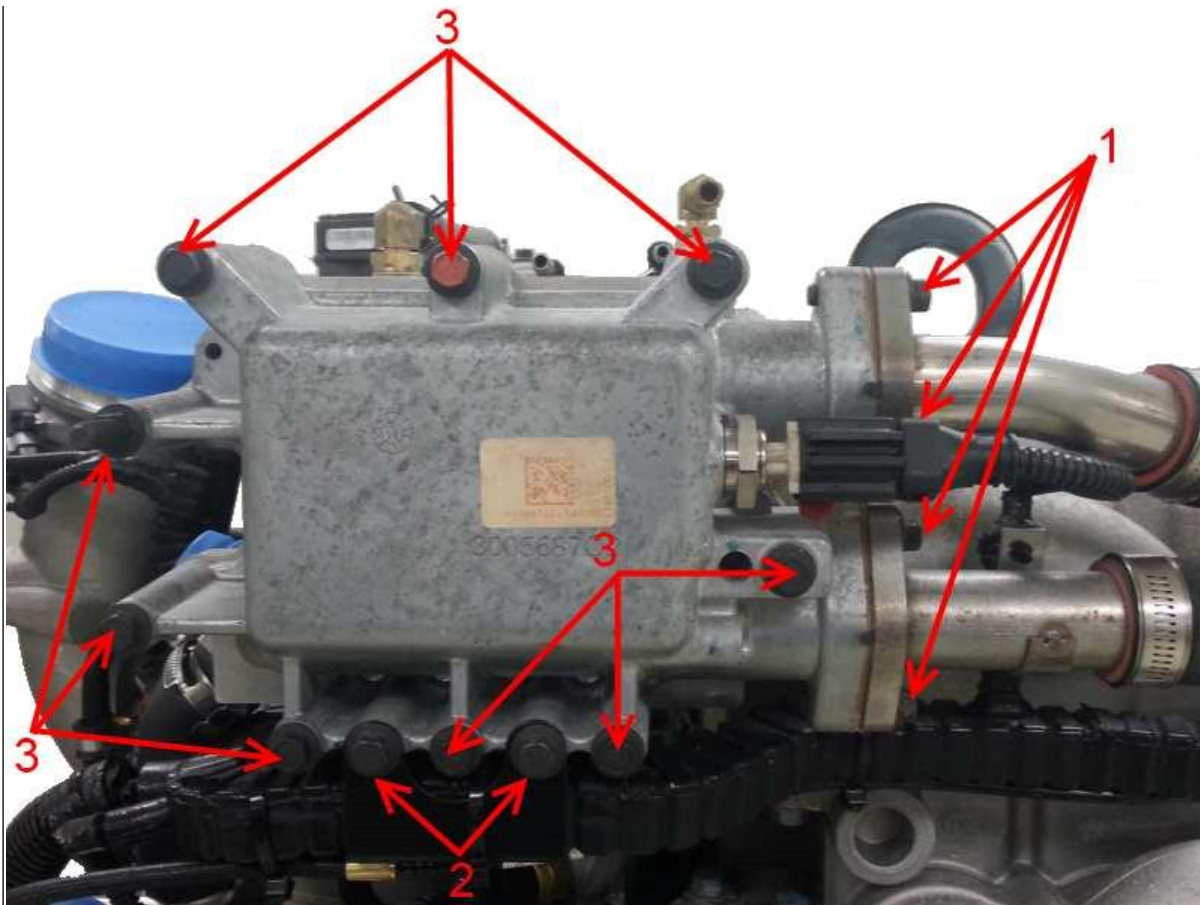
**Figure 2: EGR Outlet Cover, Bolts and Tubes**

Item 1: EGR Outlet Tube Bolts  
Item 2: Engine Harness Bracket Bolts  
Item 3: EGR Outlet Cover Bolts

1. Remove the eight bolts and one stud bolt from the front cover, and remove (**Figure 2**, Item 3).

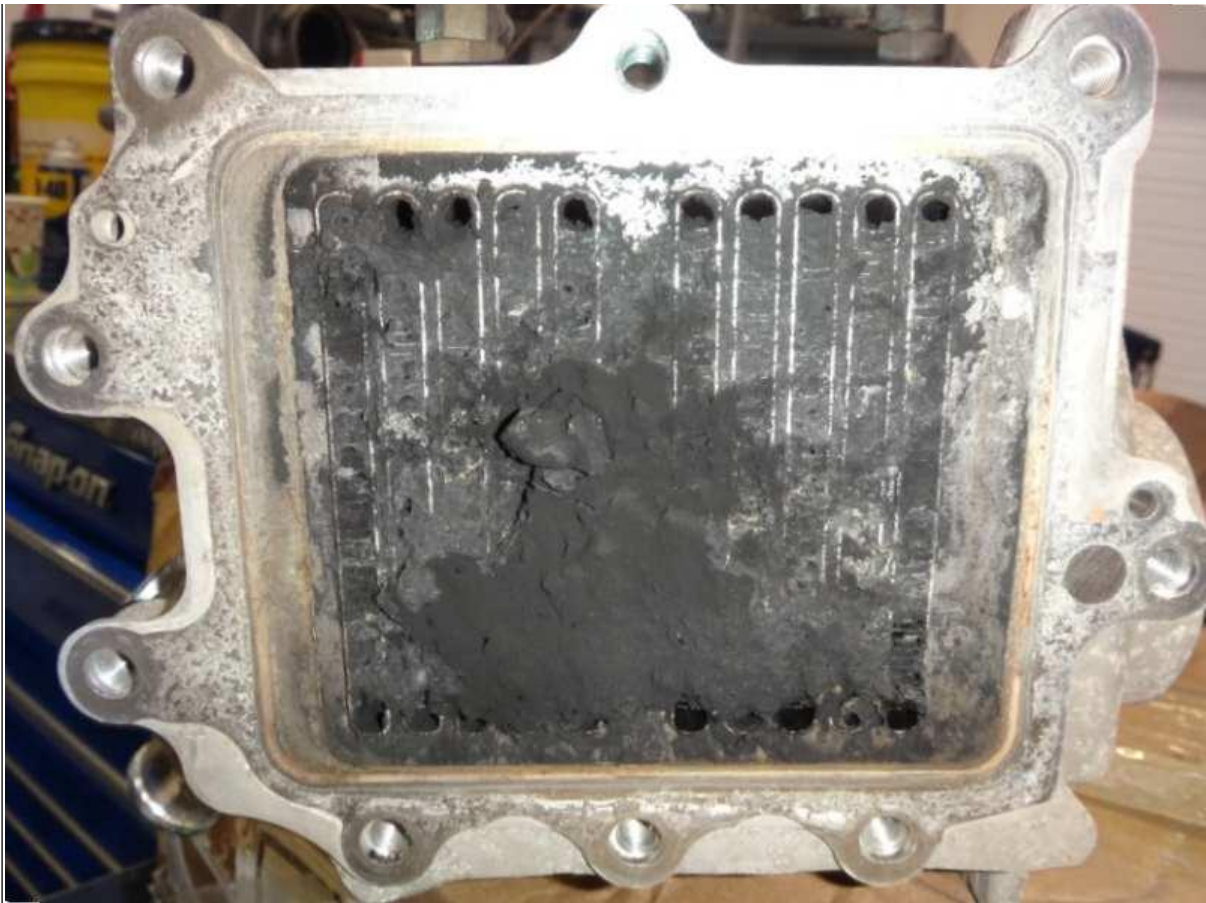
**Figure 3: Soot Build-Up on the Core Face**

Significant build-up will not allow the tool to sit against the core.

2. If necessary, scrape off soot build-up on the outlet of the core. The plate must sit flat against the face.

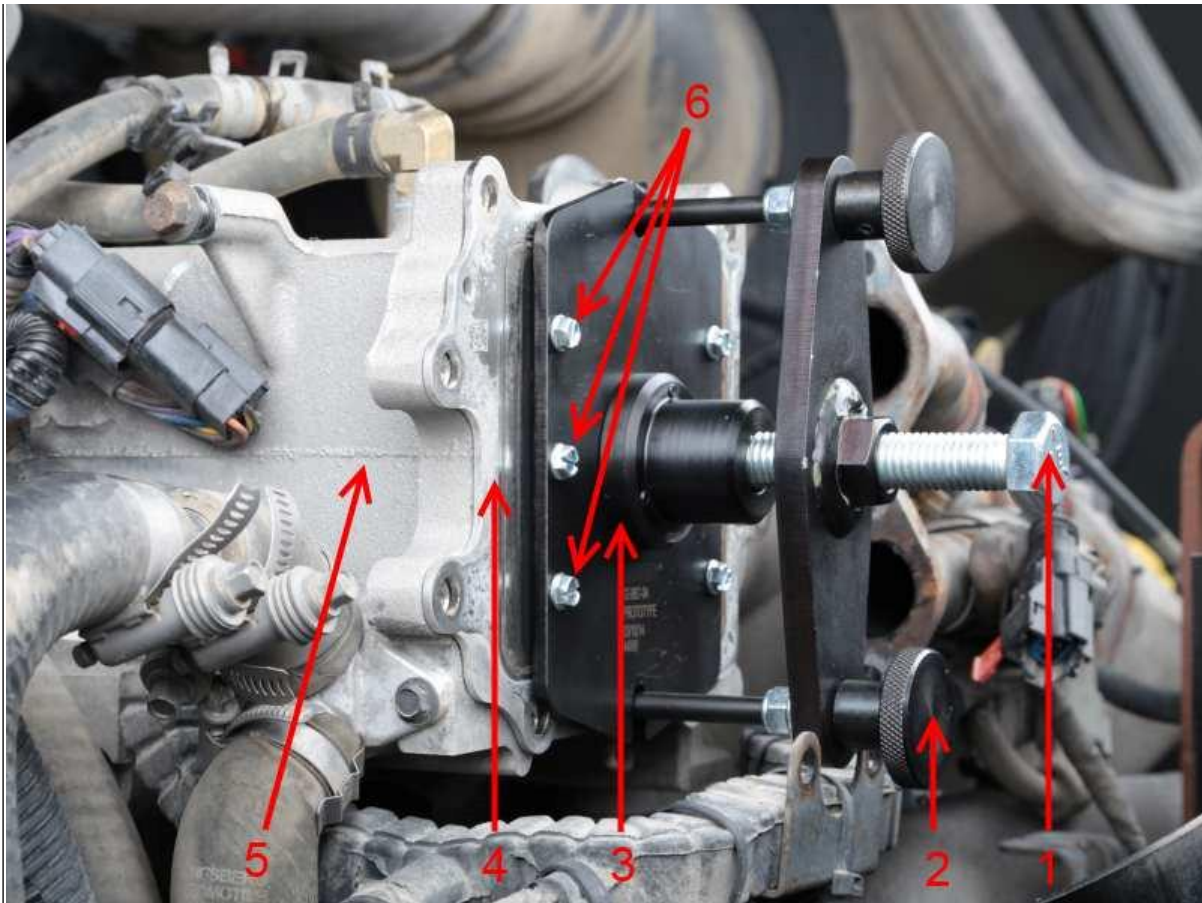
**Figure 4: Low Temp EGR Core Extractor**

- Item 1: Removal Bolt
- Item 2: Thumb Screws
- Item 3: Removal Plate
- Item 4: LT Core
- Item 5: LT Housing
- Item 6: Self Tapping Screws

3. Install the LT EGR Core Puller Tool (12-892-04), [per the tool instructions](#).
4. Back out the bolt (**Figure 4**, Item 1) until the core pulls loose (typically 3/4" from the housing).
5. Remove the tool and pull the core from the housing.

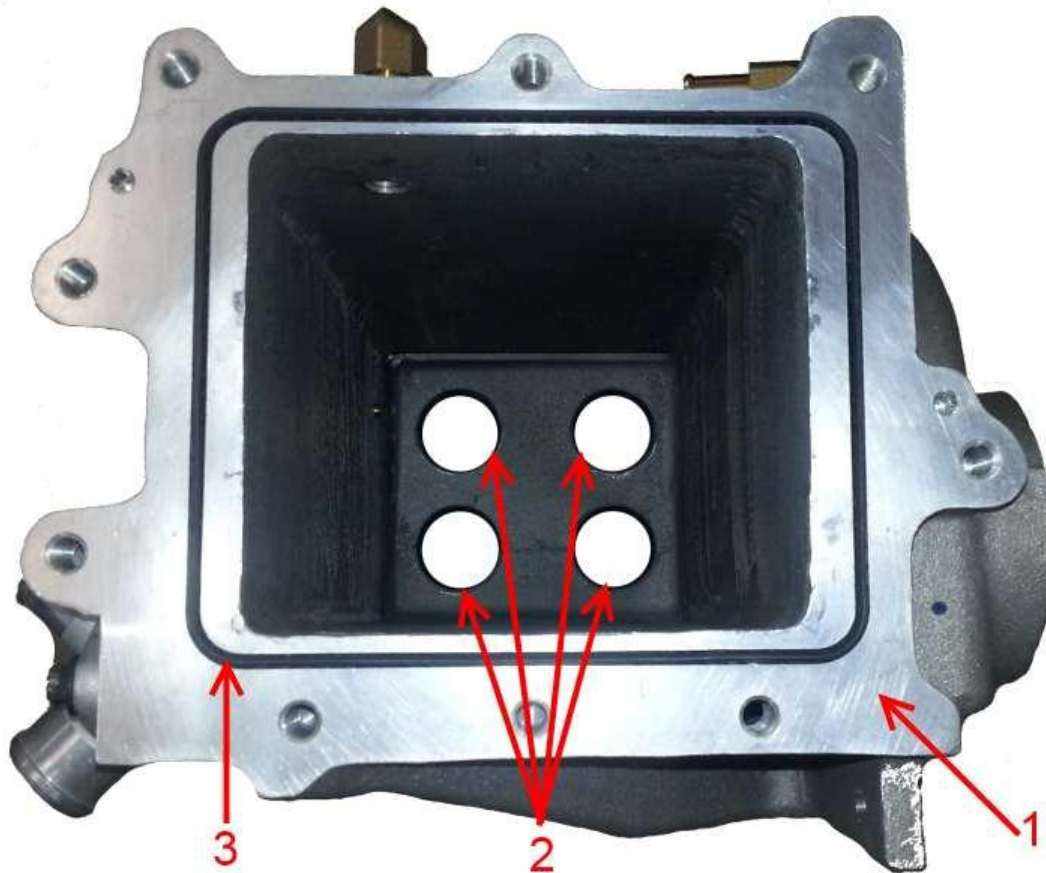
**Figure 5: Low Temp Cooler Housing Face**

Item 1: Housing  
Item 2: Core O-Rings  
Item 3: Housing Seal

6. Remove the housing seal and discard (**Figure 14**, Item 3)
7. Use a seal pick to remove the four o-rings at the housing inlet and discard (**Figure 14**, Item 2).

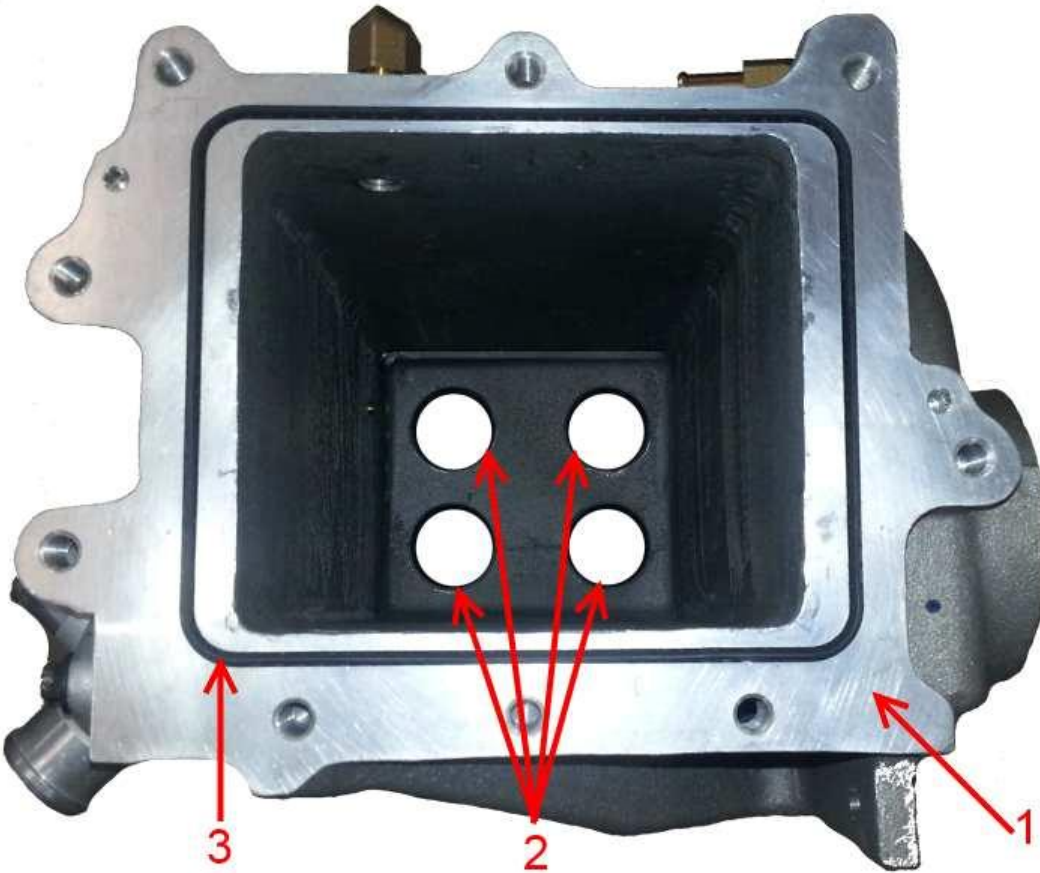
**Figure 6: Low Temp Cooler Housing Face**

Item 1: Housing  
Item 2: Core O-Rings  
Item 3: Housing Seal

Ensure no soot or other debris are left in the grooves. Debris can cause leaks from improper sealing and/or cause the o-ring to be damaged by the core during installation.

1. Install the new seal into the LT housing (**Figure 6**, Item 3).
2. Clean the o-ring grooves of contaminants (soot). Coolant is not a concern, and will act as a lubricant.
3. Install the new o-rings from the LT core kit (**Figure 6**, Item 2).

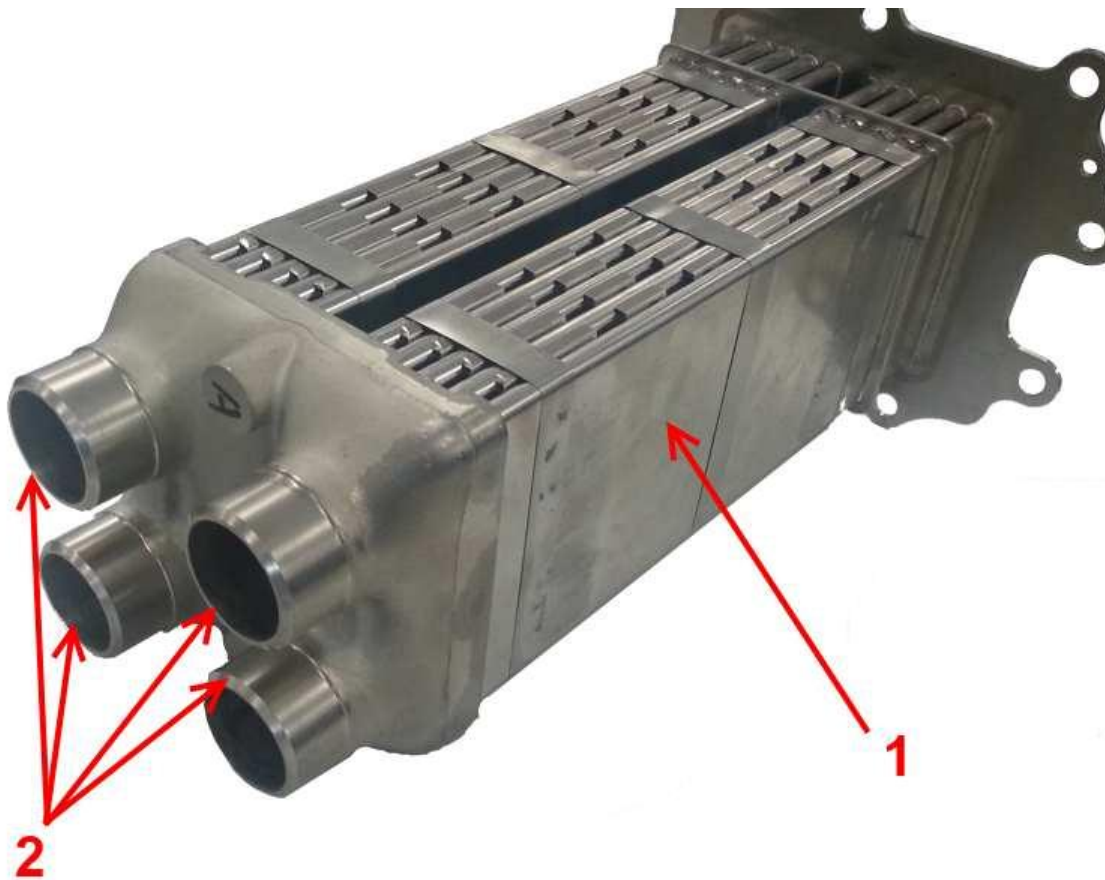
**Figure 7: Low Temp Cooler Inlet Manifold**

Item 1: Low Temp EGR Cooler Core  
Item 2: Inlet Manifold Ports

3. Use liberal amounts of P-80 to lubricate the LT core inlet manifold and the four o-rings in the LT housing.
4. Insert the core into the housing and maneuver it into the o-rings.

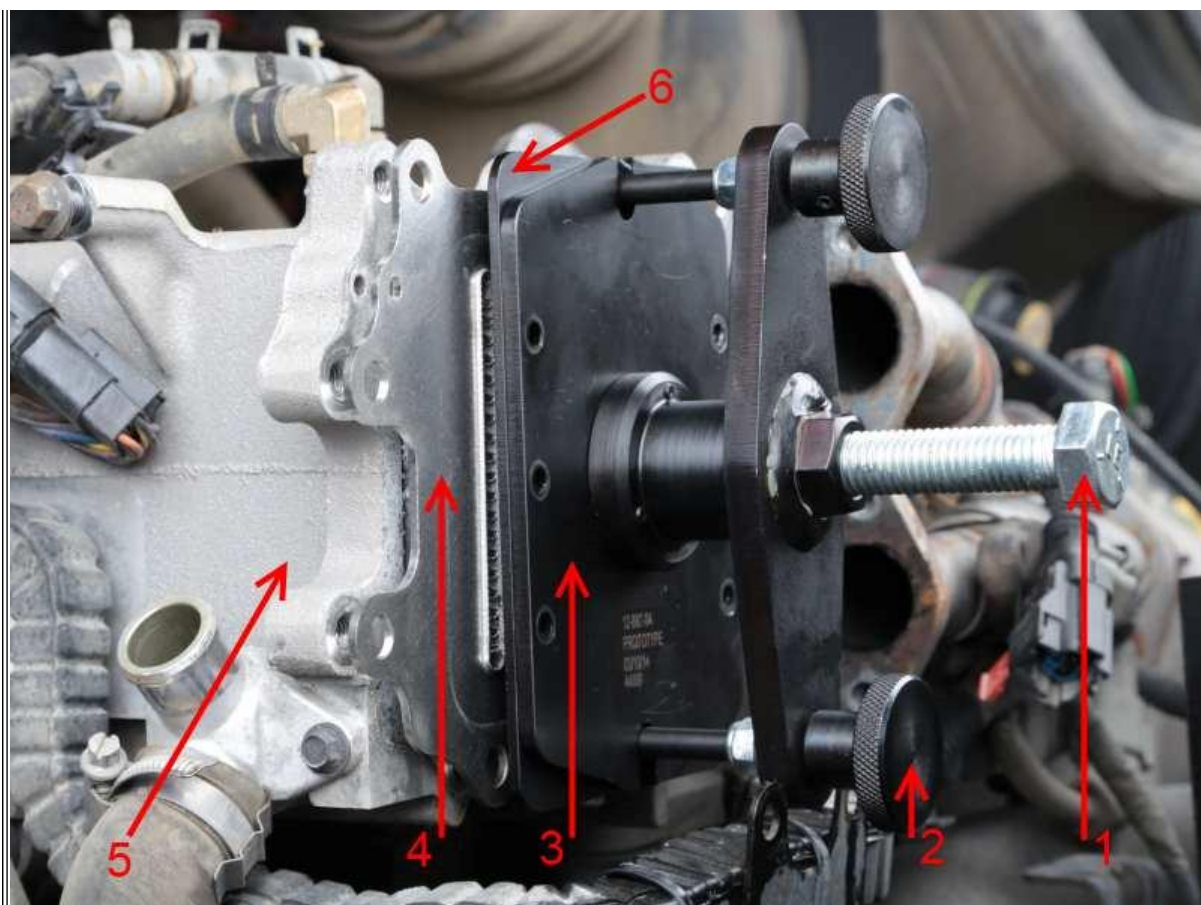
**Figure 8: Low Temp Core Install Tool**

Item 1: Insertion Bolt  
 Item 2: Thumb Screw  
 Item 3: Removal Plate  
 Item 4: LT Core  
 Item 5: LT Housing  
 Item 6: Installation Plate

**DO NOT** over-torque the bolt, as damage to the core may result. Typical installation will take less than 5 lb-ft of torque to drive the core in. It is normal for the core to sit a couple millimeters off the face of the housing, and will seat/seal when the front cover is installed.

5. Install the LT Core installation tool, [per the tool instructions](#).
6. Press the EGR cooler core into the housing **until the core header plate makes contact with the housing seal**.

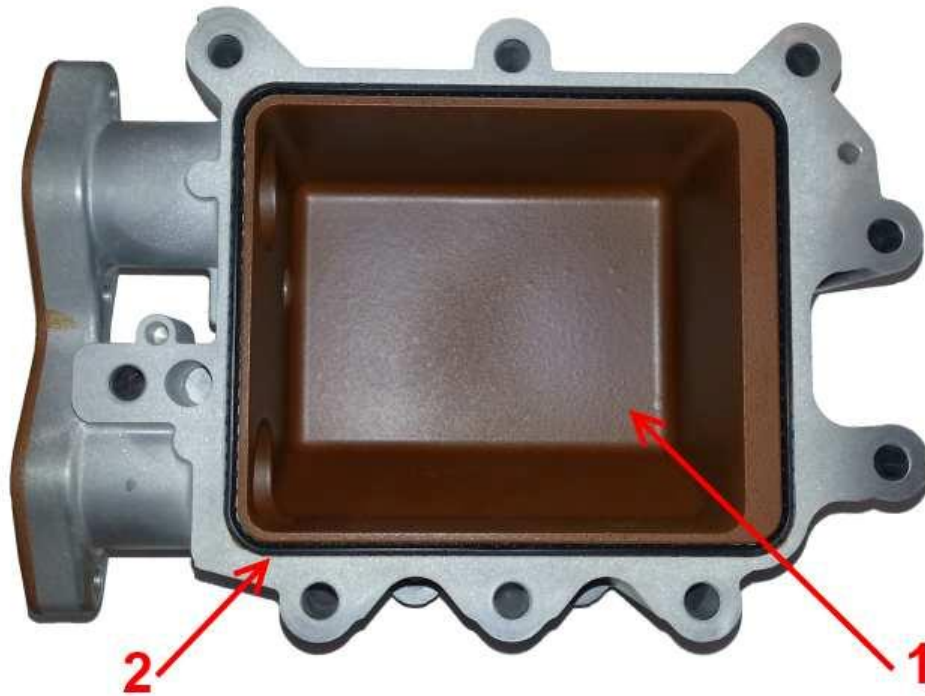
**Figure 9: EGR Outlet Cover**

Item 1: Front Cover  
Item 2: Ring Seal

7. Inspect the front cover for reuse--Review [IK1201087 - Front Cover Reuse Guidelines](#) for direction.
8. Remove the seal from the groove and discard.
9. Insert the new seal from the LT Core kit.

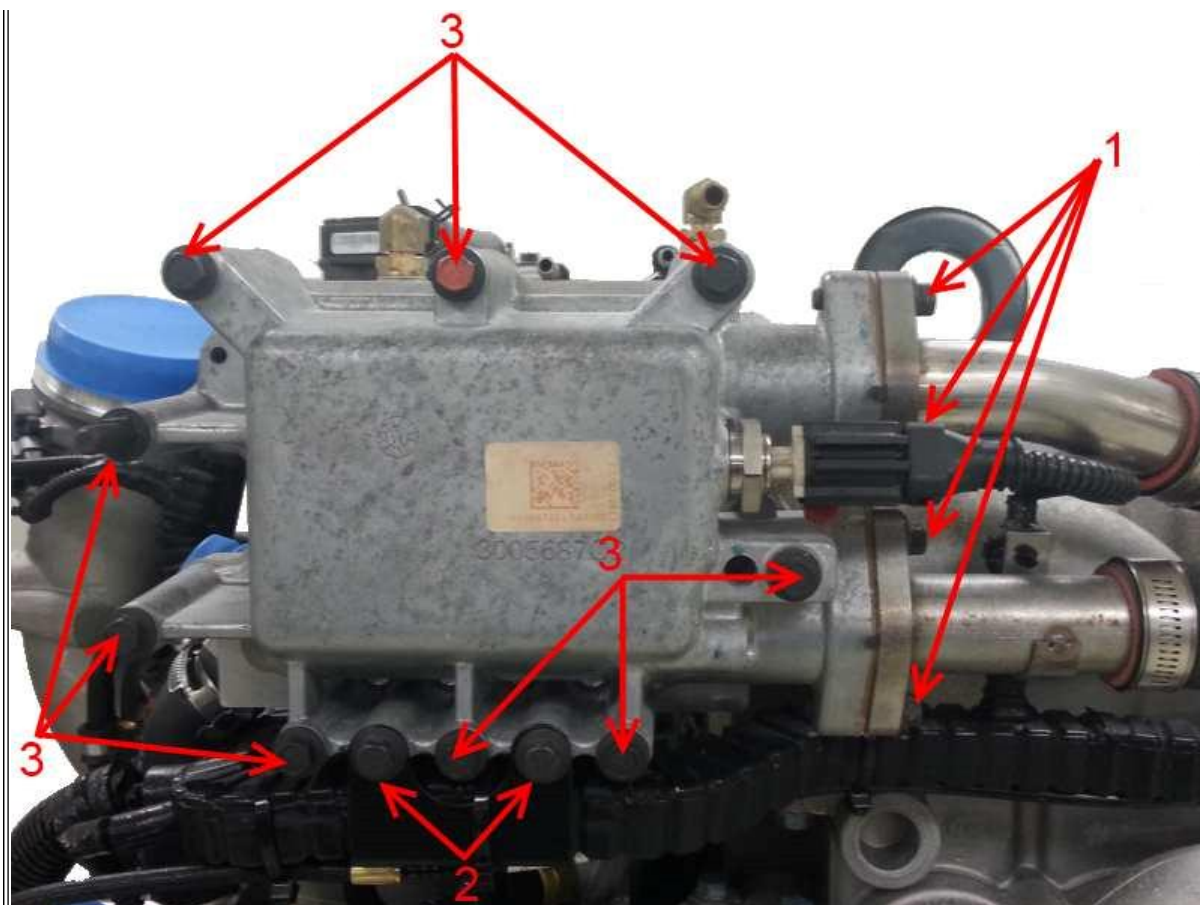
**Figure 10: EGR Outlet Cover, Bolts and Tubes**

- Item 1: EGR Outlet Tube Bolts
- Item 2: Engine Harness Bracket Bolts
- Item 3: EGR Outlet Cover Bolts

10. Install the front cover, noting the location of the stud bolt in **Figure 10**.
11. Resume the cooler assembly installation instructions in the service manual.
12. Use the Coolant Management Tool to refill the cooling system.
13. If the system is unable to maintain vacuum, perform a cooling system pressure decay test. If no external leaks can be found, pressure test the EGR Cooler.
