Document ID: IK1201213
Revision: 9
Created: 9/25/2014
Last Modified: 7/9/2015
Author: Aaron Mimbs

Title: MaxxForce 7 DTC 3055 Fuel System Diagnostics

Applies To: 2010 - 2013 MaxxForce 7

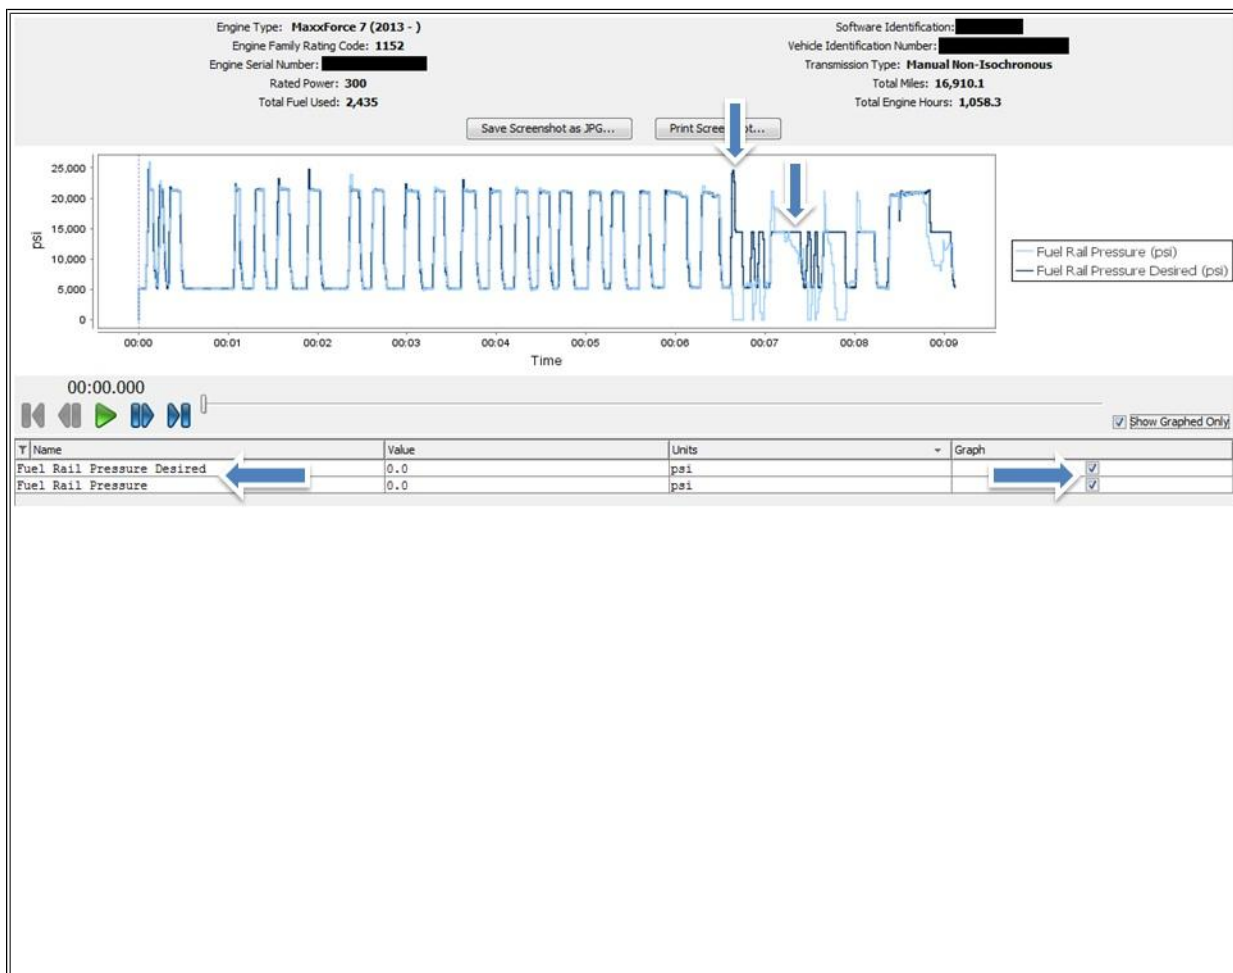
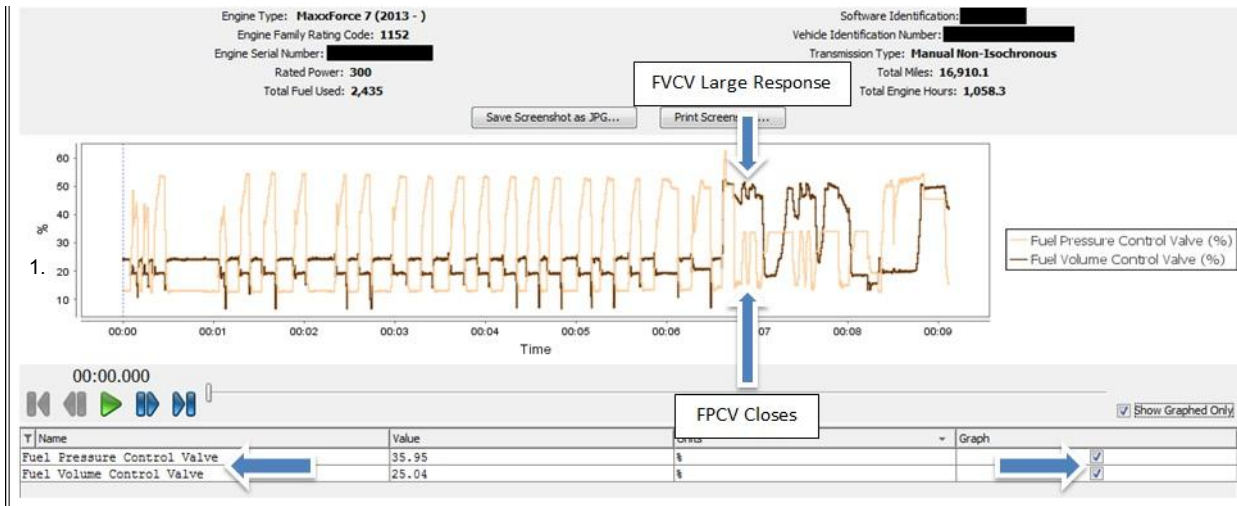
Figure 3: Fuel Rail Pressure Data Recording

High Pressure Fuel Pump Insufficient Fuel Supply Failure Characteristics

Recording
Notes:
Most likely to

- Item 1: FRP Drops Below Desired
- Item 2: FRP Meets Desired

1. occur during high fuel volume demand
2. FRP may rise to desired then fall below
3. FRP may fall to 0 psi and the engine will remain running
4. During this time the FPCV & FVCV will attempt to compensate for the loss in FRP
5. The FVCV will open as much as possible to attempt letting more fuel reach the pump

Step	Action	Decision
<p>10</p>	<p>DTC: 3055 FMI 15/16</p> <p>High Pressure Fuel Pump Insufficient Fuel Supply Failure Characteristics</p> <p>See EGED 0000001681 (Diagnostic Manual)</p> <p>1. Hard Start No Start Diagnostics Special Test Procedures Low-pressure Fuel System (LP.1 - LP.8)</p> <p>Also, check for fuel return aeration and fuel supply pressure under a torque stall.</p> <p>NOTE: Do not continue to the High Pressure Fuel System Diagnostic section once complete</p> <p>Were any low pressure fuel system issues noted?</p>	<p>Yes. Repair and rediagnose for the issue. If resolved STEP 9.</p> <p>No. Re-evaluate condition, perform the Fuel Rail Pressure Monitoring with ServiceMaxx as outlined below again with a new recording, follow the next See the next closest representation of the issue.</p>

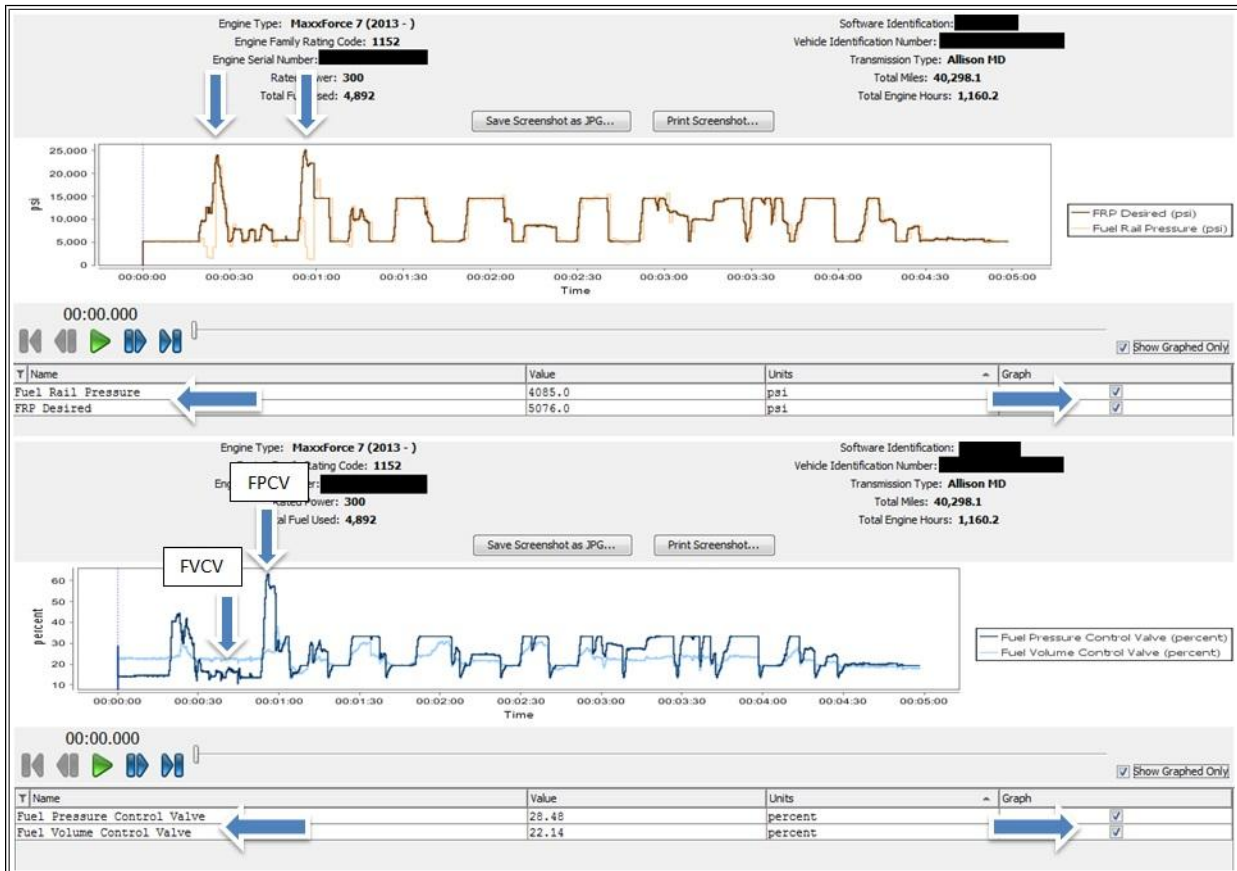
Figure 4: Fuel Rail Pressure Data Recording

High Pressure Fuel Pump Harness FVCV Connection Failure Characteristics

- Item 1: FRP Drops Below Desired
- Item 2: FRP Meets Desired

1. Most likely to occur at the beginning of a hard acceleration
2. FRP Drops to nearly 1000psi or lower then can return to desired FRP
3. During this time the FPCV will attempt to compensate and the FVCV will remain low.

Step	Action	Decision
<p>11</p>	<p>DTC: 3055 FMI 15/16</p> <p>High Pressure Fuel Pump Harness FVCV Connection Failure Characteristics High Pressure Fuel Pump Harness PVCV Connection Failure Characteristics</p> <p>Replace the High Pressure Fuel Pump Harness per the revised replacement SRT steps (Click Here). For properly installing and securing the harness see the Repair Steps: Installation Procedure section below. Reset the fuel pressure adaptives and perform ServiceMaxx Recording.</p> <p>NOTE: To access the high pressure fuel pump it is no longer required to remove the turbochargers, please review the SRT steps for greater detail.</p> <p>Can the codes be recreated?</p>	<p>Yes. STEP 14</p> <p>No. Finish any other work necessary and release to customer</p>

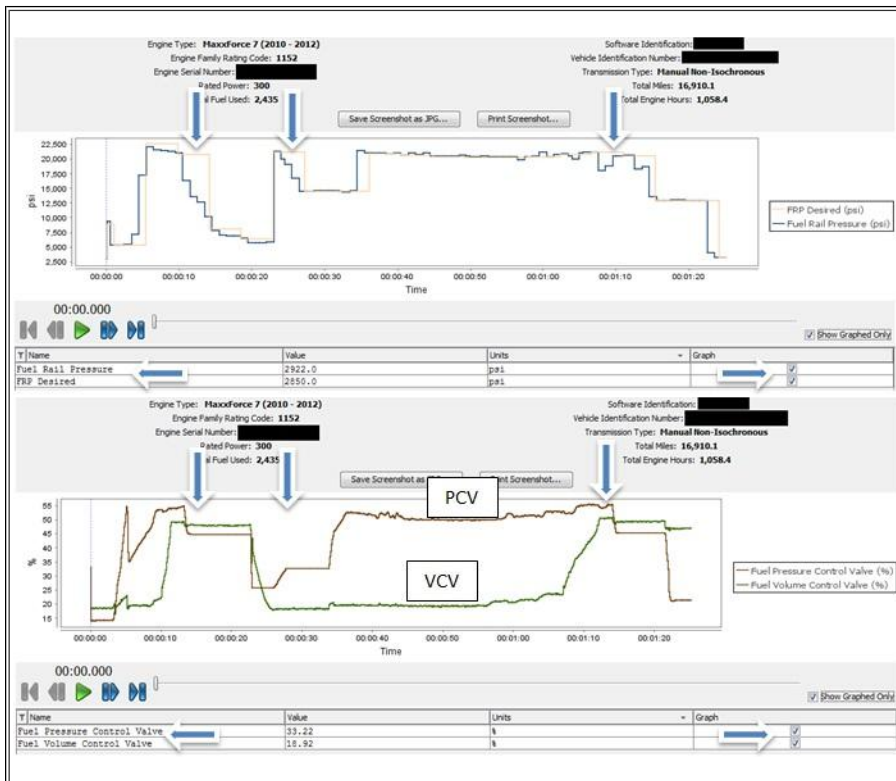
Figure 5: Fuel Rail Pressure Data Recording

High Pressure Fuel Pump Harness FPCV Connection Failure Characteristics

- Item 1: FRP Drops Below Desired
 Item 2: FRP Meets Desired

1. Most likely to occur during the peak of a hard acceleration
2. FRP will rise with desired but may not fully reach it or reaches it then drops below
3. During this time the FPCV & FVCV will attempt to compensate for the loss in FRP
4. FPCV will be nearly maxed while FVCV has a gradual response
5. Could also be a representation of Fuel Supply Issues

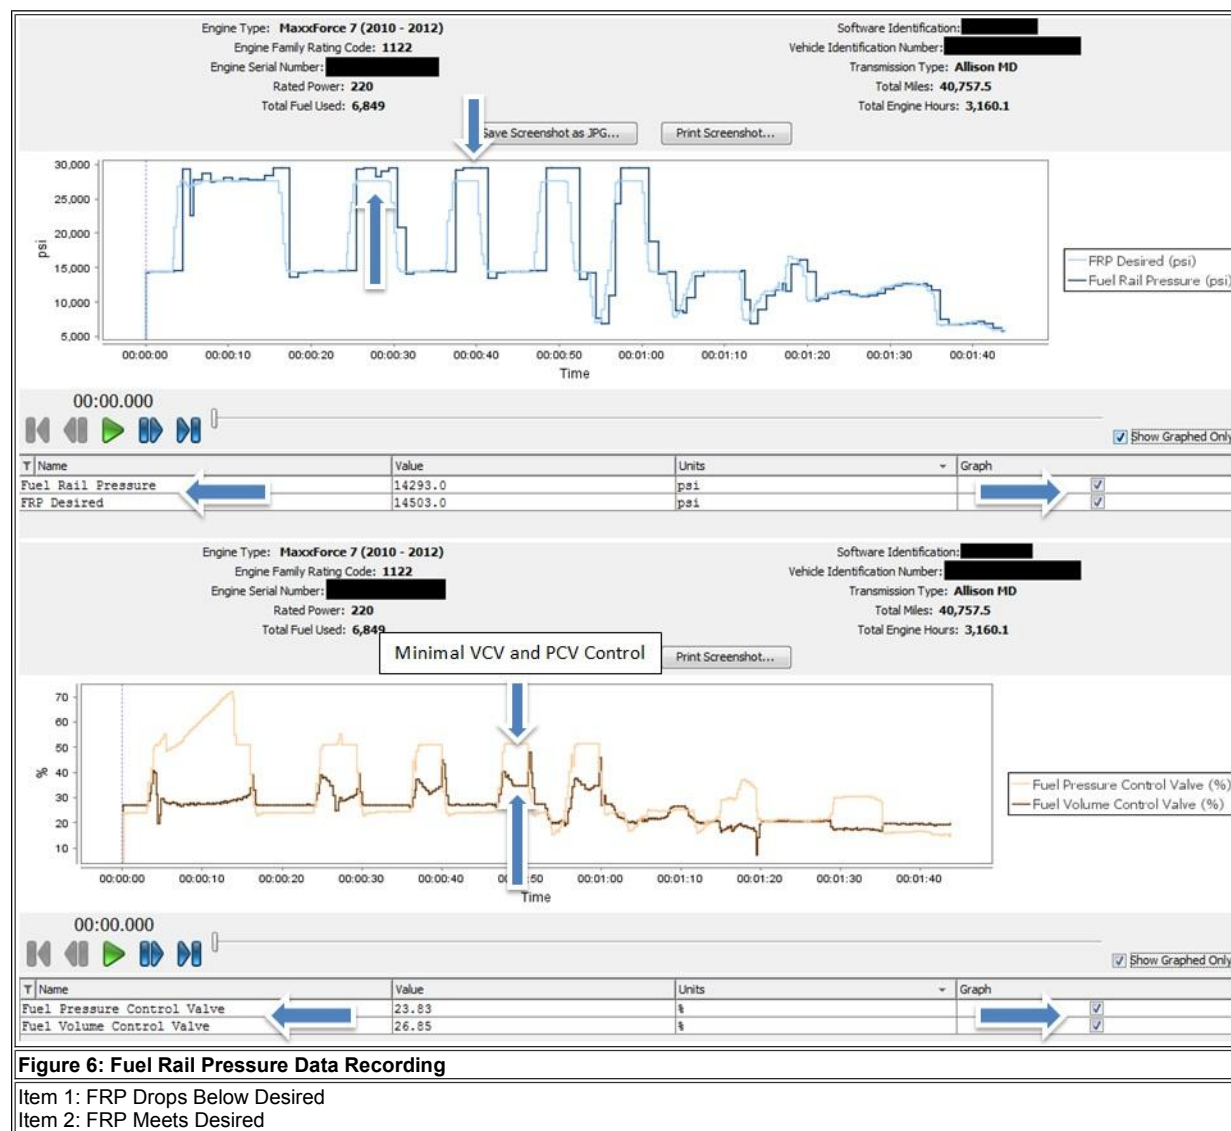
High Pressure Fuel Pump Efficiency Loss Characteristics

1. FRP can meet desired at lower pressures but FRP rises above desired at higher demand 3055 FMI 17/18 (Above Maximum)
2. FRP can meet desired at high pressures but FRP drops below desired at lower demand 3055 FMI 15/16 (Below Minimum)
3. Resetting the Fuel Pressure Adaptives may resolve the issue temporarily

Step	Action	Decision
<p>12</p>	<p>DTC: 3055 FMI 15/16/17/18</p> <p>High Pressure Fuel Pump Efficiency Loss Characteristics</p> <p>If not done so already, Perform Step 10 then return to this step.</p> <p>Were any issues noted?</p>	<p>Yes. Correct issue and see STEP 13</p> <p>No. STEP 14</p>

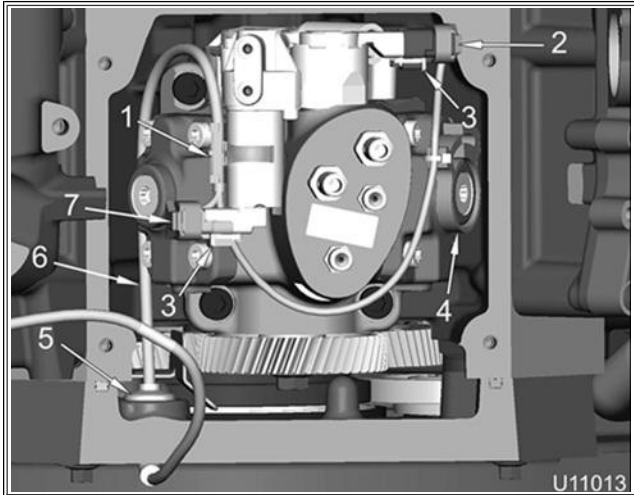
Figure 7: High Pressure Fuel Pump Harness

- Item 1: C-clip
- Item 2: PCV Connector (Black)
- Item 3: Yellow CPA
- Item 4: Snapper Clip
- Item 5: Pass-through Overmold Plug
- Item 6: High Pressure Pump Harness Assembly
- Item 7: VCV Connector (Orange)

1. Remove the old harness, clean and dry the inside of the high pressure fuel pump control valve connectors (Oil intrusion is common in the harness; it needs to be cleaned out and dried before installing the new harness)
2. Obtain both wire ties and high pressure fuel pump harness
