**Document ID:** IK1201270

**Title:** Interstage Cooler Interference With Valve Cover Sound Shield Mounting Bolts

**Applies To:** EPA 2013 HD-OBD and later DT/9/10 and N9/N10

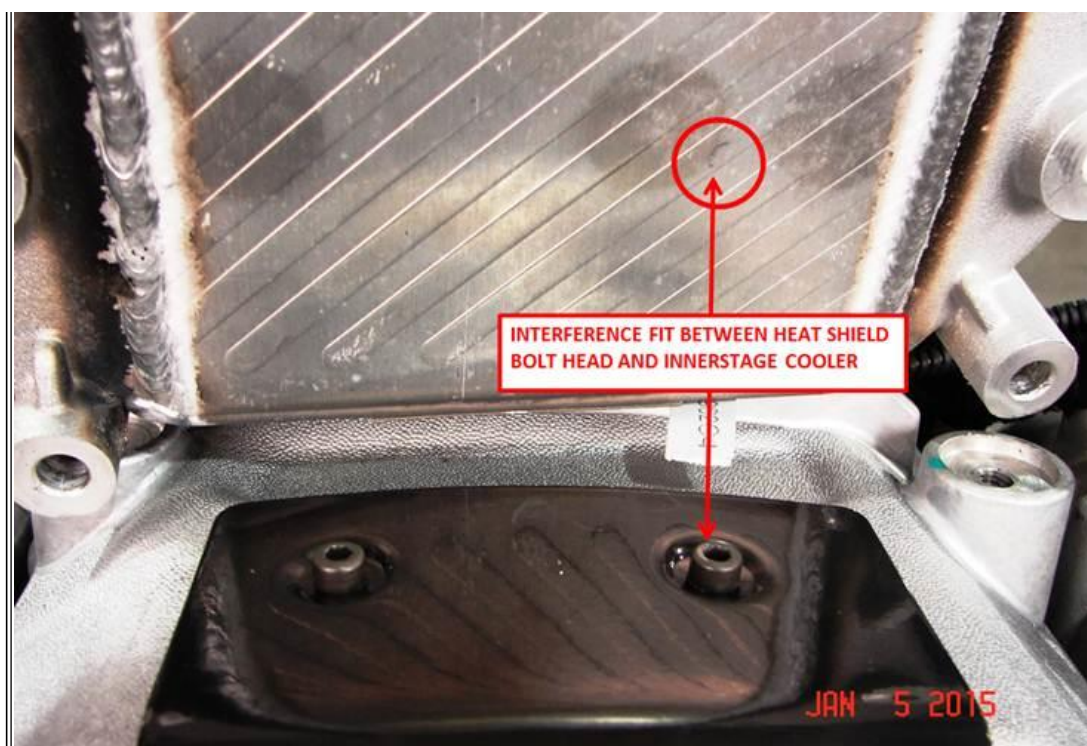
**Figure 1: Example of interference**

There are incidents of contact between the bottom panel of the interstage cooler and the valve cover sound shield mounting bolt on High Torque and SCR equipped medium duty engines. The current socket head screw could cause interference issues between itself and the interstage cooler. This document reviews the concern and repair steps for assembling with button head screws.

1. Install four button head cap screws to heat shield.
2. Install a new 2.62 x 61.6 ID O-ring in groove on HP turbocharger.
3. Attach turbocharger inlet elbow to HP turbocharger with V-band clamp. Do not fully tighten V-band clamp at this time. Allow turbocharger inlet elbow to rotate as necessary to allow for ISC to be installed.
