TECHNICAL SERVICE BULLETIN

Fluid Leak from Allison Housing Breather in Cold Conditions at Startup

Group:	0-GENERAL
Bulletin No.:	SB-15-009
Issue Date:	01-22-2015

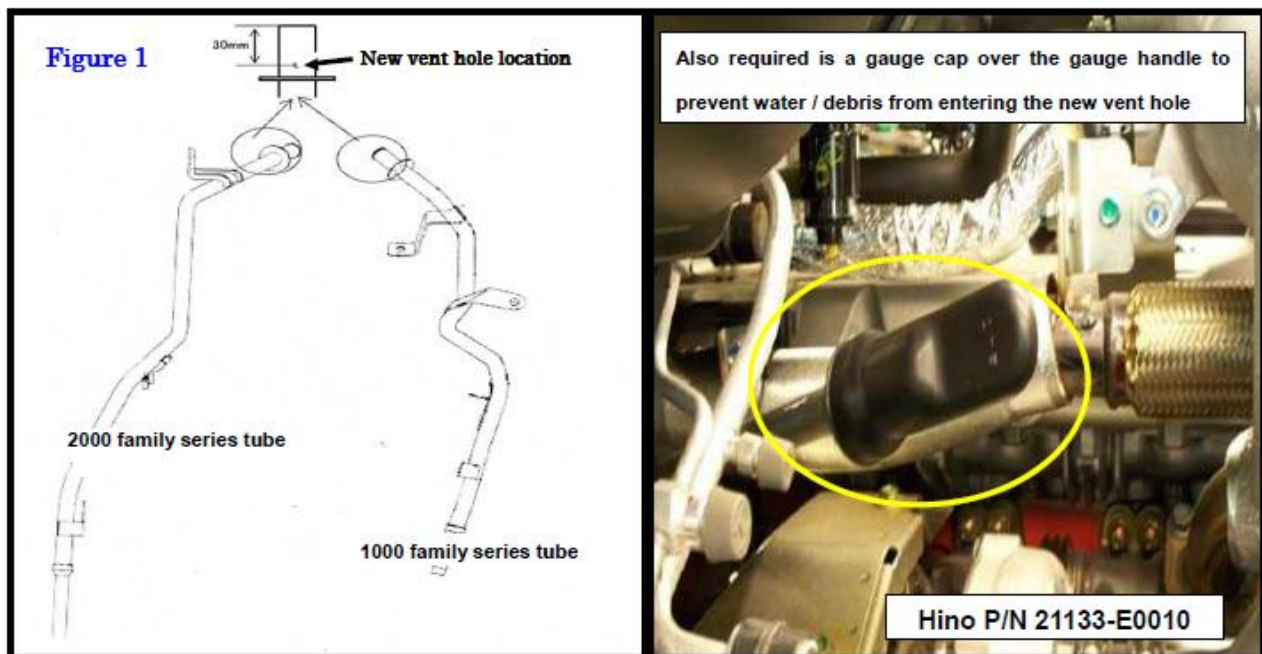
This bulletin provides the corrective action for a fluid overflow condition from the main housing breather at startup in cold ambient temperatures at or below +5F (-15C).

3. Measure 30 mm down from the top of the tube and drill a 2 mm (1/16") hole from the outside of the tube to the inside of the tube. See **Figure 1** below
