Group:	17-Intake and Exhaust
Bulletin No.:	SB-15-017
Issue Date:	03-06-2015

# TECHNICAL SERVICE BULLETIN

## 08MY-10MY J05 Broken Exhaust Manifold Studs

*Supersedes SB-11-001 dated 7-21-2011*

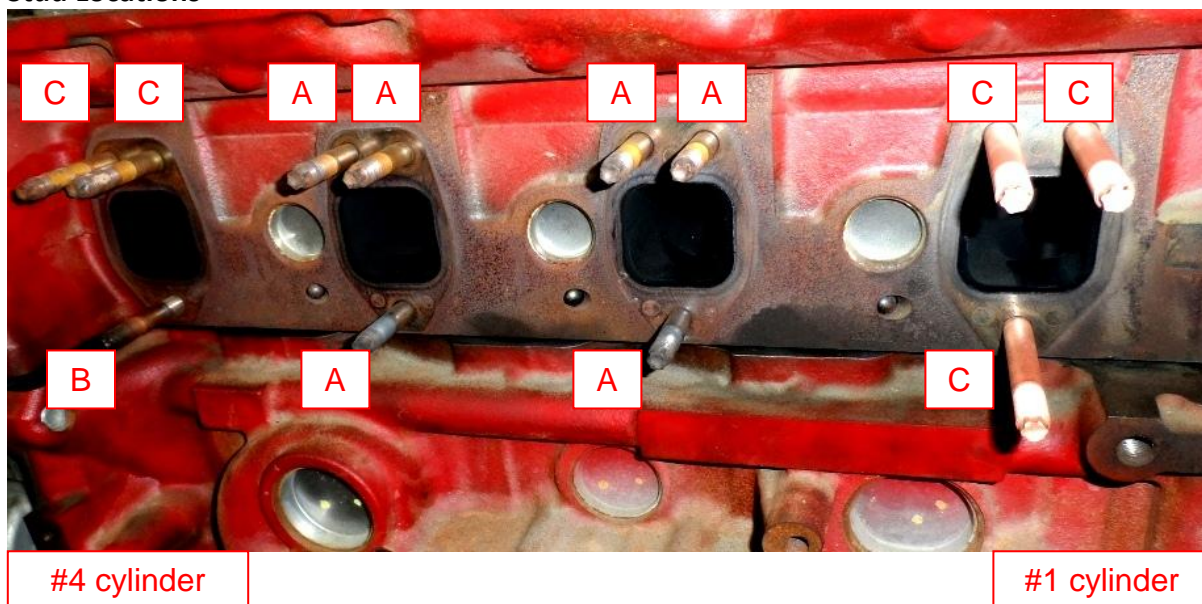
### Stud Locations

**NOTICE:** There are three different lengths of the studs to be installed in the cylinder head. Be sure to install each stud in the correct location.

**NOTICE:** Excessive torque on the exhaust manifold studs could cause the cylinder head to crack.

**3.** Install the new studs into the cylinder head as shown in the photograph below. Reference the table below for the correct stud location. Tighten the studs to the specified torque.

**Specified Torque:** 22 lb-ft (30 Nm)

Location	Stud	
	Part Number	Length
A	SZ12610012	56 mm
B	SZ12610006	67 mm
C	SZ12610009	96 mm

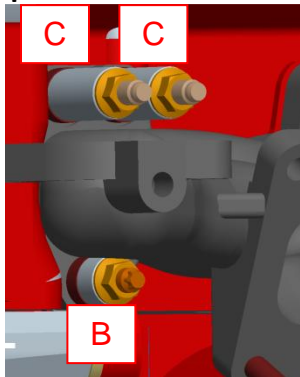
#4 cylinder

**NOTICE:** There are three different lengths of the spacers to be installed. Be sure to install each spacer in the correct location.

Install the spacers as shown in the illustration below. Refer to the table below for the part number of each spacer. Install the 14mm nut (SZ17810007) onto each of the studs, and tighten the nuts to the specified torque following the torque sequence outlined in the workshop manual. Once all 12 nuts have been torqued to specification, re-torque them again in the same sequence.

**Specified Torque:** 43.5 lb-ft (59 Nm)

Location	Spacer	
	Part Number	Length
A	SZ91016217	8 mm
B	17444E0060	20 mm
C	SZ91016297	45 mm

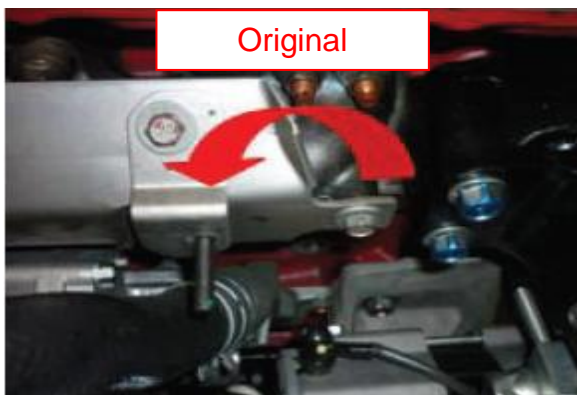
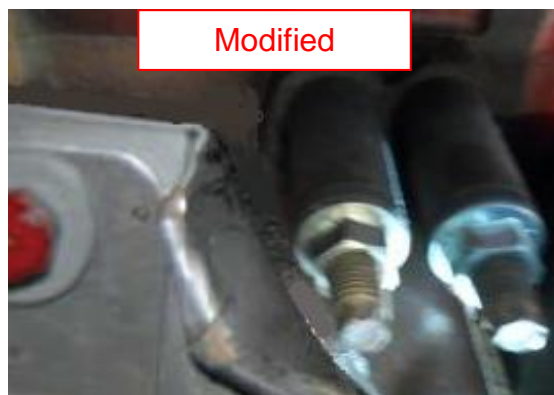
6. The original end of the exhaust manifold insulator shield will not allow proper clearance to the longer #1 exhaust stud spacers. If the insulator has not already been modified, the insulator will need to be bent downward to accommodate the longer studs on the #1 cylinder. Bend the corner of the shield downward to provide additional clearance for the #1 stud and spacer. Install the exhaust manifold insulator shield onto the exhaust manifold.

**NOTICE:** Do not cut the shield or bend the shield more than 4 times to prevent strength reduction. Also do not bend the shield in the opposite direction.

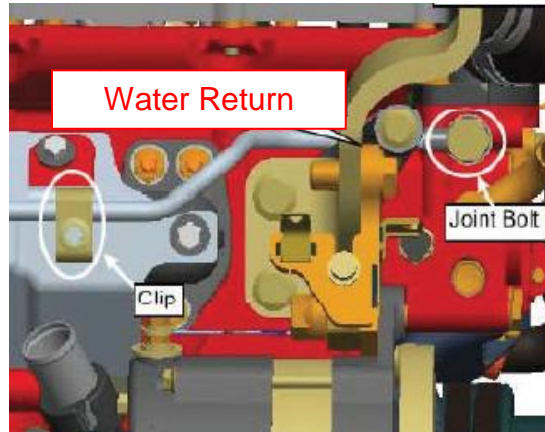
**NOTICE:** As set forth in Step 1, the water return pipe only requires replacement if the engine was equipped with the short 56 mm exhaust manifold studs on the #1 cylinder. **NEVER** attempt to reuse the water return pipe if the engine had the short 56 mm exhaust manifold studs on the #1 cylinder.

7. Install the water return pipe (16895E0200) using new sealing washers.
