TECHNICAL SERVICE BULLETIN

05MY-15MY CONVENTIONAL J08 ENGINE CYLINDER HEAD GASKET

Group:	11-Engine
Bulletin No.:	SB-15-026
Issue Date:	06-02-2015

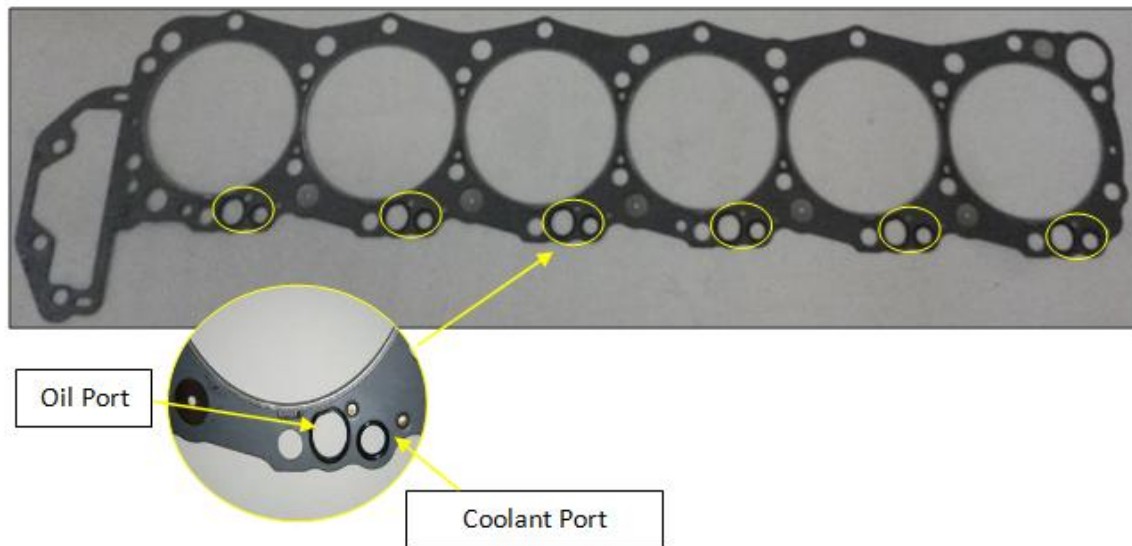
A subject vehicle may exhibit an engine oil leak or engine coolant leaking externally from the engine head gasket sealing area on the exhaust manifold side of the engine. An improved head gasket has been made available as a service part and should be used if replacement of the head gasket is necessary. Improvement of the head gasket includes the addition of rubber seals around the engine oil and engine coolant port holes.

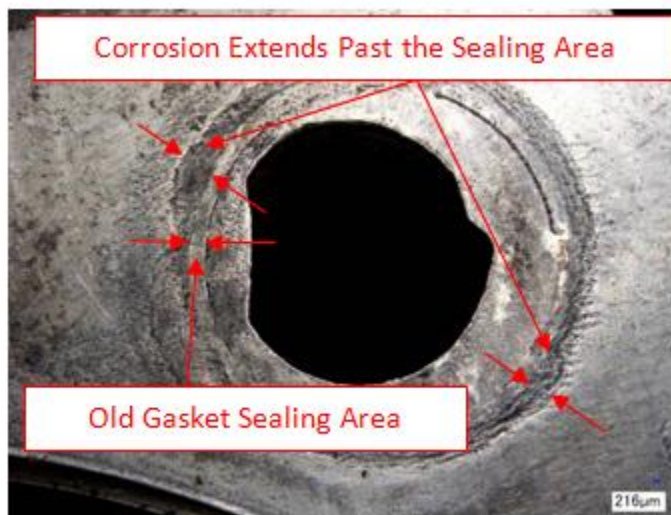
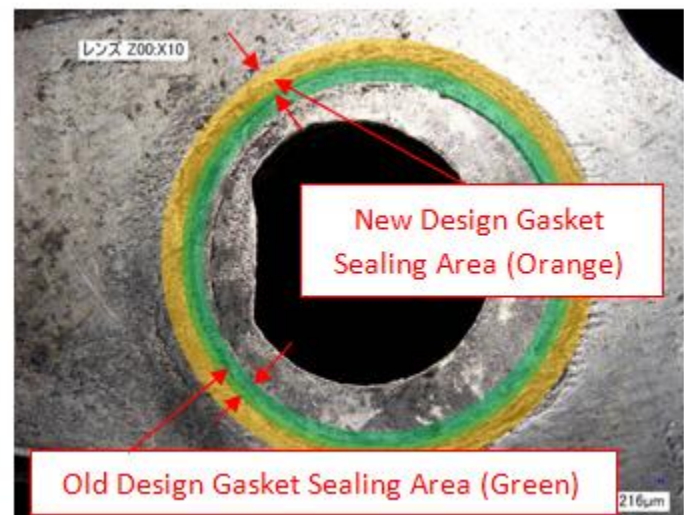
- In rare cases, corrosion or fretting may occur around the engine oil return ports and engine coolant ports. There are 24 corresponding ports which are located on the cylinder head and engine block. The locations correspond to the rubber seals which were added to the new design head gasket. Refer to the corresponding locations using the new cylinder head gasket as a template.

NOTICE: Do not use any abrasive wheels of any type to clean the head gasket sealing surface of the cylinder head or engine block. Use caution to avoid scratching, gouging or removing any steel from these surfaces.
