Group:	SERVICE MANUAL UPDATE
Bulletin No:	SB-15-034
Issue Date:	8-12-2015

## Subject: CORRECTION OF WORKSHOP MANUAL FOR HINO COE Revision of Troubleshooting Procedure for the DTC P0A84 (TC66)

**RELEVANT MODEL:** 14MY-15MY Hino 155, 195, 155h, 195h

Troubleshooting information and inspection procedure of the DTC P0A84 (TC66) were revised.

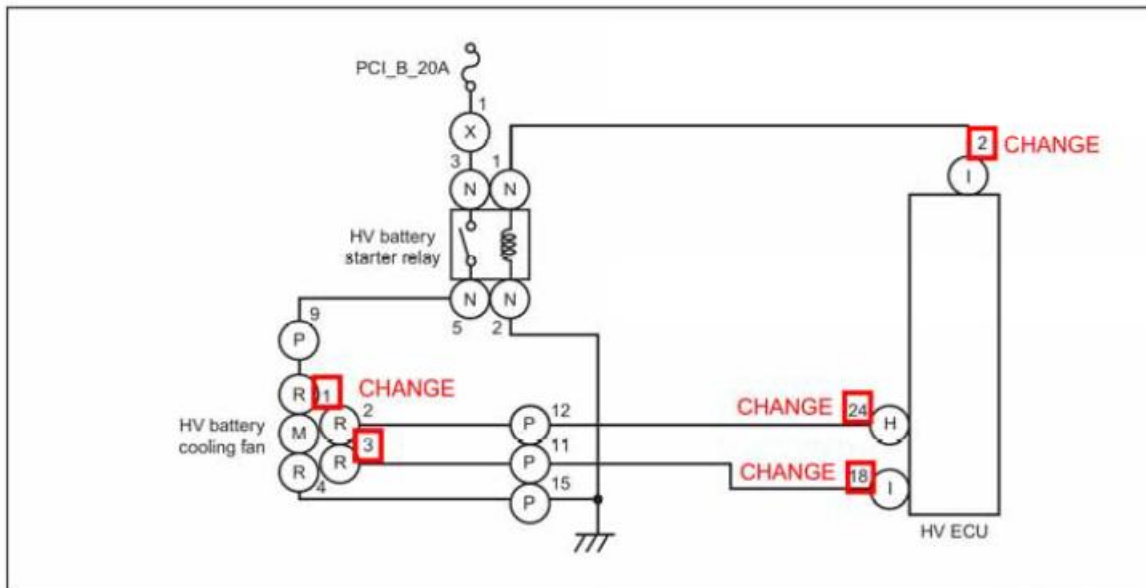
SHTS03ZZ0300112

- Detected a disconnection or GND short circuit in the HV battery cooling fan drive signal circuit.

- Disconnection or short circuit of harness
- Improper connector connection or fitting
- Malfunction of HV battery cooling fan
- Malfunction of HV ECU

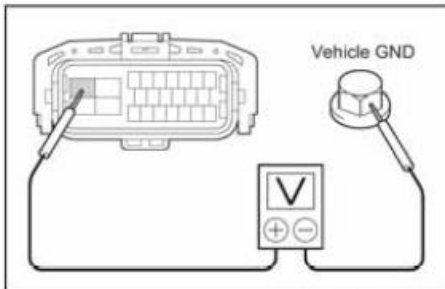
SHTS03ZZZ0300114

1. Set the starter key to the "LOCK" position.
2. Disconnect the PCU harness (24P) connector.
3. Set the starter key to the "ON" position.
4. Using the electrical tester, measure the voltage between the 1st terminal of PCU harness (24P) vehicle-side connector and the ground.

Measurement conditions	Tester connections	Standard values
Starter key: ON	PCU harness (24P) vehicle-side connector 1st terminal - GND	9 V or more

Inspect the power supply circuit ([PCI-B 20A] fuse and wire harness).

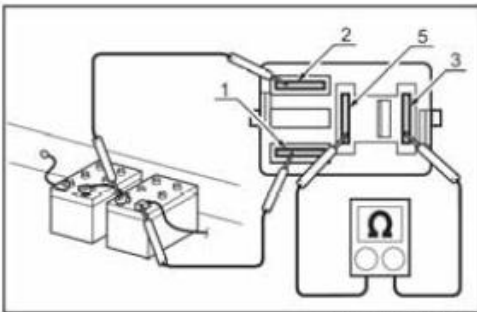
SHTS03ZZZ0300115

1. Set the starter key to the "LOCK" position.
2. Remove the HV battery start relay.
3. Using the electrical tester, measure the resistance between the 3rd and 5th terminals of HV battery start relay. (With no voltage applied)
4. Apply the voltage of 12 V between the 1st and 2nd terminals of HV battery start relay and measure the resistance between the 3rd and 5th terminals. (With voltage applied)

Measurement conditions	Tester connections	Standard values
Starter key: LOCK	HV battery start relay 3rd terminal – 5th terminal	Without voltage: 10 k $\Omega$ or more With voltage: less than 1 $\Omega$

Replace the HV battery start relay.

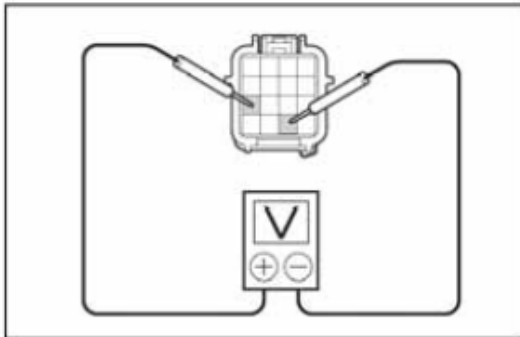
SHTS03ZZZ0300116

1. Connect the PCU harness (24P) connector and the HV battery start relay.
2. Disconnect the PCU harness (16P) connector.
3. Set the starter key to the "ON" position.
4. Using the electrical tester, measure the voltage between the lower-side connector terminals of PCU harness (16P).

Measurement conditions	Tester connections	Standard values
Starter key: ON	PCU harness (16P) lower-side connector 9th terminal – 15th terminal	9 V or more

Replace the PCU wire harness (lower side).

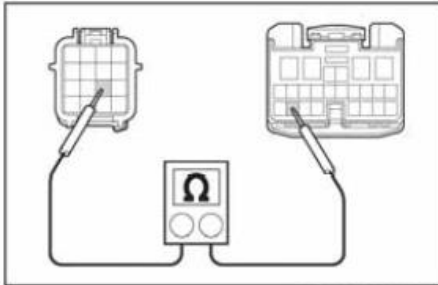
SHTS03ZZZ0300117

1. Set the starter key to the "LOCK" position.
2. Disconnect the HV ECU2 connector.
3. Using the electrical tester, measure the resistance between the lower-side connector terminal of PCU harness (16P) and the HV ECU2 connector terminal.

Measurement conditions	Tester connections	Standard values
Starter key: LOCK	PCU harness (16P) lower-side connector – HV ECU2 connector 11th terminal – 18th terminal	Less than 1 $\Omega$

Replace the PCU wire harness (lower side).

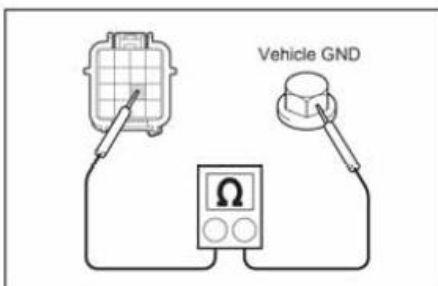
SHTS03ZZZ0300118

1. Using the electrical tester, measure the resistance between the lower-side connector 11th terminal of PCU harness (16P) and the ground.

Measurement conditions	Tester connections	Standard values
Starter key: LOCK	PCU harness (16P) lower-side connector 11th terminal – GND	10 k $\Omega$ or more

Replace the PCU wire harness (lower side).

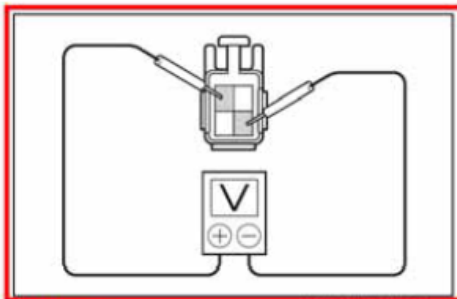
SHTS03ZZZ0300119

- Set the starter key to the "LOCK" position.
- Connect all the connectors that have been disconnected.
- Disconnect the connector of HV battery cooling fan.
- Set the starter key to the "ON" position.
- Using the electrical tester, measure the voltage between the connector terminals of HV battery cooling fan.

Measurement conditions	Tester connections	Standard values
Starter key: ON CHANGE	HV battery cooling fan connector 1st terminal – 4th terminal	9 V or more

Replace the PCU wire harness (upper side).

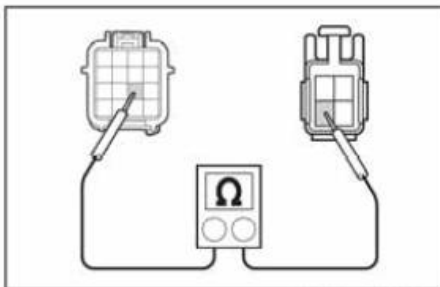
SHTS03ZZZ0300120

1. Using the electrical tester, measure the resistance between the lower-side connector terminal of PCU harness (16P) and HV battery cooling for connector terminal.

Measurement conditions	Tester connections	Standard values
Starter key: LOCK	PCU harness (16P) lower-side connector – HV battery cooling for connector 11th terminal – 3rd terminal	1 $\Omega$ or less

Replace the PCU wire harness (upper side).

Replace the HV battery cooling fan.  
After replacement, go to step 11.

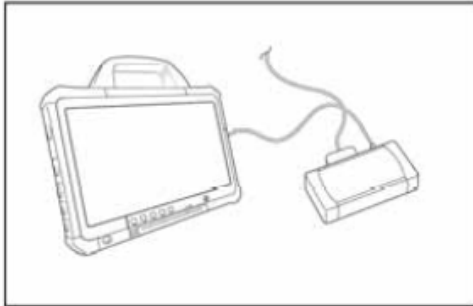
SHTS03ZZZ0300121

1. Connect all the connectors that have been disconnected to restore the system.
2. Set the starter key to the "LOCK" position.
3. Connect the diagnosis tool (HINO DX II ) to the vehicle.
4. Set the starter key to the "ON" position.
5. Clear the malfunction history.
6. Set the starter key to the "LOCK" position and wait for 1 minute.
7. Set the starter key to the "ON" position.
8. On the diagnosis tool screen, check if P0A84-66 is detected.

Is DTC P0A84-66 detected?

Replace the HV ECU.
