TO: Mazda Dealership General Managers, Service and Parts Managers

DATE: April 2015

**SUBJECT: 2014 CX-9 and 2015 MX-5 Liftgate/Trunk Lid Latch Replacement
Special Service Program (SSP) 97**

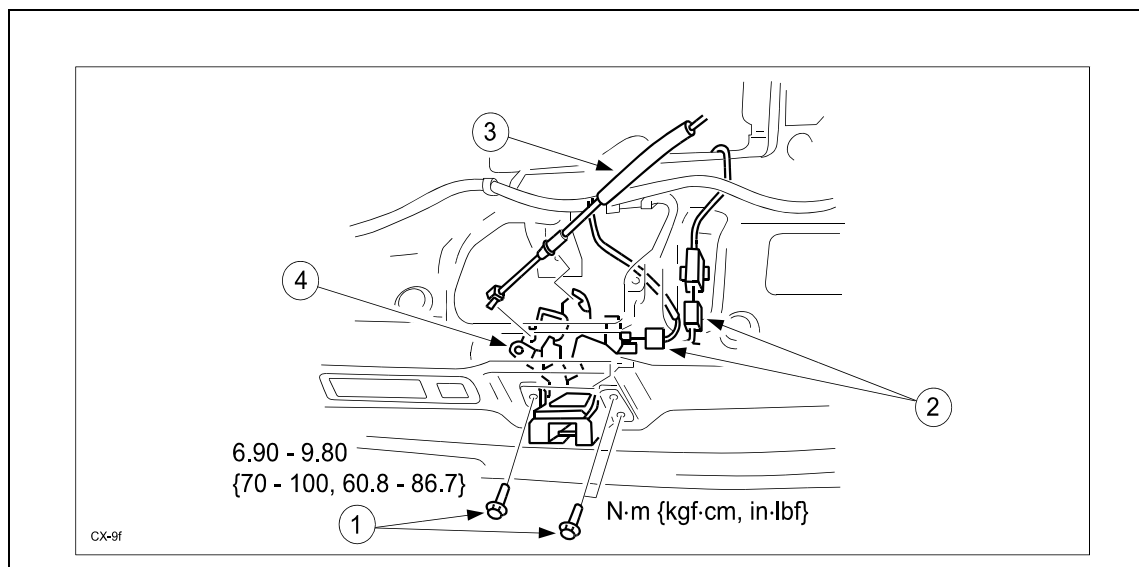
On 2014 CX-9 vehicles with manual liftgate and certain 2015 MX-5 vehicles, the liftgate/trunk lid latch may have insufficient strength for repeated lock-unlock operation. In some cases, the liftgate/trunk lid latch may become broken, affecting locking and/or unlocking operations. In the worst case, the lift-gate/trunk lid cannot be opened electrically.

1	Bolt
2	Connector
3	Cable
4	Liftgate and lock actuator

- 5. Replace the liftgate and lock actuator with a modified part.

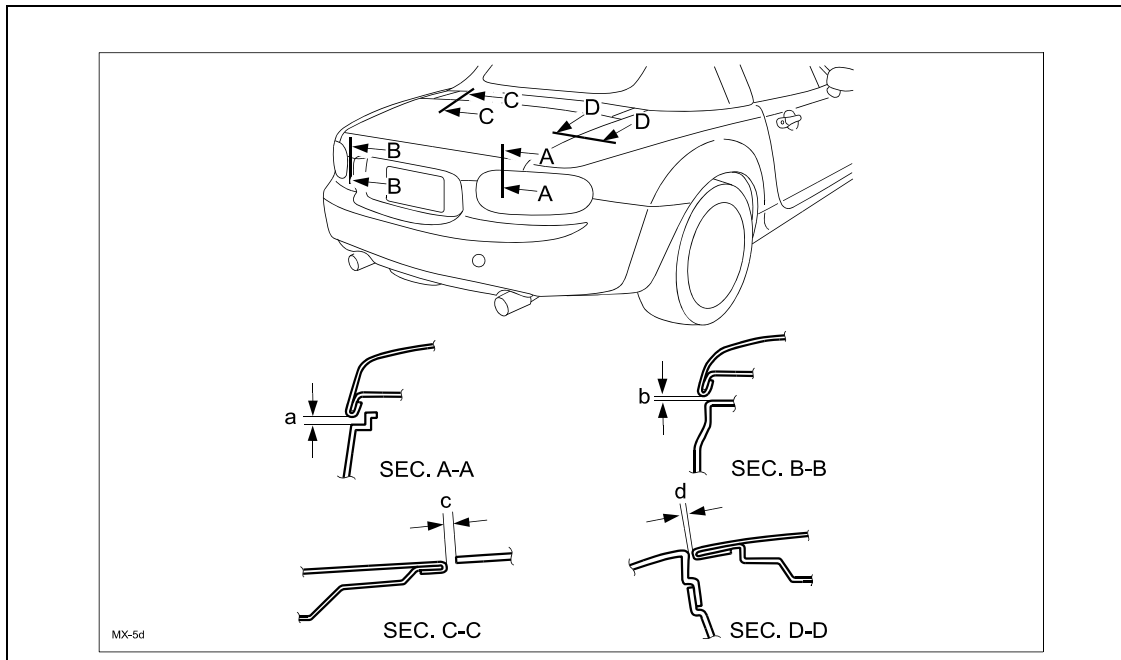
Standard Clearance	Notes
A: 4.5—7.5 mm {0.18—0.29 in.}	w/o power retractable hardtop
A: 5.5—8.5 mm {0.22—0.33 in.}	w/ power retractable hardtop
B: 5.0—9.0 mm {0.20—0.35 in.}	---
C: 3.0—6.0 mm {0.12—0.23 in.}	w/o power retractable hardtop
C: 4.0—8.0 mm {0.16—0.31 in.}	w/ power retractable hardtop
D: 3.0—5.0 mm {0.12—0.19 in.}	---

- a. Measure the gap and height difference between the trunk lid and the body.
- b. Loosen the trunk lid hinge installation nuts or the trunk lid lock striker installation screws, and adjust the trunk lid.
