## SERVICE BULLETIN

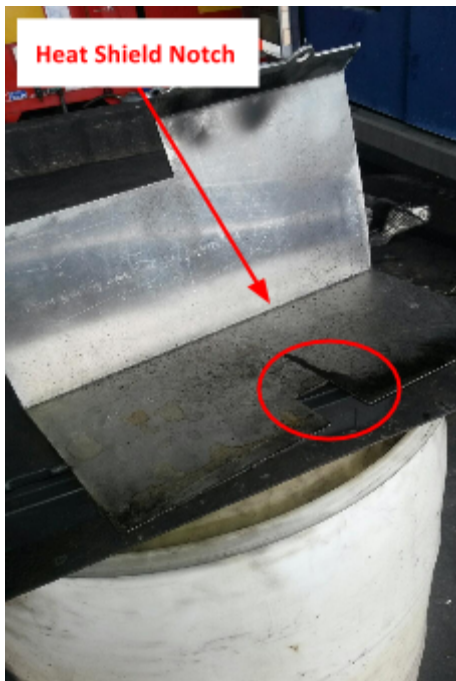
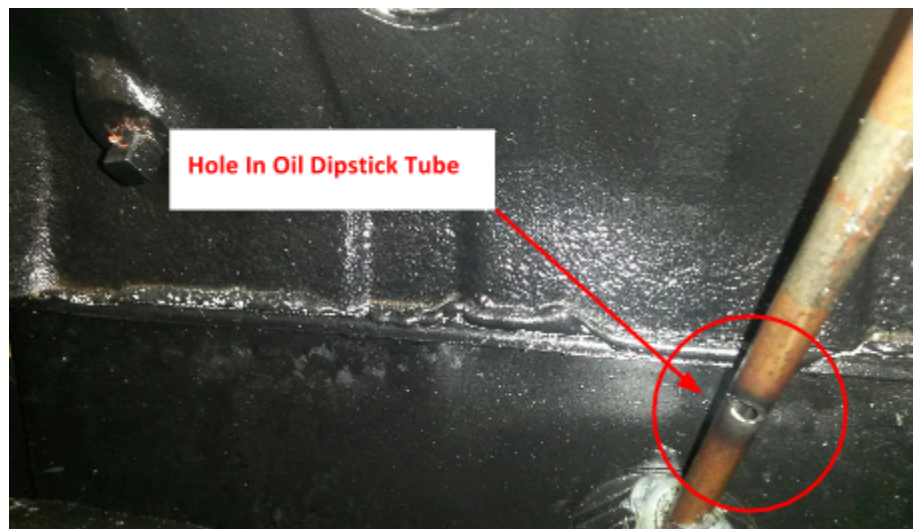
**REASON FOR RELEASE:** During inspection an excessive amount of engine oil was observed collecting below the engine. Further investigation revealed that the exhaust heat shield had chafed against the engine oil dipstick tube causing a hole to develop. While the heat shield was designed with a relief notch to avoid such chaffing, the oil dipstick tube continued to be chafed causing the hole resulted in the collection of engine oil in bilge.

1. Examine all Truck Duck engine dipstick tubes for chafing
2. Replace any dipsticks tubes found with holes
3. Add chafe protection where dipsticks tube are chaffing:
  - A. Add rubber hose on dipstick tube or
  - B. create further clearance in the heat shield notch to avoid chaffing or both.
4. See photo below of resulting damage caused by chafing
