## SERVICE BULLETIN

**REASON FOR RELEASE:** With the installation of the "Passenger Wall Grab Rail" (on certain duck configurations), the emergency helm stations steering arm makes contact with the passenger wall not allowing the emergency steering arm to make full rotation.

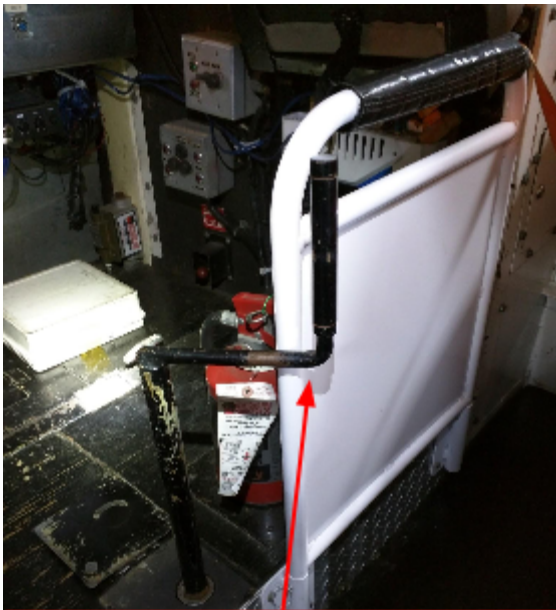
**PHOTO #1**  
**EMERGENCY STEERING ARM CONTACT WITH PASSENGER WALL**
