*** * TECHNICAL INFORMATION NOTICE * ***

DATE: April 24, 2015
TO: Mitsubishi Motors US Dealer Service Managers
RE: Stumble on Acceleration
TIN NO. TIN-15-23-001

AFFECTED VEHICLES: 2015 Outlander Sport Equipped with 2.0L Engine and F1CJC or W1CJC CVT Automatic Transaxle

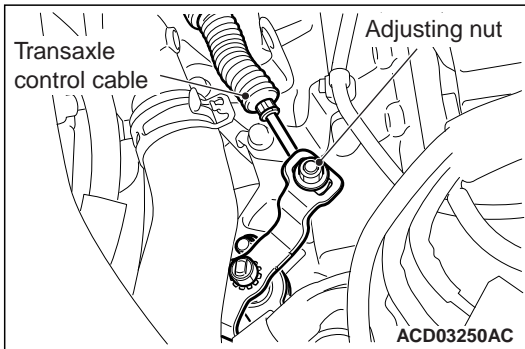
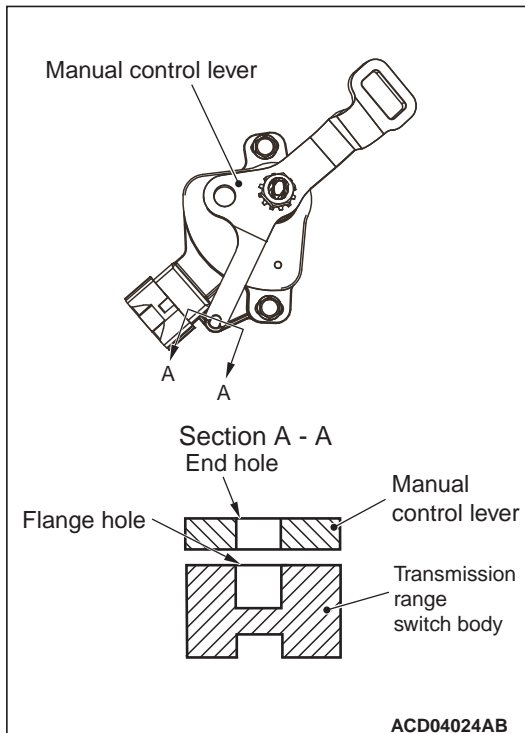
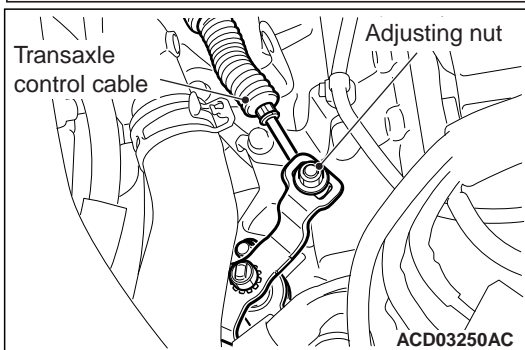
TRANSMISSION RANGE SWITCH AND CONTROL CABLE ADJUSTMENT

MMNA is investigating an intermittent condition where during acceleration; customers may report a momentary stumble or lack of acceleration at low speeds.

1. Move the selector lever to the "N" range.
2. Loosen the adjusting nut so that the manual control lever moves freely.
3. Move the manual control lever to neutral position.
4. Align the hole at the end of the manual control lever and the hole in the transmission range switch body flange (section A - A).
5. Use the adjusting nut to tighten the transaxle control cable to the specified torque.
Tightening torque: 9.5 ± 3.5 N·m (84 ± 30 in-lb)
6. Make sure that the selector lever is in the "N" range.
7. Make sure that the transaxle ranges that are corresponding to the selector lever position operate and function properly.
