TO: Mazda Dealership General Managers, Service Managers, and Parts Managers
DATE: December 2015
**SUBJECT: 2010 Mazda3 Dashboard Upper Panel Sticky Surface
Warranty Extension Program – Special Service Program (SSP) 99**

2010 MAZDA3 DASHBOARD UPPER PANEL STICKY SURFACE SSP99

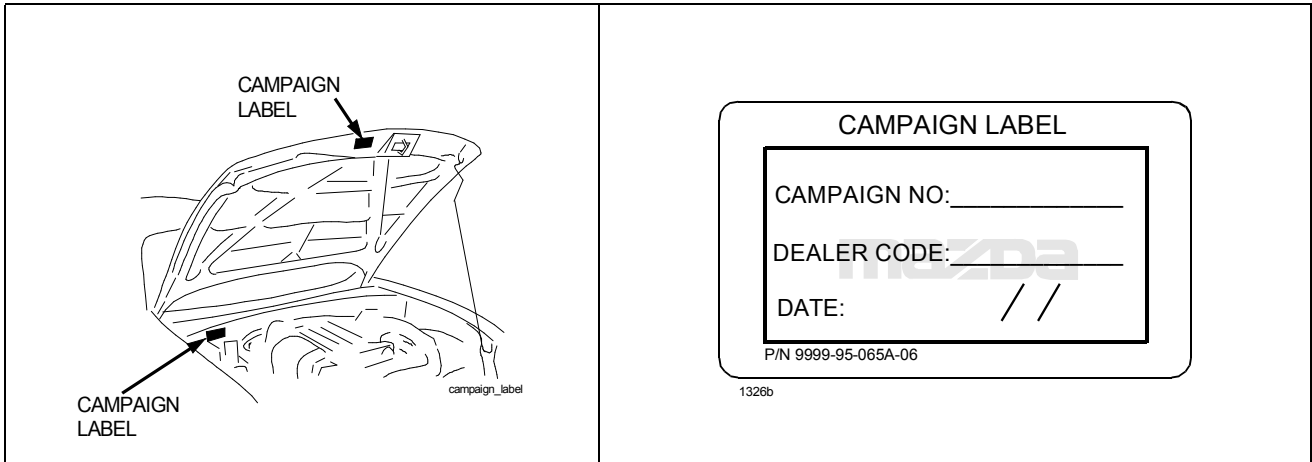
- If the vehicle is within the above ranges, proceed to step 2.
 - If the vehicle is not within the above ranges, SSP99 is not applicable.
2. Perform a Warranty Vehicle Inquiry using your eMDCS System and inspect vehicle for a Campaign Label **SSP99** attached to the vehicle's hood or bulkhead. Refer to eMDCS System - Warranty Vehicle Inquiry Results table below.

NOTE: Verify SSP99 number as the vehicle may have multiple SSPs.
