WARRANTY BULLETIN

Campaign no.: 2015-0003

Subject: **Knock Sensor Harness Incorrectly Routed.**

YEAR	MODELS	SERIAL NUMBER
2015	Spyder F3	See warranty campaigns to verify in unit history

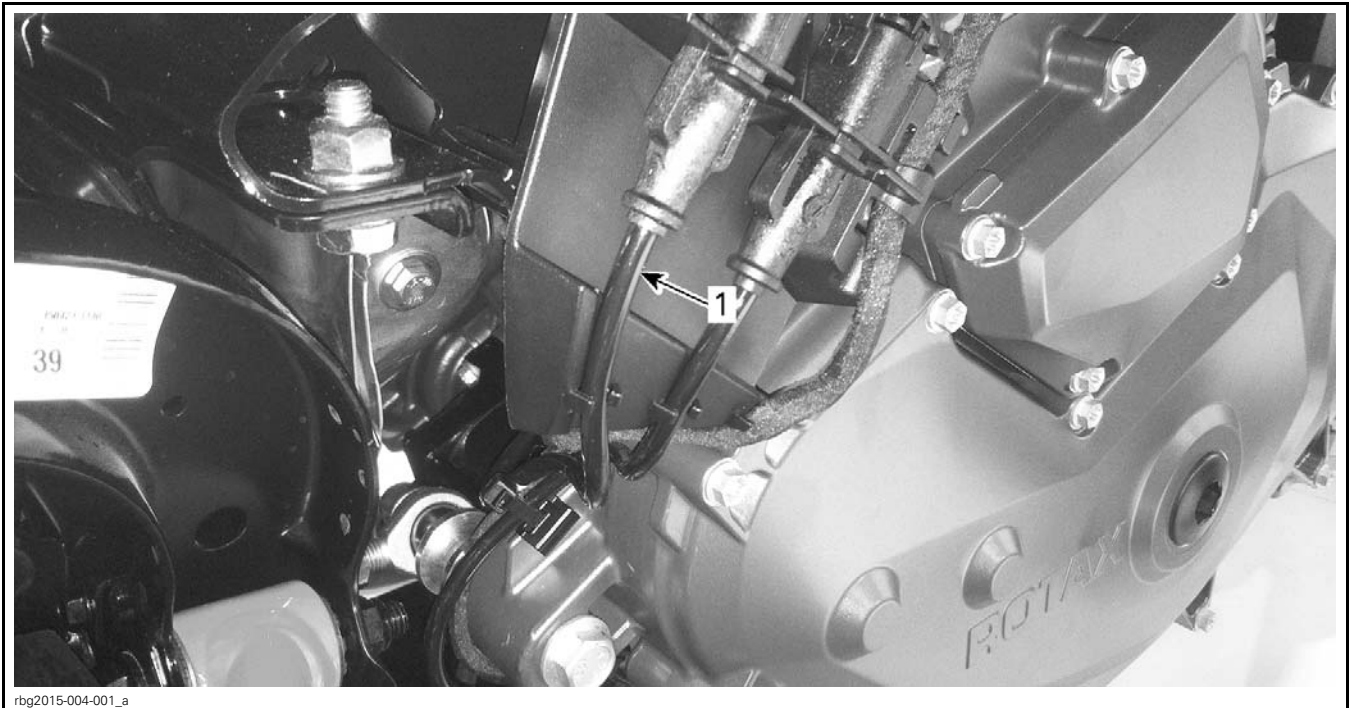
LOCATION - FRONT LH SIDE OF ENGINE

1. Knock sensor harness

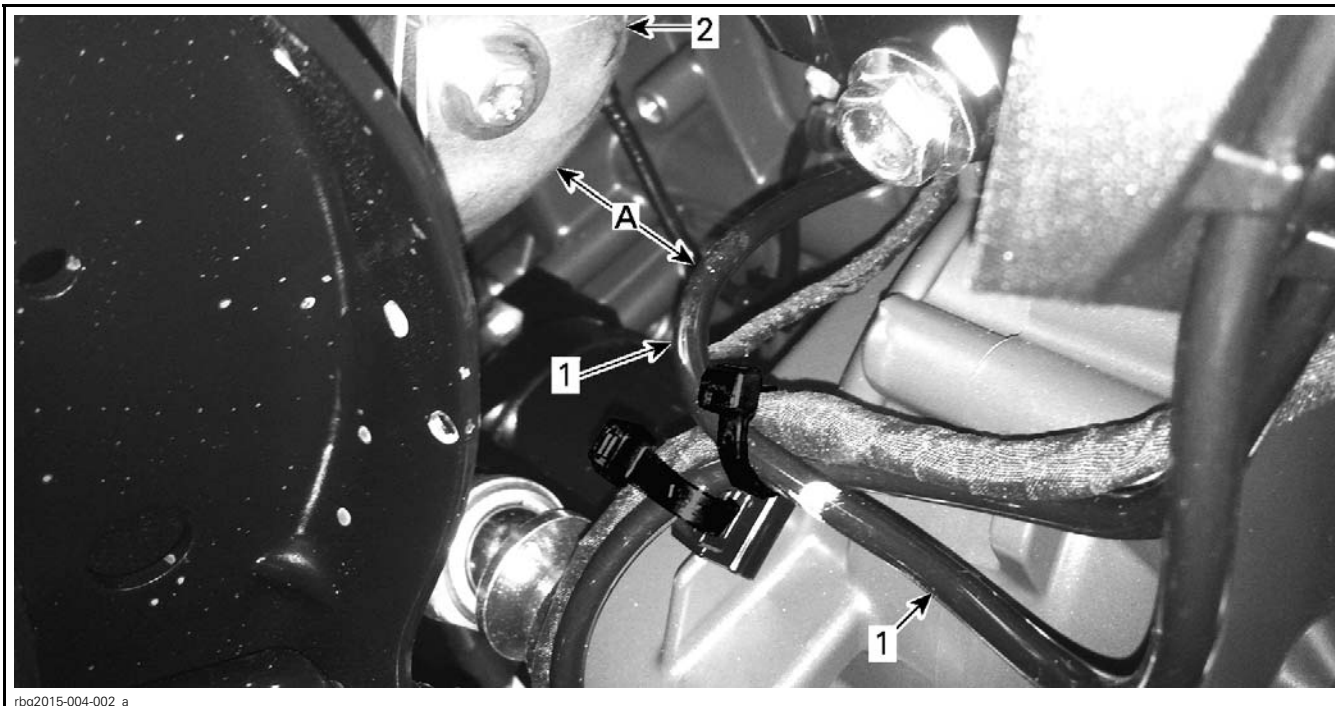
rbg2015-004-002_a

- 1. Knock sensor harness
- 2. Exhaust manifold heat shield
- A. Distance between harness and heat shield

DISTANCE BETWEEN HARNESS AND HEAT SHIELD		
Distance "A"	Greater or equal to 30 mm (1-3/16 in)	ok
	Less than 30 mm (1-3/16 in)	Repair
