## Service Bulletin No. 426

| MODEL | J4500 Series | TYPE | Field Change Program | SECTION/GROUP | 8-Engine | DATE | June 10, 2015 |
| SUBJECT | COOLANT SENSOR | | | | | | |

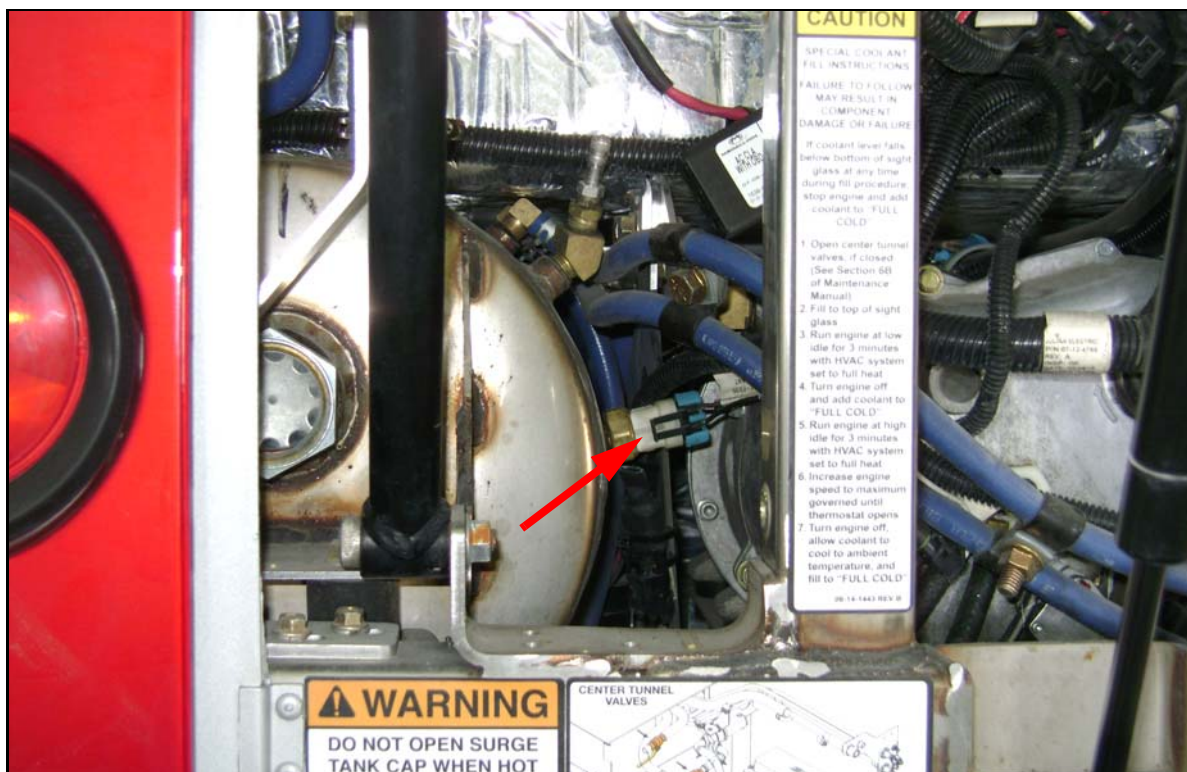
**Figure 1.**

1. Open the engine door. Position the ENGINE RUN and ENGINE START switches on the engine compartment remote control box to the OFF position.
2. Chock both sides of the tires.
3. Using a clean, suitable sized container, drain the coolant to the bottom of the sight glass ( refer to Figure 1 ).
4. Locate the coolant sensor in the upper, roadside of the engine compartment ( refer to Figure 1 ).

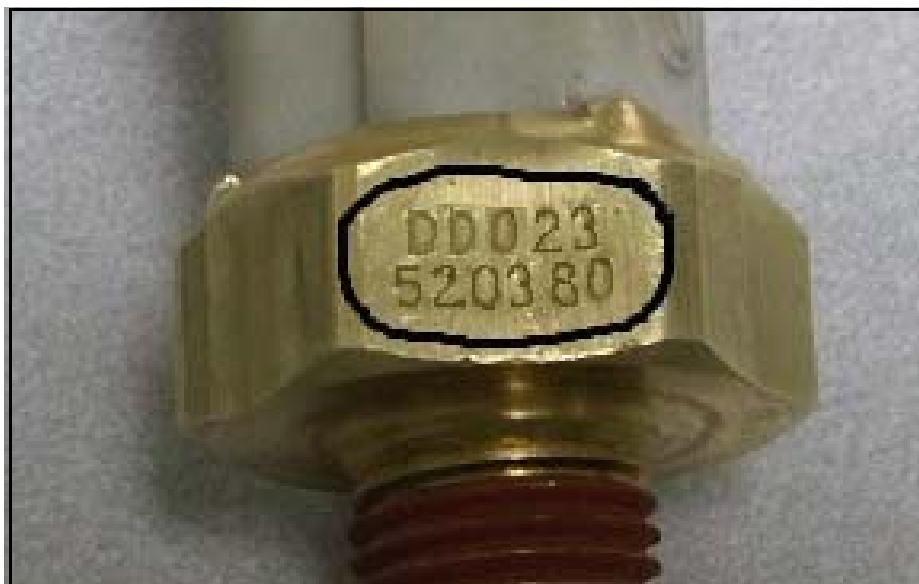
5. Disconnect the harness from the coolant sensor. Remove the coolant sensor and visually inspect the stamped identification text ( refer to Figure 2 ).

**Figure 2. Correct coolant sensor identification text.**

*Upon visual inspection, if the coolant sensor text matches the identification text in Figure 2, proceed to Step 6.*

*Upon visual inspection, if the coolant sensor text does NOT match the identification text in Figure 2, a replacement coolant sensor will have to be ordered. Proceed to Step 6.*

*If the coolant sensor text matches the identification text in Figure 2, re-install the existing coolant sensor.*

*If the coolant sensor text does NOT match the identification text in Figure 2, re-install the existing coolant sensor. Upon receipt of the new replacement coolant sensor, remove and replace the existing coolant sensor by performing the outlined steps in the procedure.*
