# Service Bulletin No. 427

| <i>SUBJECT</i> | ZF LOWER SEAL CARRIER ON KING PIN MOUNT | | | | | | |

## Important field retrofitting action: Replacement of lower seal carrier on kingpin mounting in ZF steering knuckle with ZF wheel head of the series RL 80 A/E/EM by steel version

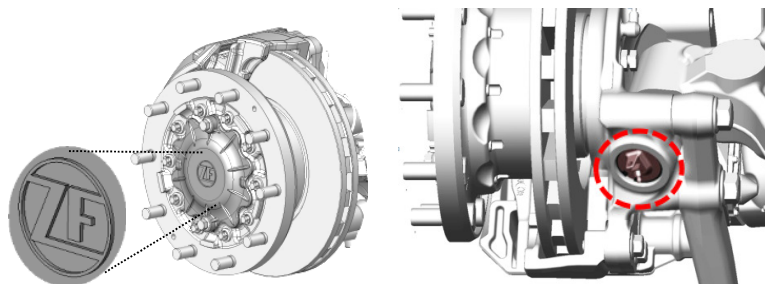
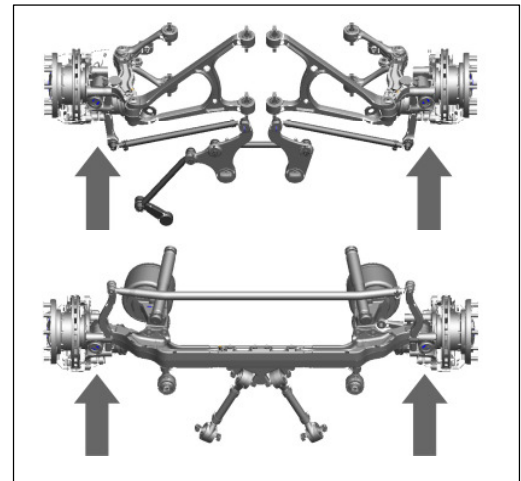
The originally installed lower seal carrier must be replaced by a steel seal carrier (ZF repair kit: 4474.298.368).

Change of die cast seal carrier  
to steel seal carrier

Grease fitting  
tightening  
torque: 15 Nm

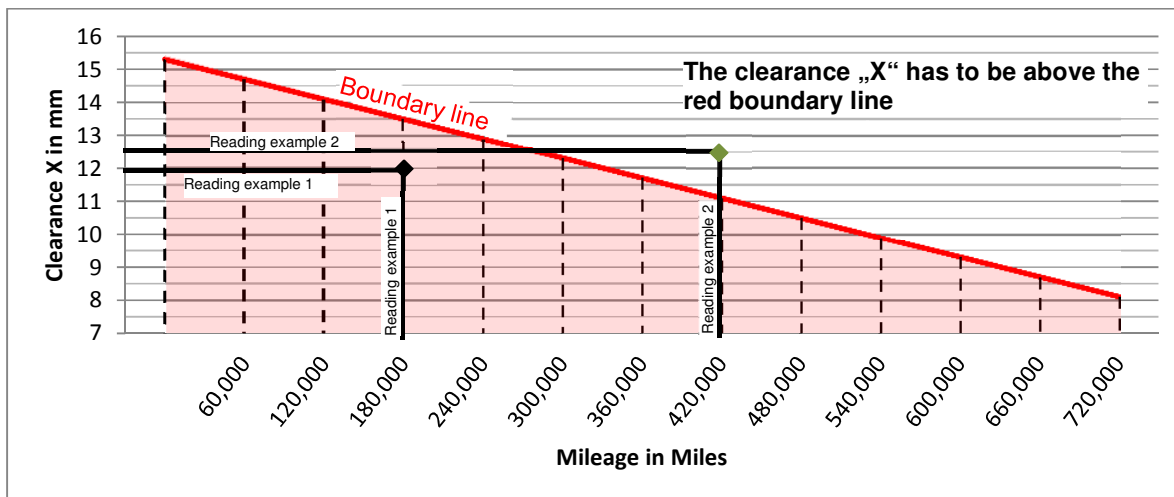
The measured clearance „X“ has to be above the red boundary line according following diagram.

**Reading example 1: Vehicle mileage 180.000 Miles / Clearance “X” 12,0 mm**

If the measured clearance “X” is below the red boundary line (acc. Reading example 1) the kingpin has to be exchanged using ZF repair kit No. 4474.298.384. It has to be assured that the axial play is below 1,3 mm (acc. RS 85/11).

**Reading example 2: Vehicle mileage 420.000 Miles / Clearance “X” 12,5 mm**

If the measured clearance “X” is above the red boundary line (acc. Reading example 2), however the steel seal carrier cannot be mounted, the kingpin shall be pressed back into the specified position of X = 16,0 – 20,0 mm. It has to be assured that the axial play is below 1,3 mm (acc. RS 85/11).

In case of non-availability of ZF repair kit No. 4474.298.384, ZF repair kit 4474.298.368 has to be installed. After availability of 4474.298.384 the king pin has to be changed in a second repair.

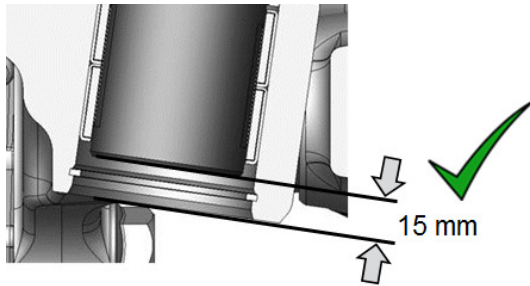
**Clearance „X“ OK  
Mount steel seal carrier**

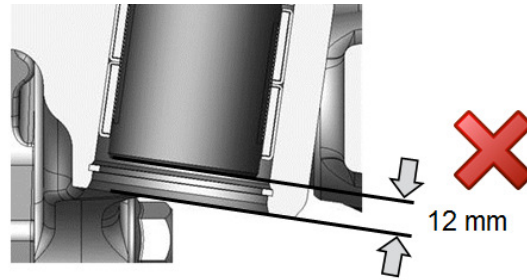
**Clearance „X“ not OK  
Kingpin has to be exchanged**

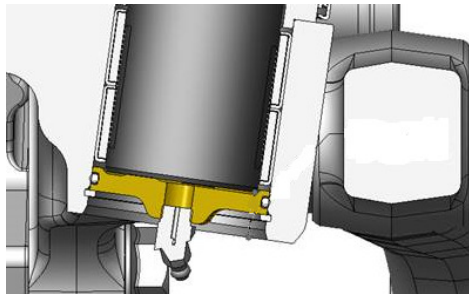
- Checking by hand whether seal carrier and grease fitting is still in position
- Cleaning of lower seal carrier and retaining ring
- Checking of lower seal carrier for damages
- Inspect seat and position of retaining ring

Inspection of seal carrier and retaining ring
