# Technical Service Bulletin

## 70 Noises from doors

70 15 43 2039023/2 January 30, 2015. Supersedes Technical Service Bulletin Group 70 number 14-41 dated November 18, 2014 for reasons listed below.

Model(s)	Year	VIN Range	Vehicle-Specific Equipment
Q5	2013 - 2014	All	Not Applicable
Q5	2015	000001 - 038877	Not Applicable

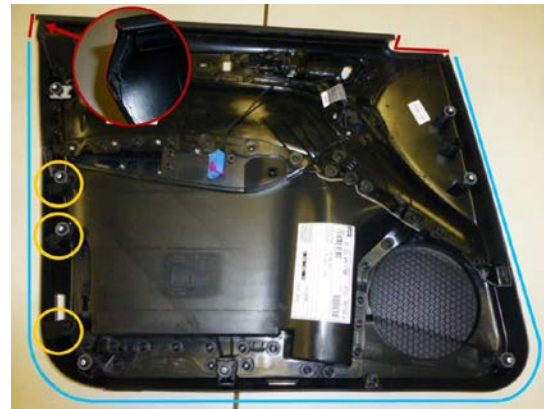
**Figure 1.** Front door panel.

1. The illustration to the right (Figure 1) shows the front door trim panel removed and the areas of the trim panel to be isolated:
  - The perimeter of the door trim panel (blue) will be isolated using **000 979 950** webbing adhesive tape.
  - The upper areas indicated in red are to have **G 052 172 A1** special lubricant applied. Carefully apply the lubricant *only* to the edges that make contact with the door.
  - The support ribs for the mounting clips (yellow) will have **533 867 910 A** adhesive felt strip applied.

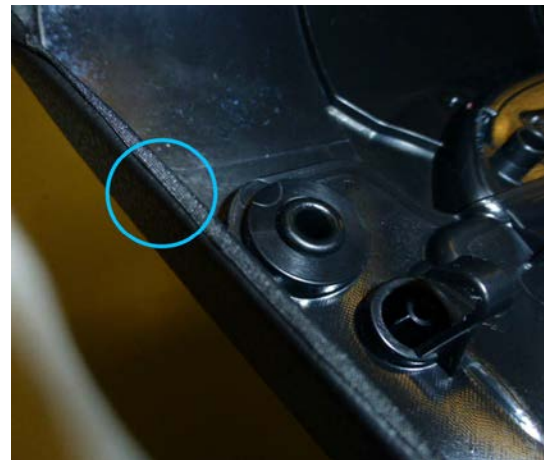
**Figure 2.** Correct application of textile adhesive tape.

2. Line the contact surface of the perimeter of the door panel using **000 979 950** webbing adhesive tape as shown in the illustration (Figure 2). Use care to apply the tape in such a way that it is not visible when the door trim panel is reinstalled.

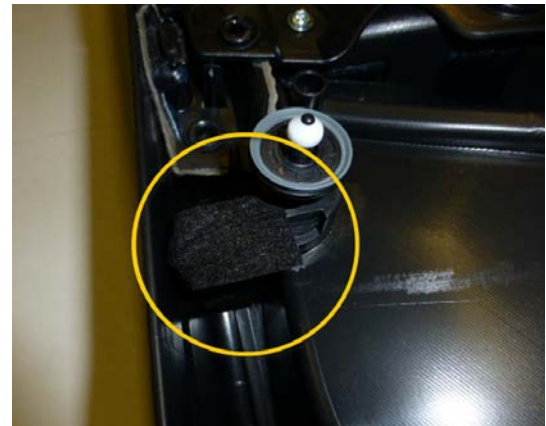
**Figure 3.** Correct application of felt strip.

3. Apply a section of **533 867 910 A** adhesive felt strip to completely surround the three support ribs, as shown in the illustration (Figure 3).

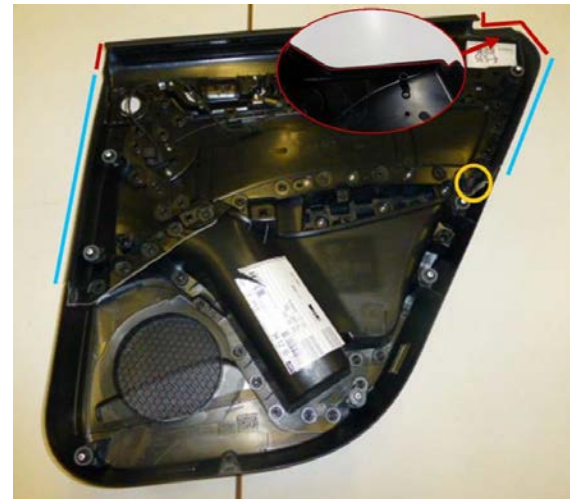
**Figure 4.** Rear door panel.

1. The illustration to the right (Figure 4) shows the rear door trim panel removed and the areas of the trim panel to be isolated.
  - The area of the door trim panel marked blue will be isolated using **000 979 950** webbing adhesive tape.
  - The upper areas indicated in red are to have **G 052 172 A1** special lubricant applied. Carefully apply the lubricant *only* to the edges that make contact with the door.
  - The support rib for the mounting clip (yellow) will have **533 867 910 A** Adhesive Felt Strip applied.

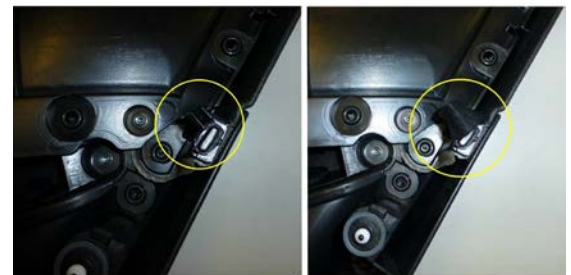
**Figure 5.** Support rib (left) and support rib with felt strip applied (right).

2. Apply a section of **533 867 910 A** adhesive felt strip to completely surround the three support ribs, as shown in the illustration (Figure 5).
