Technical Service Bulletin

94 Taillight warning appears in instrument cluster

94 15 59 2039584/1 January 29, 2015.

Model(s)	Year	VIN Range	Vehicle-Specific Equipment
A6	2012 - 2014	All	Not Applicable
A6	2015	000000 - 018245	Not Applicable

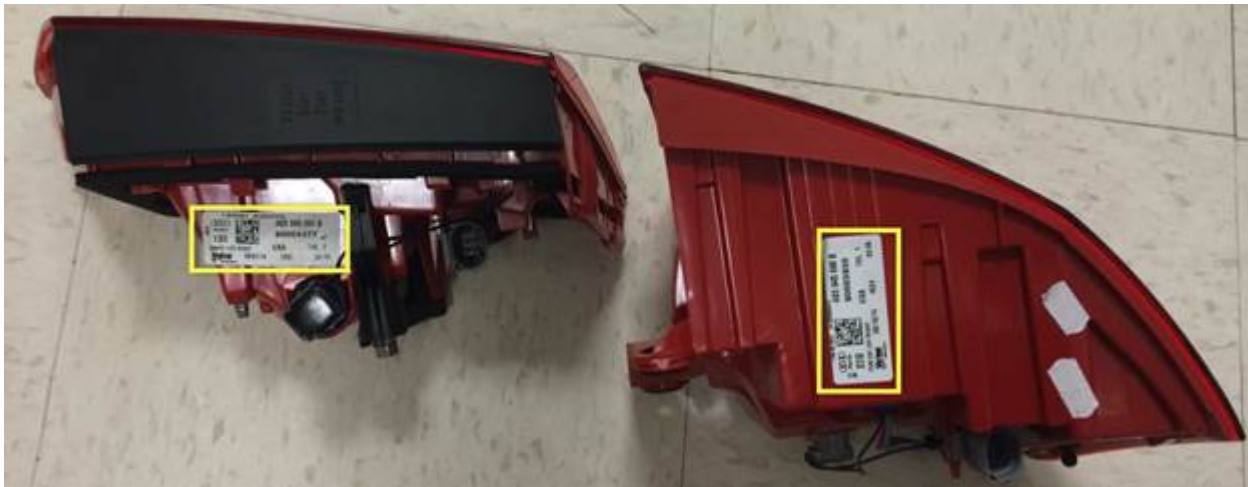
Figure 1. Location of date information.

Replace any taillights with logged DTC entries. Ensure that the updated taillights with the optimized transistor are used. The updated taillights have production date August 11, 2014 or newer, written as 11/08/2014 (DD/MM/YYYY) (Figure 1, Figure 2, Figure 3).

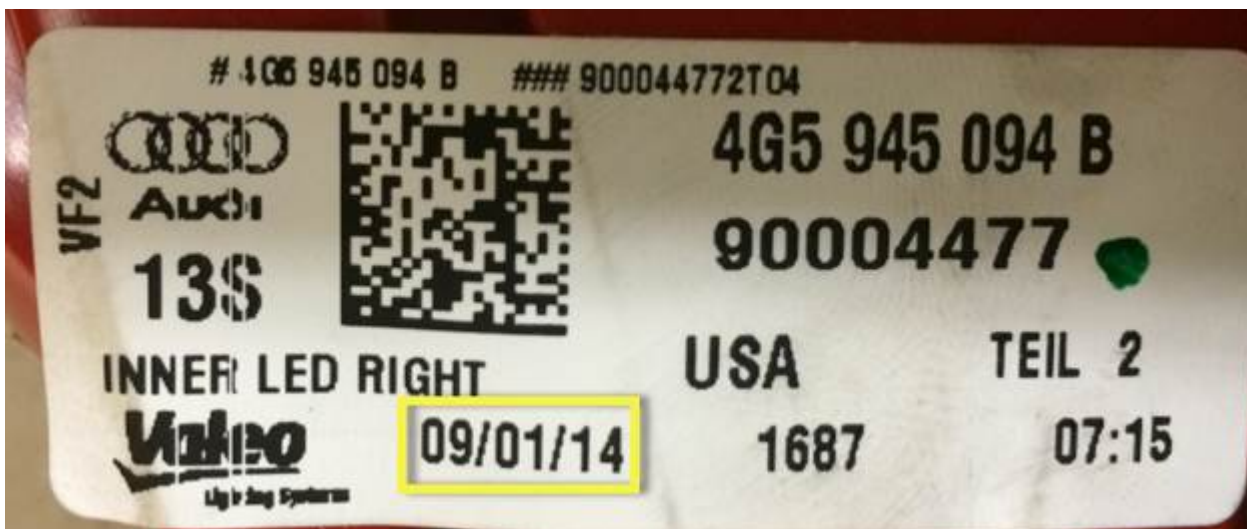
Figure 2. Location of production date, shown as DD/MM/YYYY. The production date of this taillight is January 9, 2014.

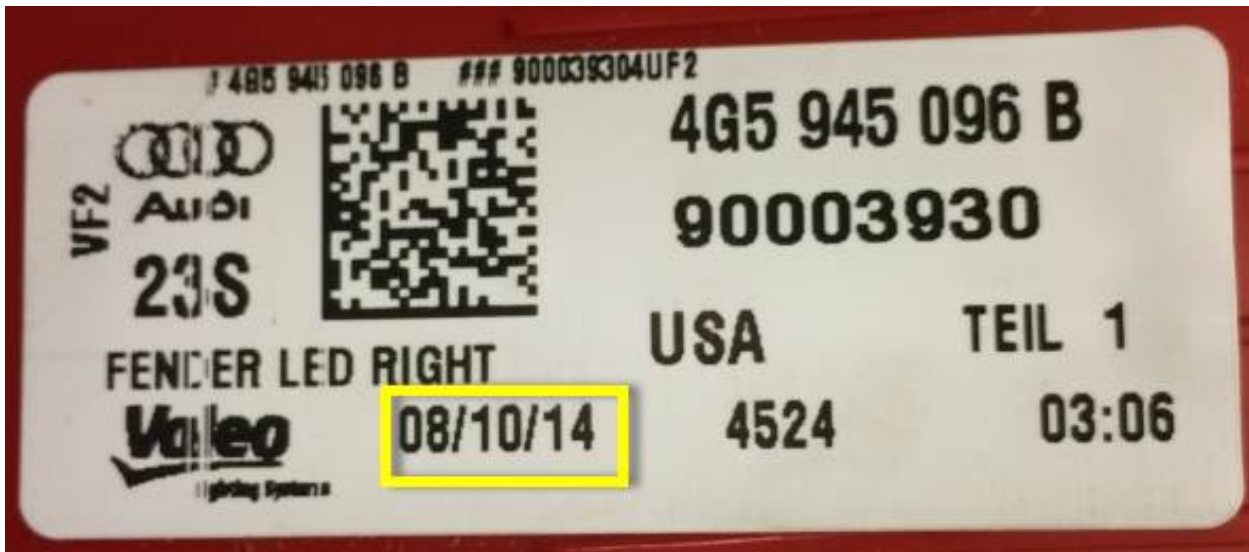
Figure 3. Location of production date, shown as DD/MM/YYYY. The production date of this taillight is October 8, 2014.
