Technical Service Bulletin

01 MIL on (DTC P0491 and P0492)

01 15 11 2039899/1 March 3, 2015.

Model(s)	Year	VIN Range	Vehicle-Specific Equipment
Q7	2011 - 2015	All	3.0T engine

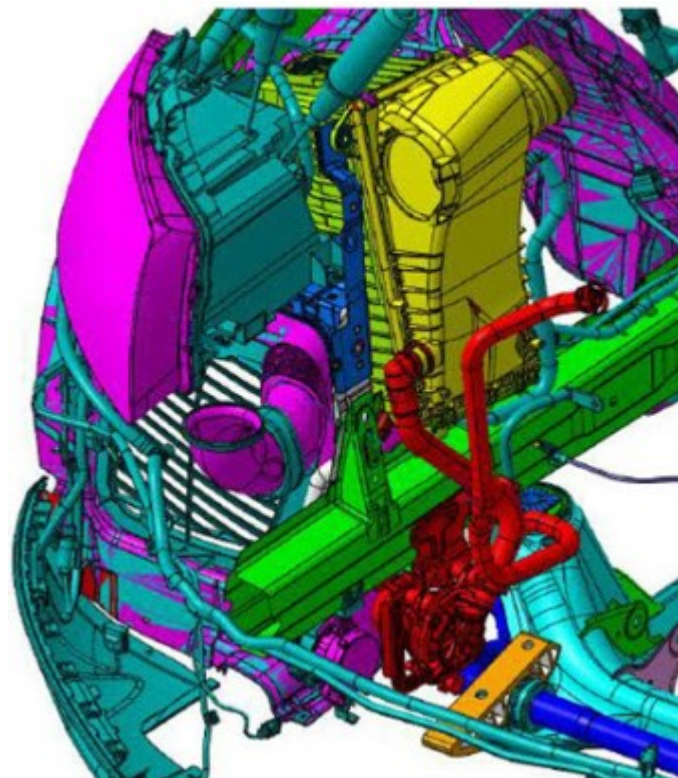
The pump has a different air hose connection and mounting points, so the intake and exhaust hose of the pump and the bracket must also be replaced (Figure 1, red).

Figure 1. All components highlighted in red must be replaced.

1. In ODIS, perform the “Secondary Air System Check” in Basic Settings. If the secondary air pump does not run, or if it makes a damaged bearing noise, replace the pump.
